Report Type: Work Plan

General Site Information:						
Site:	GJ West Coop SWD					
Company:	COG Operating LLC					
Section, Township and Range	Unit B	Sec 23	T17S	R29E		
Lease Number:						
County:	Eddy County					
GPS:	32.81175° N			104.07734° W		
Surface Owner:	State					
Mineral Owner:						
Directions:	From the intersection of CR 219 and Hwy 82, travel 5.5 miles down Hwy 82, turn left on CR 212 and travel 0.2 miles, turn right and travel 0.1 miles to site.

Re: Work Plan for the COG Operating LLC., GJ West Coop, Unit B, Section 28, Township 17 South, Range 29 East, Eddy County, New Mexico.

Work Plan

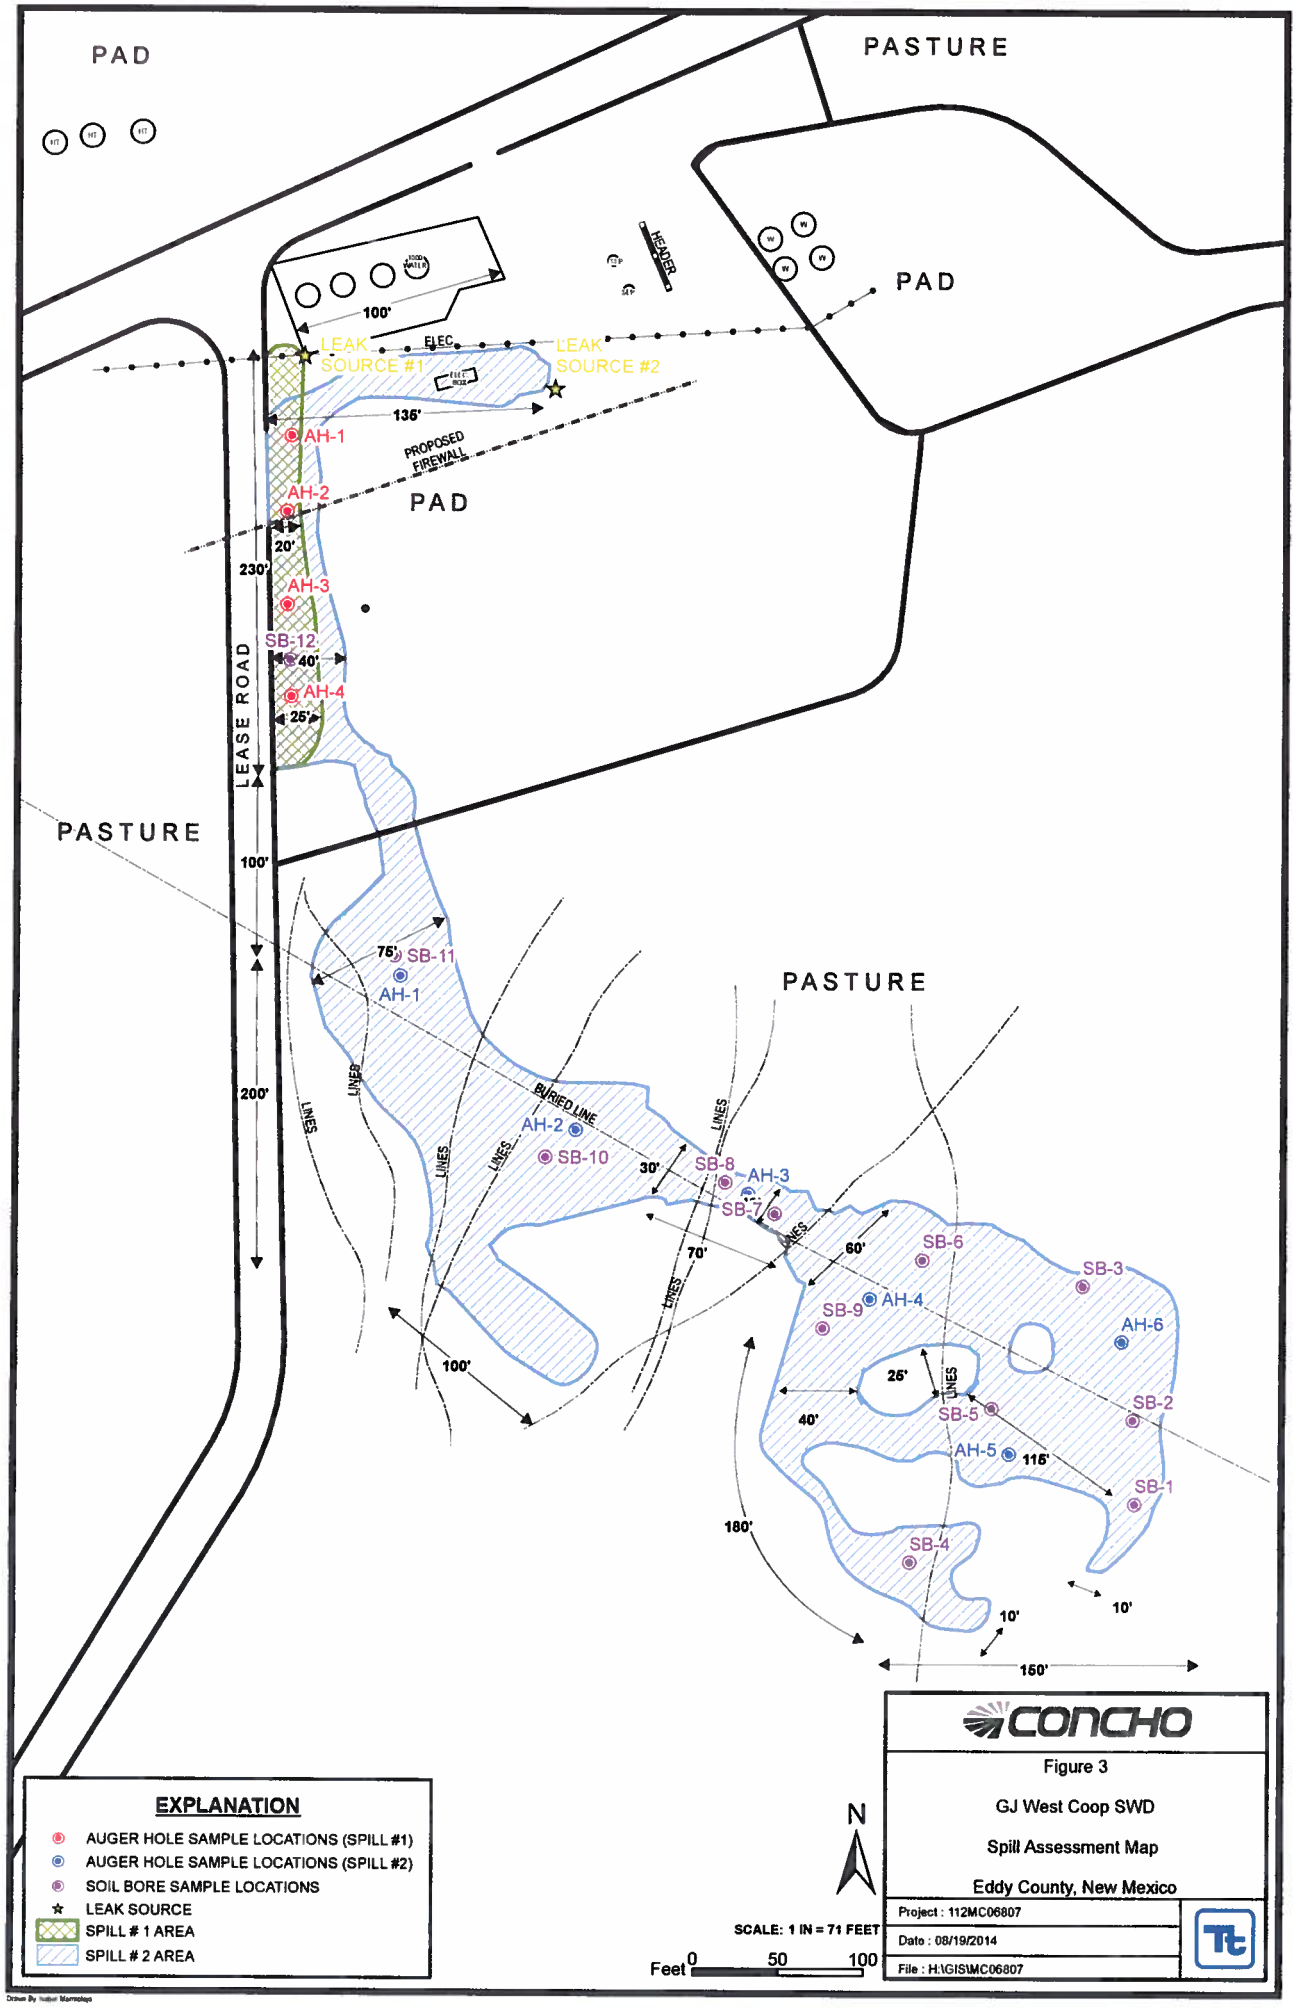
PAD
PASTURE
PAD
HEADER
100'
LEAK SOURCE #1
ELEC
LEAK SOURCE #2
136'
AH-1
PROPOSED FIREWALL
AH-2
PAD
20'
230'
AH-3
SB-12
40'
AH-4
25'
LEASE ROAD
PASTURE
100'
200'
75'
SB-11
AH-1
PASTURE
LINES
LINER
BURIED LINE
AH-2
SB-10
30'
SB-8
AH-3
SB-7
70'
60'
SB-6
SB-3
SB-9
AH-4
AH-6
100'
25'
40'
SB-5
SB-2
AH-5
115'
SB-1
180'
SB-4
10'
10'
150'
EXPLANATION
AUGER HOLE SAMPLE LOCATIONS (SPILL #1)
AUGER HOLE SAMPLE LOCATIONS (SPILL #2)
SOIL BORE SAMPLE LOCATIONS
LEAK SOURCE
SPILL # 1 AREA
SPILL # 2 AREA
N
SCALE: 1 IN = 71 FEET
Feet 0 50 100
CONCHO
Figure 3
GJ West Coop SWD
Spill Assessment Map
Eddy County, New Mexico
Project : 112MC06807
Date : 08/19/2014
File : H:\GIS\MC06807

COG proposes to remove impacted material as highlighted (green) in Table 1. Due to limited and access issues, the areas near AH-4, AH-5 and AH-6 will be excavated to a depth of approximately 3.0' to 4.0' below surface and capped with either a 40 mil plastic liner or clay.

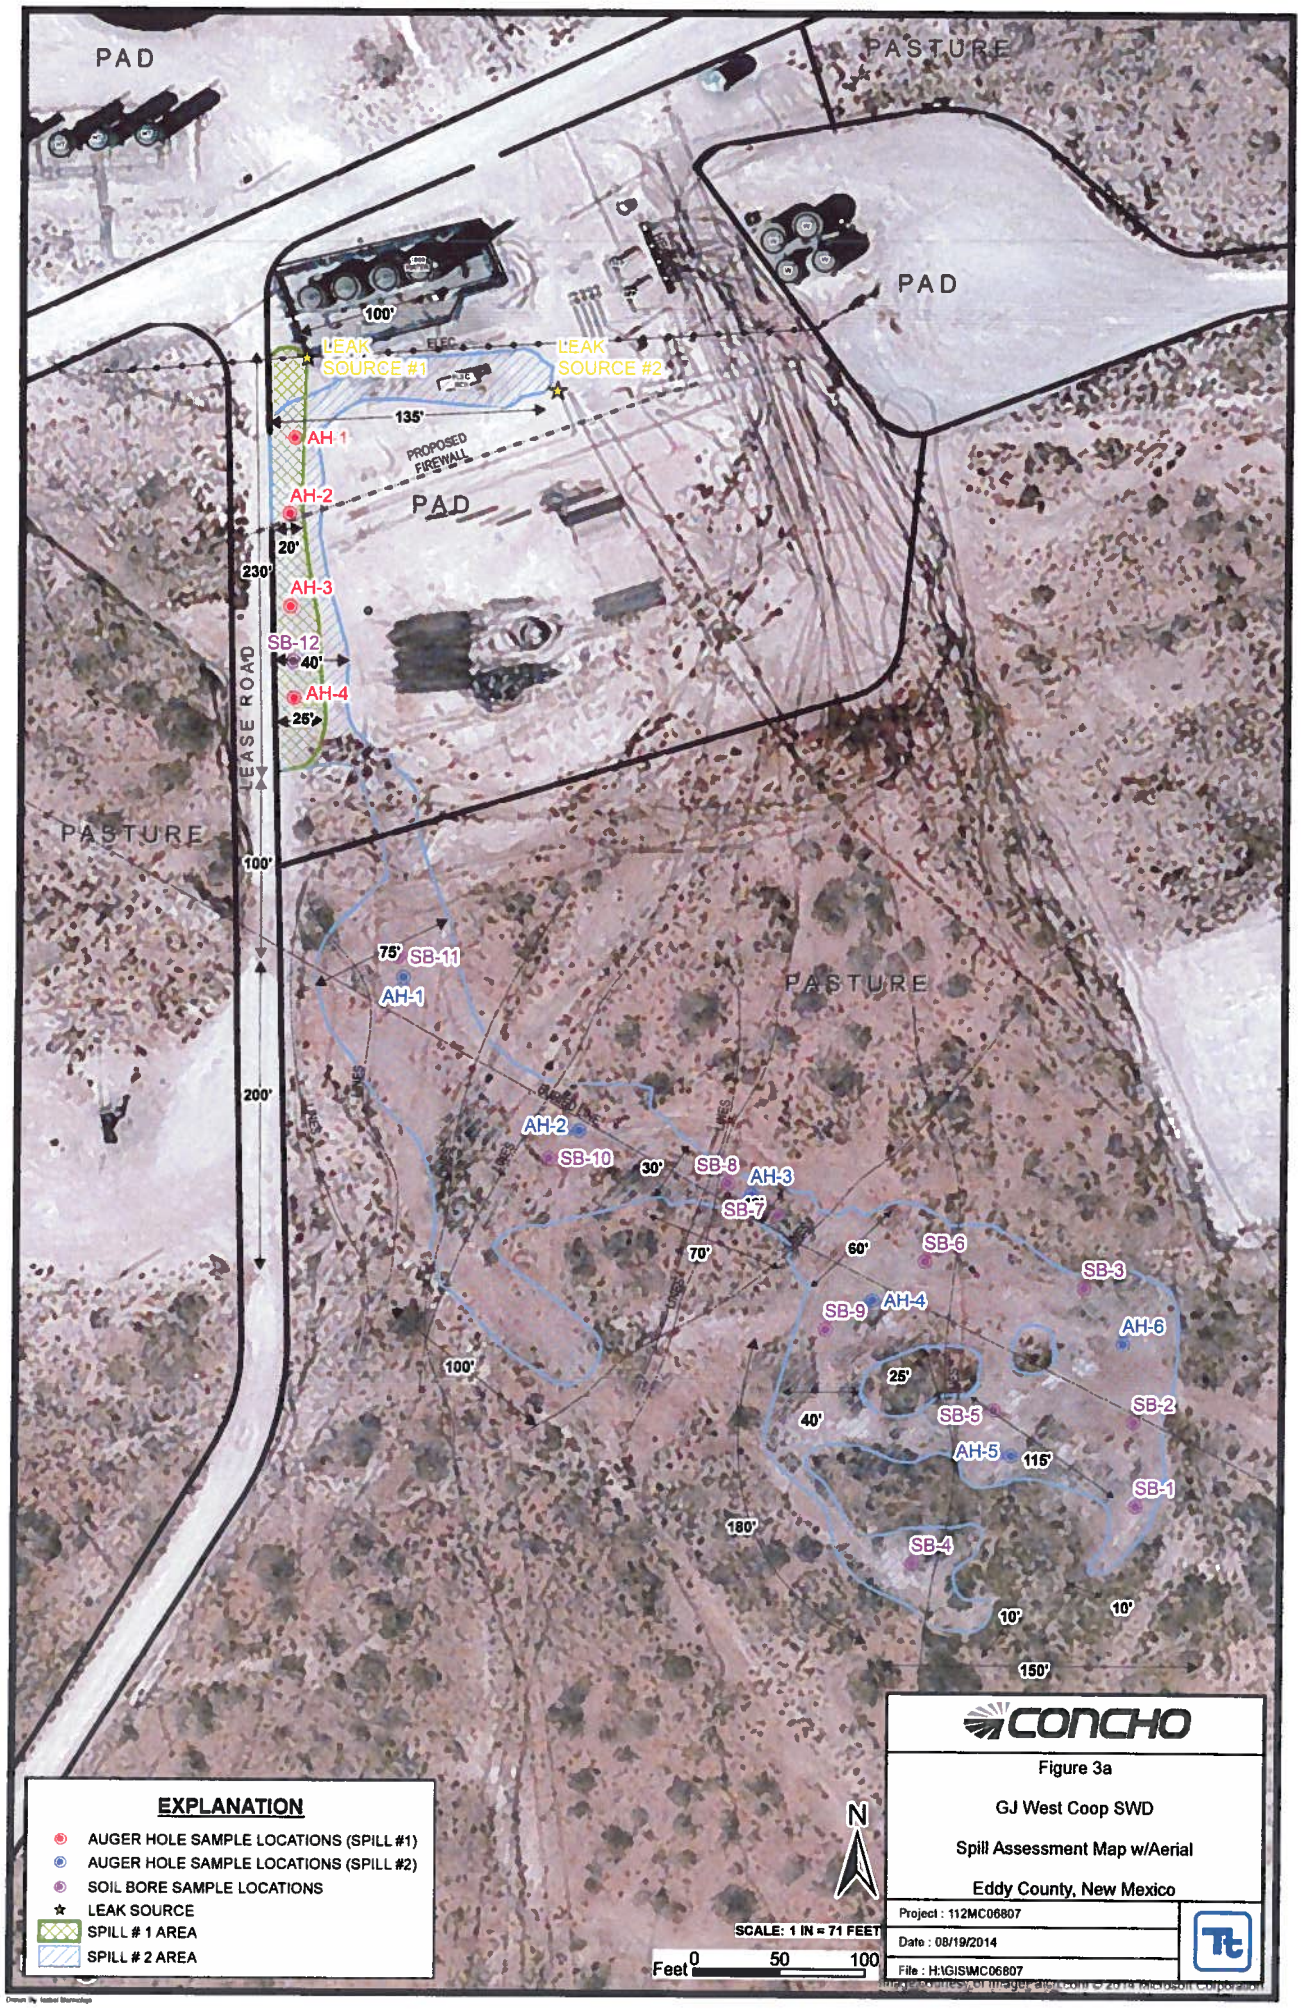
PAD
PASTURE
PAD
100'
LEAK SOURCE #1
ELEC
LEAK SOURCE #2
135'
AH-1
PROPOSED FIREWALL
AH-2
PAD
20'
230'
AH-3
SB-12
40'
AH-4
25'
LEASE ROAD
PASTURE
100'
75'
SB-11
AH-1
PASTURE
200'
AH-2
SB-10
30'
SB-8
AH-3
SB-7
70'
60'
SB-6
SB-3
SB-9
AH-4
AH-6
100'
25'
40'
SB-5
SB-2
AH-5
115'
SB-1
180'
SB-4
10'
10'
150'
EXPLANATION
AUGER HOLE SAMPLE LOCATIONS (SPILL #1)
AUGER HOLE SAMPLE LOCATIONS (SPILL #2)
SOIL BORE SAMPLE LOCATIONS
LEAK SOURCE
SPILL # 1 AREA
SPILL # 2 AREA
N
SCALE: 1 IN = 71 FEET
Feet 0 50 100
CONCHO
Figure 3a
GJ West Coop SWD
Spill Assessment Map w/Aerial
Eddy County, New Mexico
Project : 112MC06807
Date : 08/19/2014
File : H:\GIS\MC06807

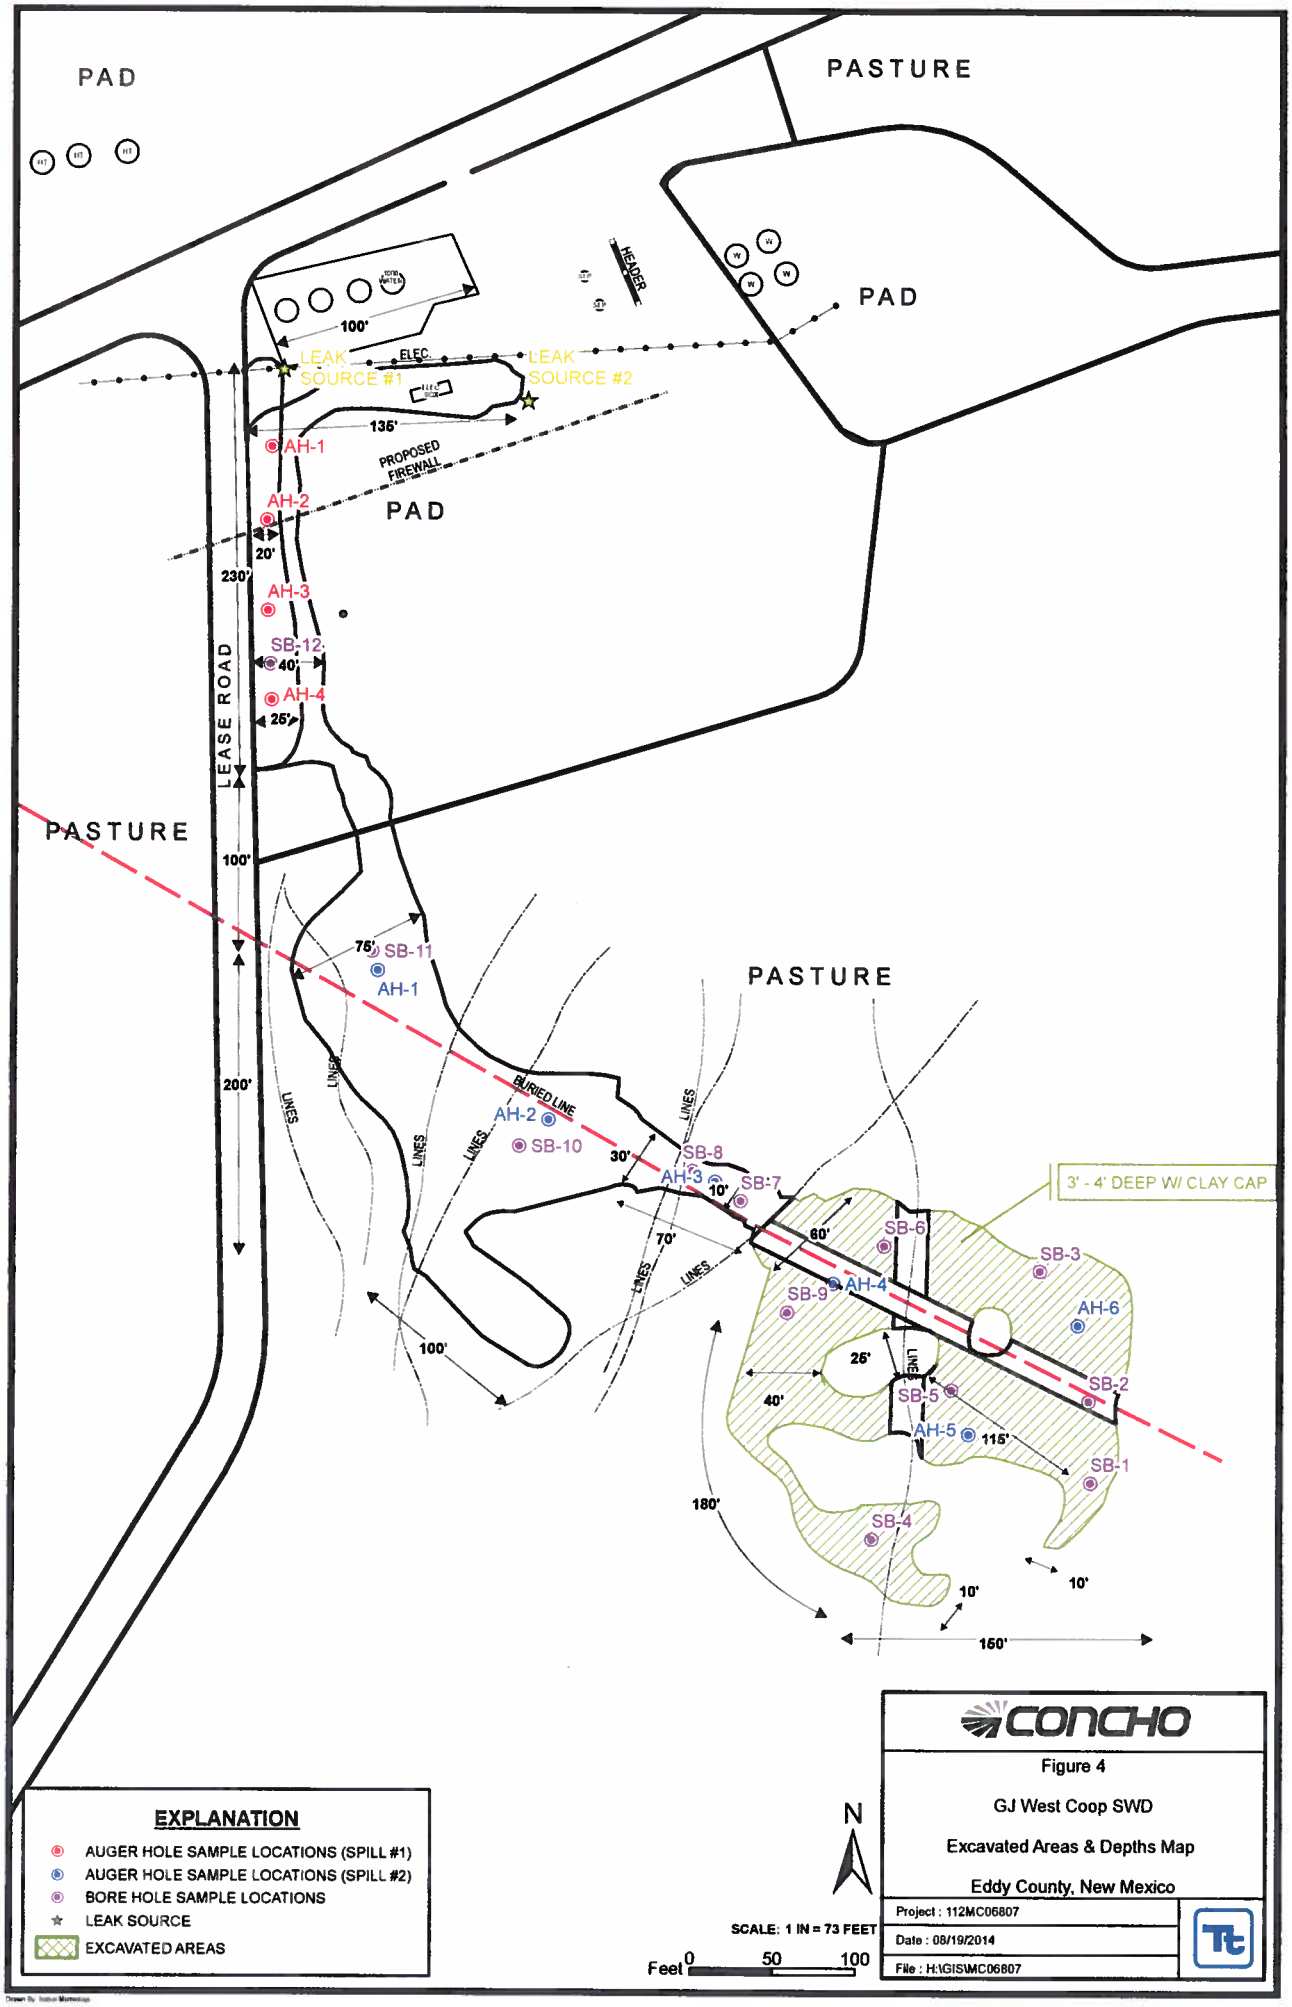
PAD
PASTURE
PAD
HEADER
100'
LEAK SOURCE #1
ELEC.
LEAK SOURCE #2
135'
AH-1
PROPOSED FIREWALL
AH-2
PAD
20'
230'
AH-3
SB-12
40'
AH-4
25'
LEASE ROAD
PASTURE
100'
75'
SB-11
AH-1
200'
PASTURE
BURIED LINE
AH-2
SB-10
30'
SB-8
AH-3
10'
SB-7
3' - 4' DEEP W/ CLAY CAP
60'
SB-6
SB-3
AH-4
SB-9
AH-6
70'
100'
25'
40'
SB-5
SB-2
AH-5
115'
SB-1
180'
SB-4
10'
10'
150'
LINES
EXPLANATION
AUGER HOLE SAMPLE LOCATIONS (SPILL #1)
AUGER HOLE SAMPLE LOCATIONS (SPILL #2)
BORE HOLE SAMPLE LOCATIONS
LEAK SOURCE
EXCAVATED AREAS
N
SCALE: 1 IN = 73 FEET
Feet 0 50 100
CONCHO
Figure 4
GJ West Coop SWD
Excavated Areas & Depths Map
Eddy County, New Mexico
Project : 112MC06807
Date : 08/19/2014
File : H:\GIS\MC06807
