June 8, 2016

RE: Excavation Oversight Work-Plan
WPX Energy, Inc.
North Brushy Draw 35-12
Eddy County, NM

WPX Energy, Inc.
North Bushy Draw 35-12 Remediation
Eddy County, New Mexico

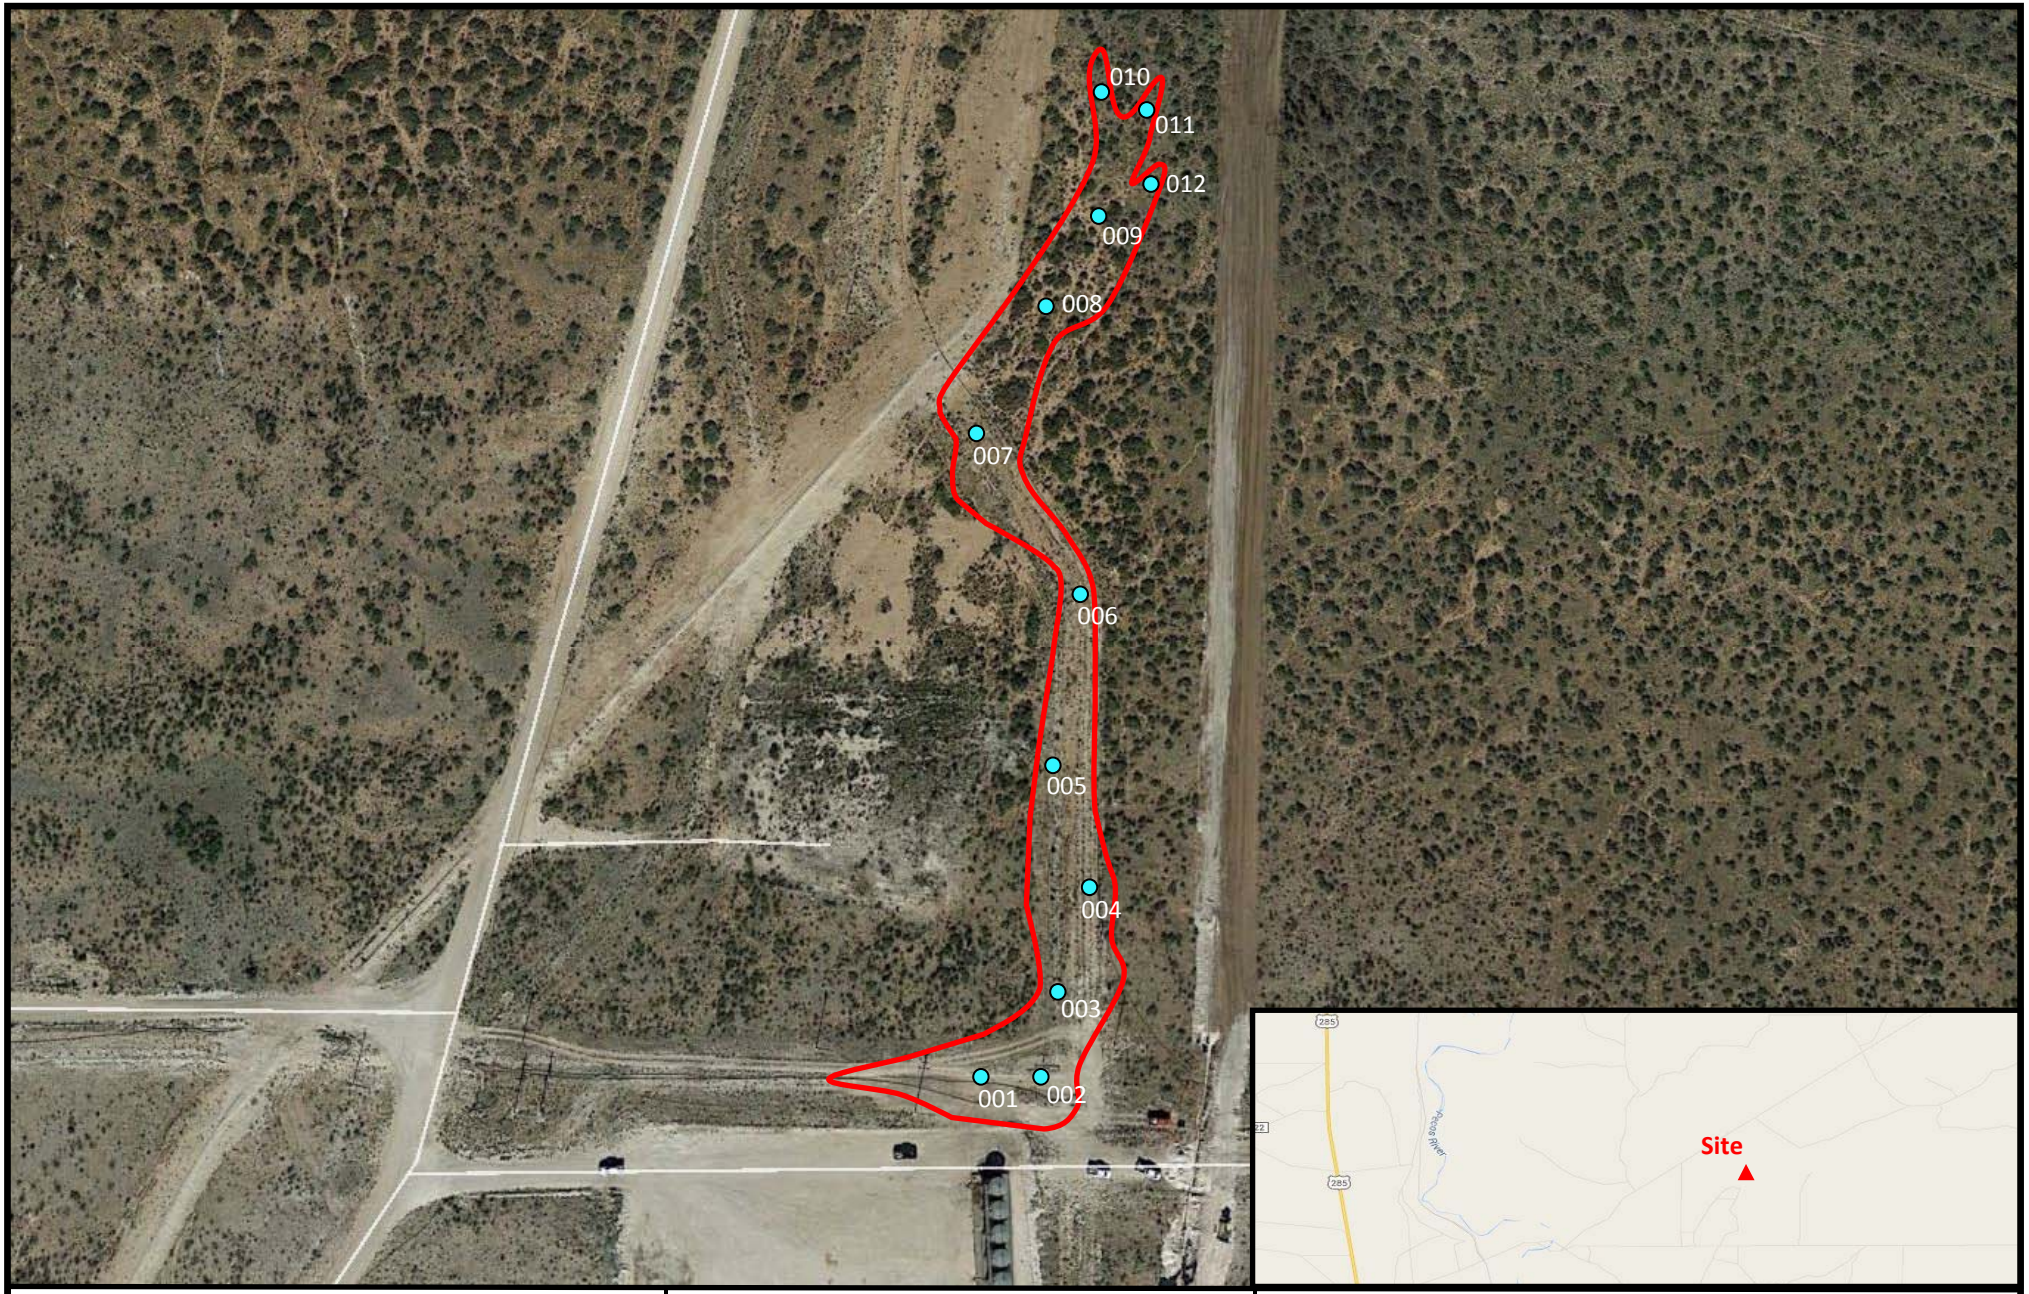
Figure 1: Site Map

This release occurred due to a valve malfunctioning at a water header, and an estimated 150 barrels (bbl) of produced water was released. The runoff path of the spill impacted approximately 1.25 square acres.

On May 16, 2016, ECS personnel visited the location to assess the release. ECS mapped the spill area and estimated the spill area. Initial samples were taken in 12 locations (001 through 012) between 0.5 to 3 feet bgs. Samples were collected in 4-ounce glass jars and transferred to Xenco Laboratories in Midland, Texas (accredited by the National Laboratory Accreditation Program (NELAP) for the technology and analytes necessary to demonstrate regulatory compliance) for Chlorides per EPA Method 300.0, total petroleum hydrocarbons (TPH) by method 8015 modified and benzene, toluene, ethylene, and xylenes (BTEX) by EPA method 8021B. A summary of the analytical results is provided in Table 1. Copies of the laboratory report and chain of custody documentation are provided in **Appendix C.**
