SUBJECT: SOIL REMEDIATION WORK PLAN FOR INCIDENT 2RP-755, State D SWD #001, UNIT N SECTION 16-T20S-R24E NMPM, API# 30-015-21572, EDDY COUNTY, NEW MEXICO

SOIL REMEDIATION WORK PLAN FOR INCIDENTS 2RP-755 AND NMLB0610137549 (NO RP #) EOG Y RESOURCES, INC.

STATE D SWD #001
UL N, SECTION 16, T20S R24E, NMPM
API #30-015-21572
EDDY COUNTY, NM

March 20, 2017
SMA Reference
5E25868 BG3

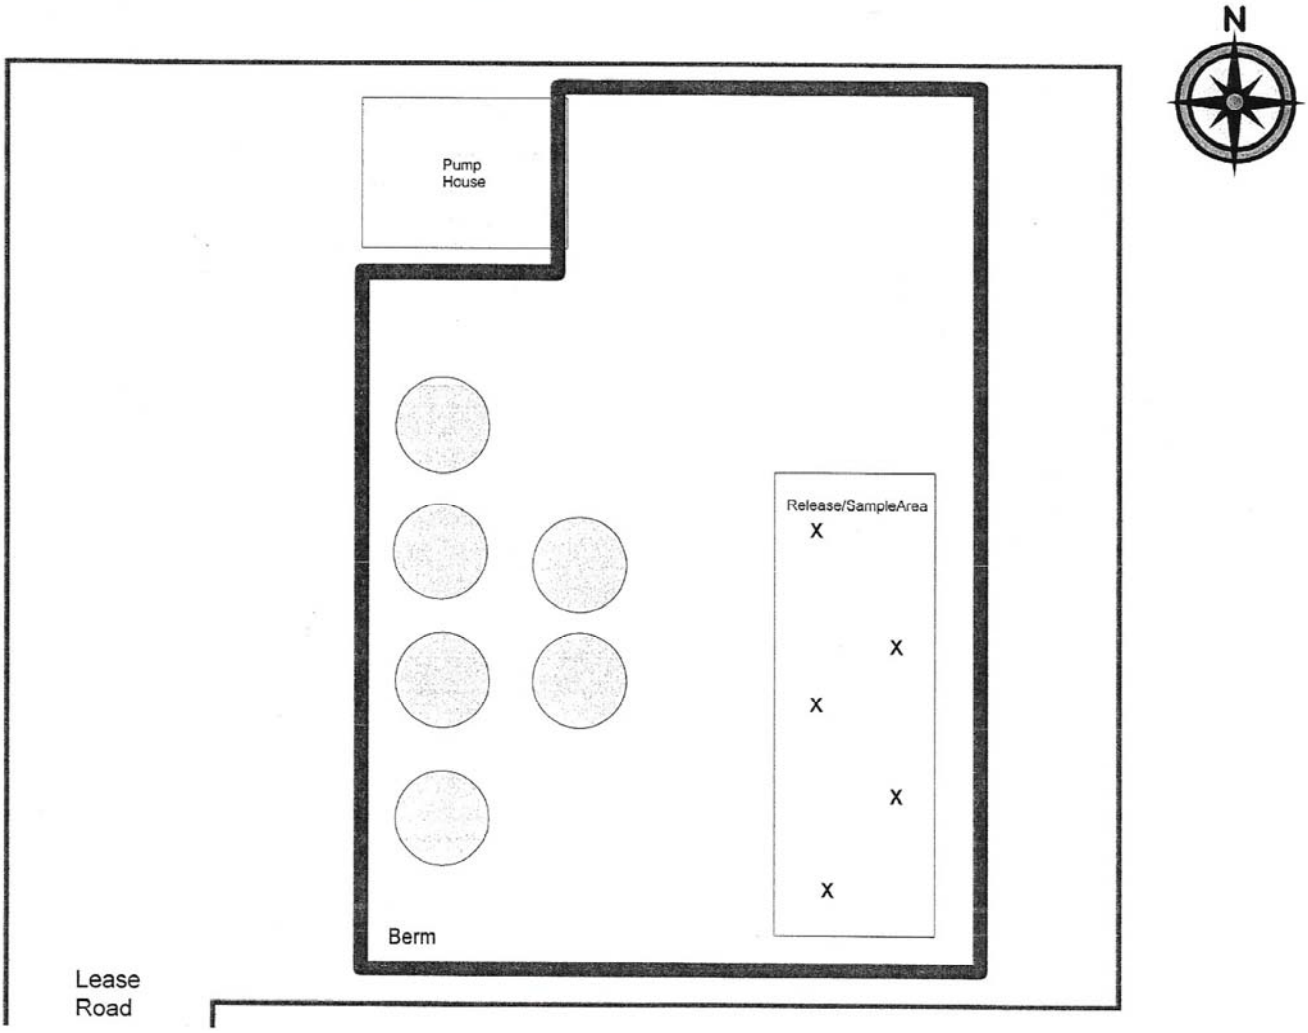
Figure 2

On March 6, 2017 SMA field personnel were on site to assess the release area using a mobile chlorides titration kit EPA method 9045D meter. The potentially affected area was found to be approximately 90 feet long and 30 feet wide within the battery, and 125 feet long and 40 feet wide outside the battery to the south and east sides. Further details about the project can be found in NMOCD Online Records under "Soil Remediation Work Plan for Incident 2RP-755." All samples were collected and processed according to NMOCD soil sampling procedures. Samples were collected in two locations and sent under chain-of-custody protocols to Hall Environmental Analysis Laboratory for analysis for Total Chlorides using EPA Method 300.0.

Soil contaminant concentrations found during the initial delineation are illustrated in Figure 2. A summary of the laboratory analyses is included in Table 3. Laboratory reports are included in Appendix A.

Site Ranking is Zero (0). Depth to Ground Water >100' (approx. 350').
All results are ppm. Chloride results are for documentation. **X - Sample Points**

SMA proposes to excavate the area within the battery to 3 feet. Since excavation in the battery will be a major undertaking, SMA proposes to obtain the vertical delineation of chlorides at the time of excavation. TPH and BTEX confirmation samples will also be collected for bottom hole and sidewalls. SMA will then request backfill approval from the OCD.

With approval from area utilities owners via 811 and NMOCD, SMA proposes to excavate the pasture to 1 foot. Sidewall and bottom hole confirmation samples will be collected.
