Delineation and Site Characterization Report

Oilfield Water Logistics SWD Operating, LLC Produced Water Release
Fulfer Saltwater Disposal Facility
Unit Letter F and G, Section 25, T25S, R36E,
Lea County, New Mexico Case No. 1RP-5489

RE: **Delineation and Site Characterization Report: Oilfield Water Logistics (OWL) SWD Operating, LLC, Fulfer Saltwater Disposal (SWD) Facility, Unit Letter F and G, Section 25, T25S, R36E, Lea County, New Mexico – Case No. 1RP-5489**

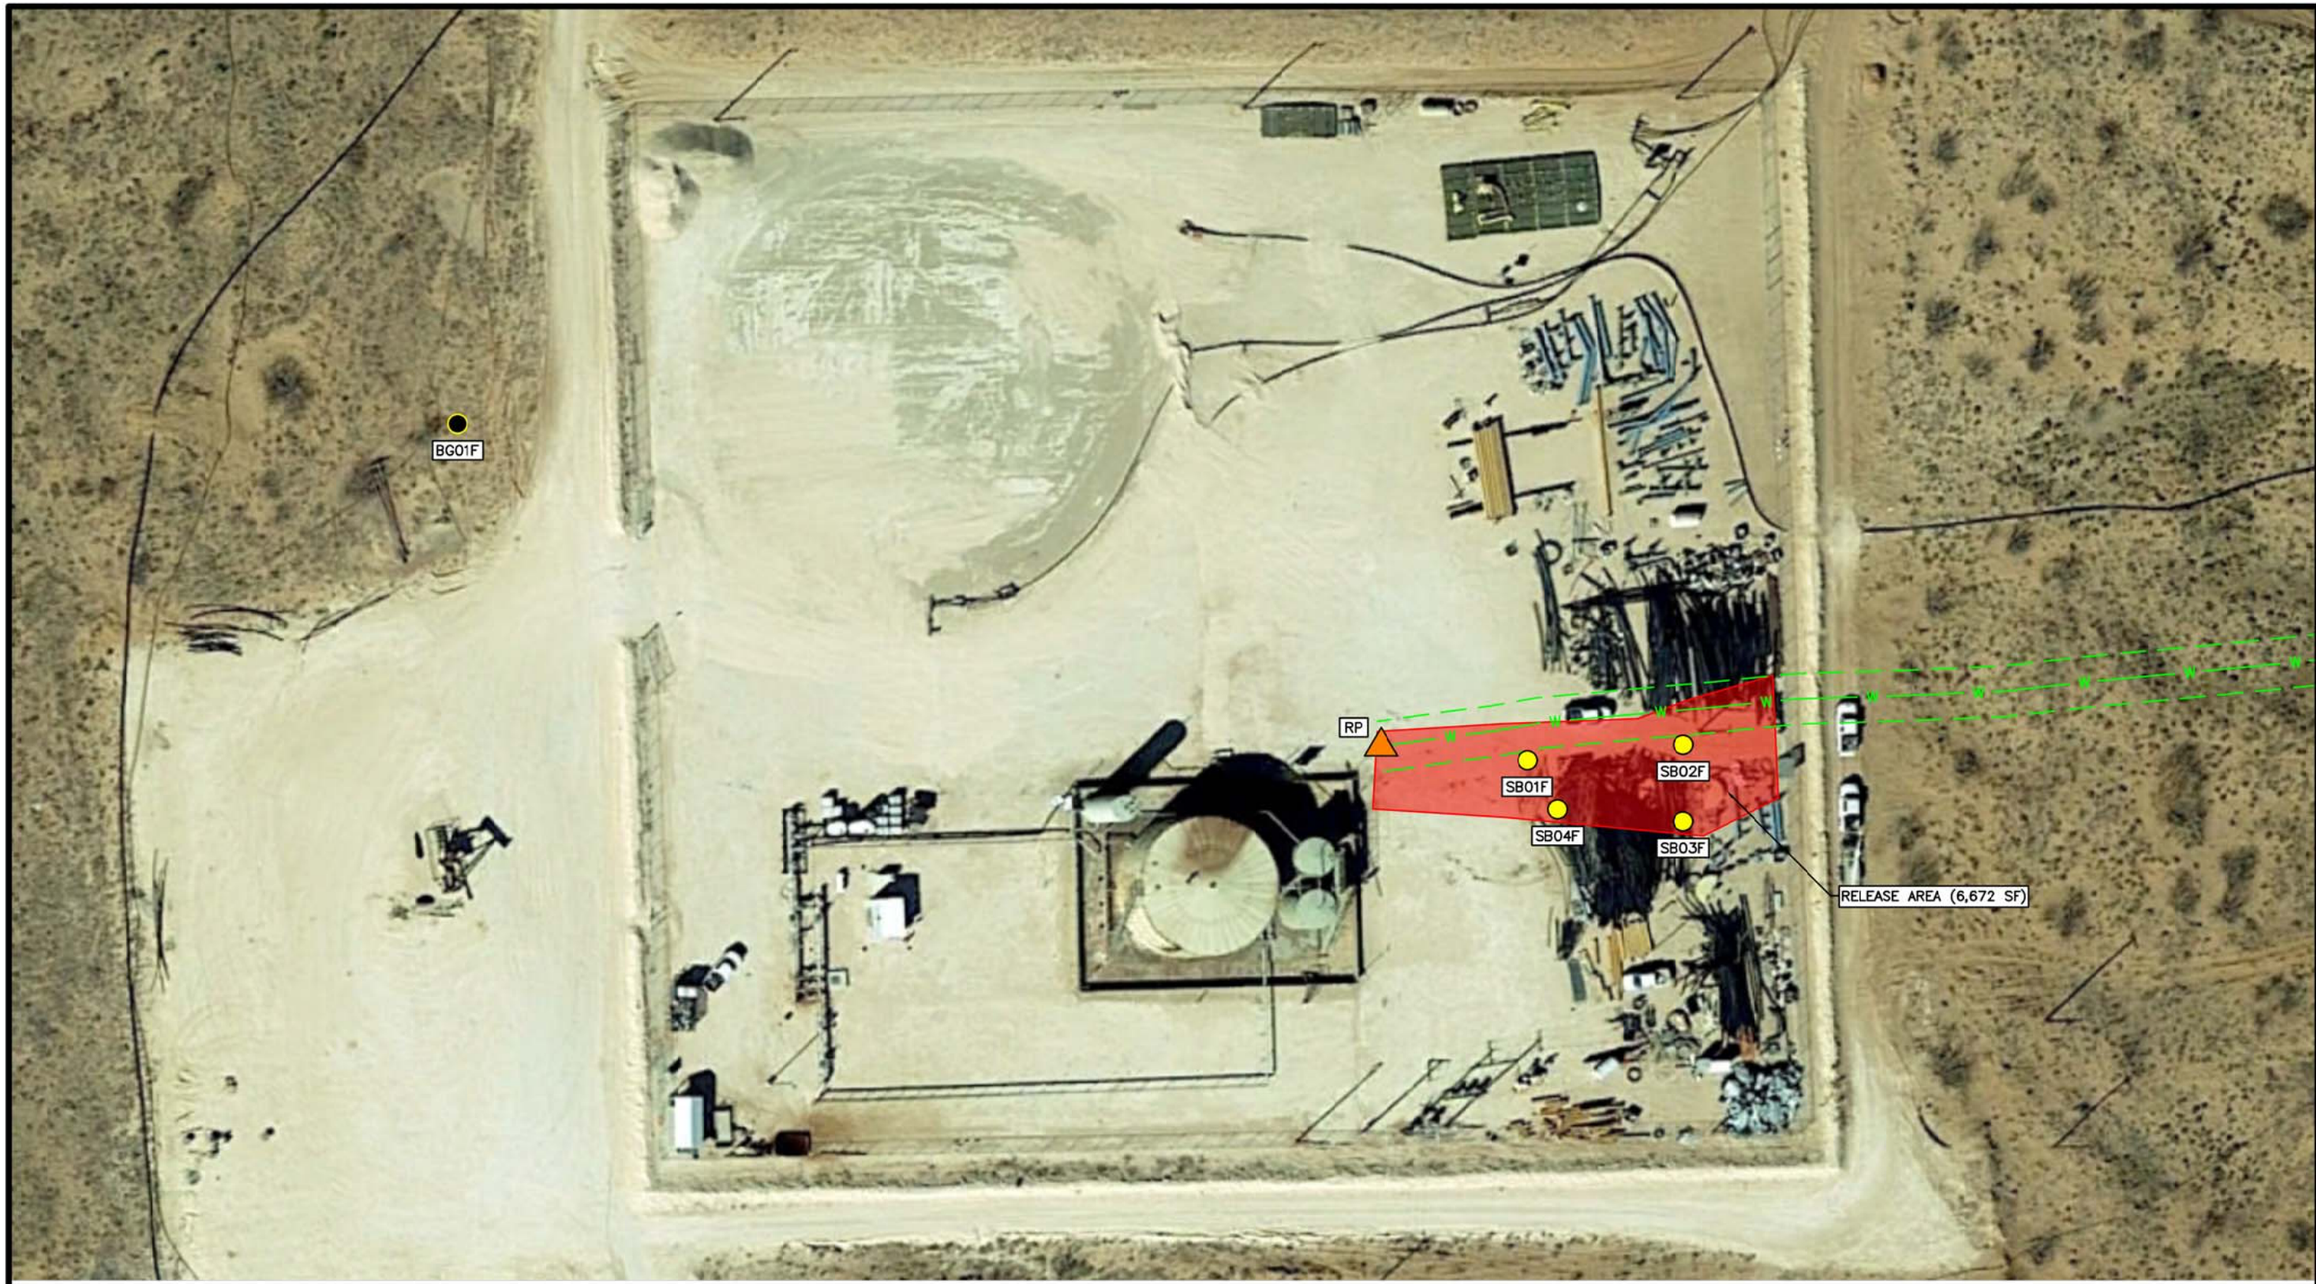
Figures

On April 30, 2019, KJE was provided notification by Mr. Phillip Sanders, Safety Director with OWL SWD Operating, LLC, regarding a release of produced water at the Fulfer SWD facility located approximately two (2) miles southwest of Jal, Lea County, New Mexico. According to OWL personnel, the hose from the discharge pump broke free and caused the release. KJE notified the NMOCD of the spill on May 2, 2019, and it was determined approximately 60 barrels (BBLs) of produced water was released. According to OWL personnel, the release occurred within the Fulfer SWD facility and did not breach the earthen berm located on the perimeter of the Fulfer well pad. In addition, KJE submitted Form C-141 to the NMOCD on May 3, 2019 for review. A response was received from Mr. Dylan Rose-Coss, with the NMOCD, indicating the incident was assigned remediation case number 1RP-5489. Additionally, based on conversations with Mr. James Amos, with the Bureau of Land Management (BLM), OWL was not required to perform an archeological survey for the Fulfer SWD facility. The general view of the spill is illustrated in Appendix A on Figure 1.
