Remediation Summary and Site Deferral Request

September 16, 2019

White Federal Com #001H (2RP-5470)

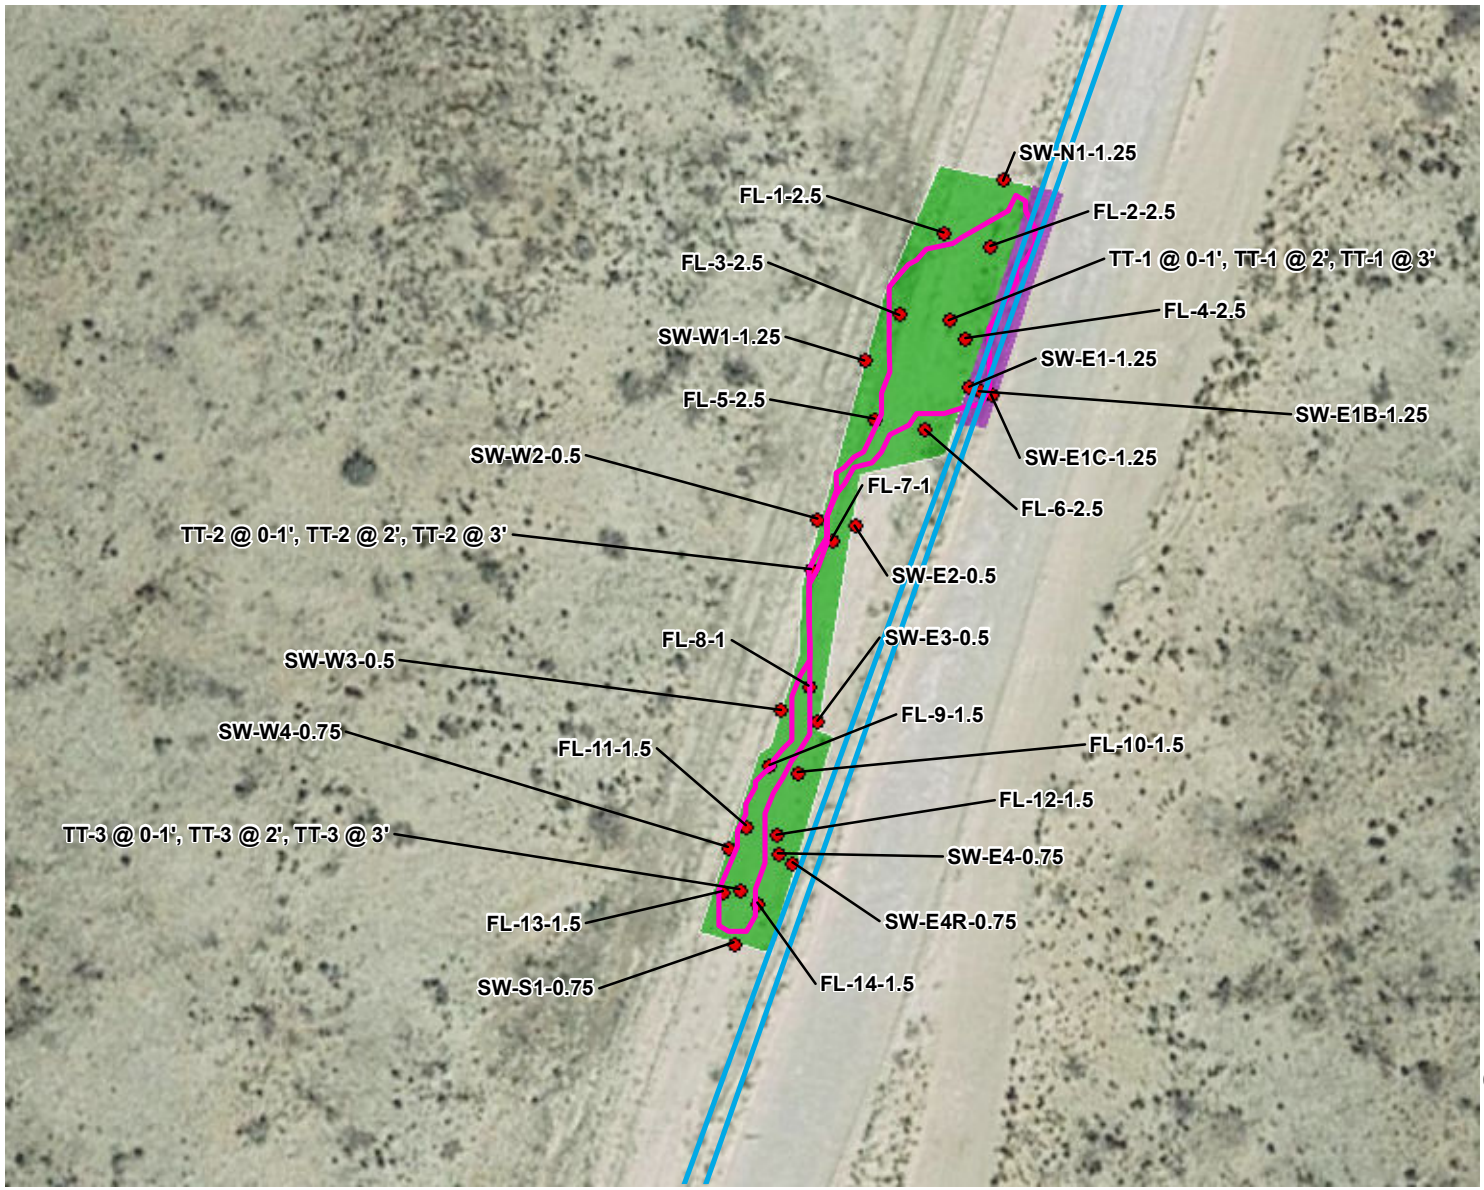
The sidewall represented by soil sample SW-E1-1.25 has been advanced laterally to the east to the maximum extent practicable. Two (2) surface flowlines lie immediately adjacent to the sidewall, which are immediately adjacent to a high traffic lease road. The distance from the excavated sidewall represented by soil sample SW-E1-1.25 and the adjacent high traffic lease road is approximately seven (7) feet. The soil sample represents approximately fifty (50) linear feet of sidewall. COG maintains further lateral excavation of the affected area represented by soil samples SW-E1-1.25, SW-E1B-1.25, and SW-E1C-1.25 in the affected pipeline corridor and adjacent high traffic lease road pose a risk which could result in potentially hazardous conditions and/or property damage. Based on laboratory results, the presence of a rock layer at approximately one (1) foot bgs which limits potential vertical migration of the contaminants of concern, the proximity to flowlines, and the high traffic lease road, COG requests remediation, restoration, and reclamation of the area represented by soil samples SW-E1-1.25, SW-E1B-1.25 and SW-E1C-1.25 be deferred until the equipment is removed during other operations and/or at time of abandonment, whichever occurs first. The area is approximately fifty (50) feet by seven (7) feet, or three-hundred and fifty (350) square feet.

On August 2, 2019, remediation activities commenced at the Release Site. The area represented by test trench location TT-1 was excavated to a depth of approximately thirty (30) inches bgs. The northern portion of the area represented by test trench TT-2 was excavated to a depth of approximately twelve (12) inches bgs. Excavated soil was stockpiled on a plastic liner, pending disposition at an NMOCD approved disposal facility. Seven (7) five-point composite floor confirmation soil samples (FL-1-2.5, FL-2-2.5, FL-3-2.5, FL-4-2.5, FL-5-2.5, FL-6-2.5, FL-7-1) were collected from the base of the excavation. Five (5) five-point composite sidewall confirmation soil samples (SW-N1-1.25, SW-E1-1.25, SW-W1-1.25, SW-W2-0.5, and SW-E2-0.5) were collected from the excavation walls. The sidewall represented by soil sample SW-E1-1.25 was advanced to the east to the maximum extent practicable without interfering with the adjacent surface flowlines and a high traffic lease road. To characterize the area between the sidewall and the lease road, two (2) grab samples (SW-E1B-1.25 and SW-E1C-1.25) were collected adjacent to SW-E1-1.25 at 1.25 feet bgs. Collected soil samples were submitted to Xenco Laboratories in Midland, TX for chloride and/or TPH and BTEX analyses. TPH and BTEX concentrations were below laboratory reporting limits in each sample submitted for TPH and BTEX analyses. Chloride concentrations were below NMOCD regulatory guidelines in each submitted soil sample, with the exception of soil samples SW-E1-1.25, SW-E1B-1.25, and SW-E1C-1.25. Excavation continued to the south and the remainder of the area represented by soil sample TT-2 was excavated to twelve (12) inches bgs and the area represented by soil sample TT-3 was excavated to eighteen (18) inches bgs.

The excavated material was transported under manifest to the R360 Red Bluff facility for final disposition. The excavation was backfilled to grade with locally sourced, non-impacted 'like' material. A review of the analytical results indicated the collected soil samples exhibited concentrations below NMOCD regulatory guidelines for each constituent of concern, with the exception of the area represented by soil samples SW-E1-1.25, SW-E1B-1.25, and SW-E1C-1.25. The locations of all confirmation soil samples are depicted in **Figure 4 – Excavation and Sample Location Map**. Laboratory analytical reports are located in **Appendix C**.
