DEVON ENERGY
Todd 22 Federal #2 Battery

Work Plan

U/L B, Section 22, T23S, R31E
Eddy County, New Mexico

2RP-5341

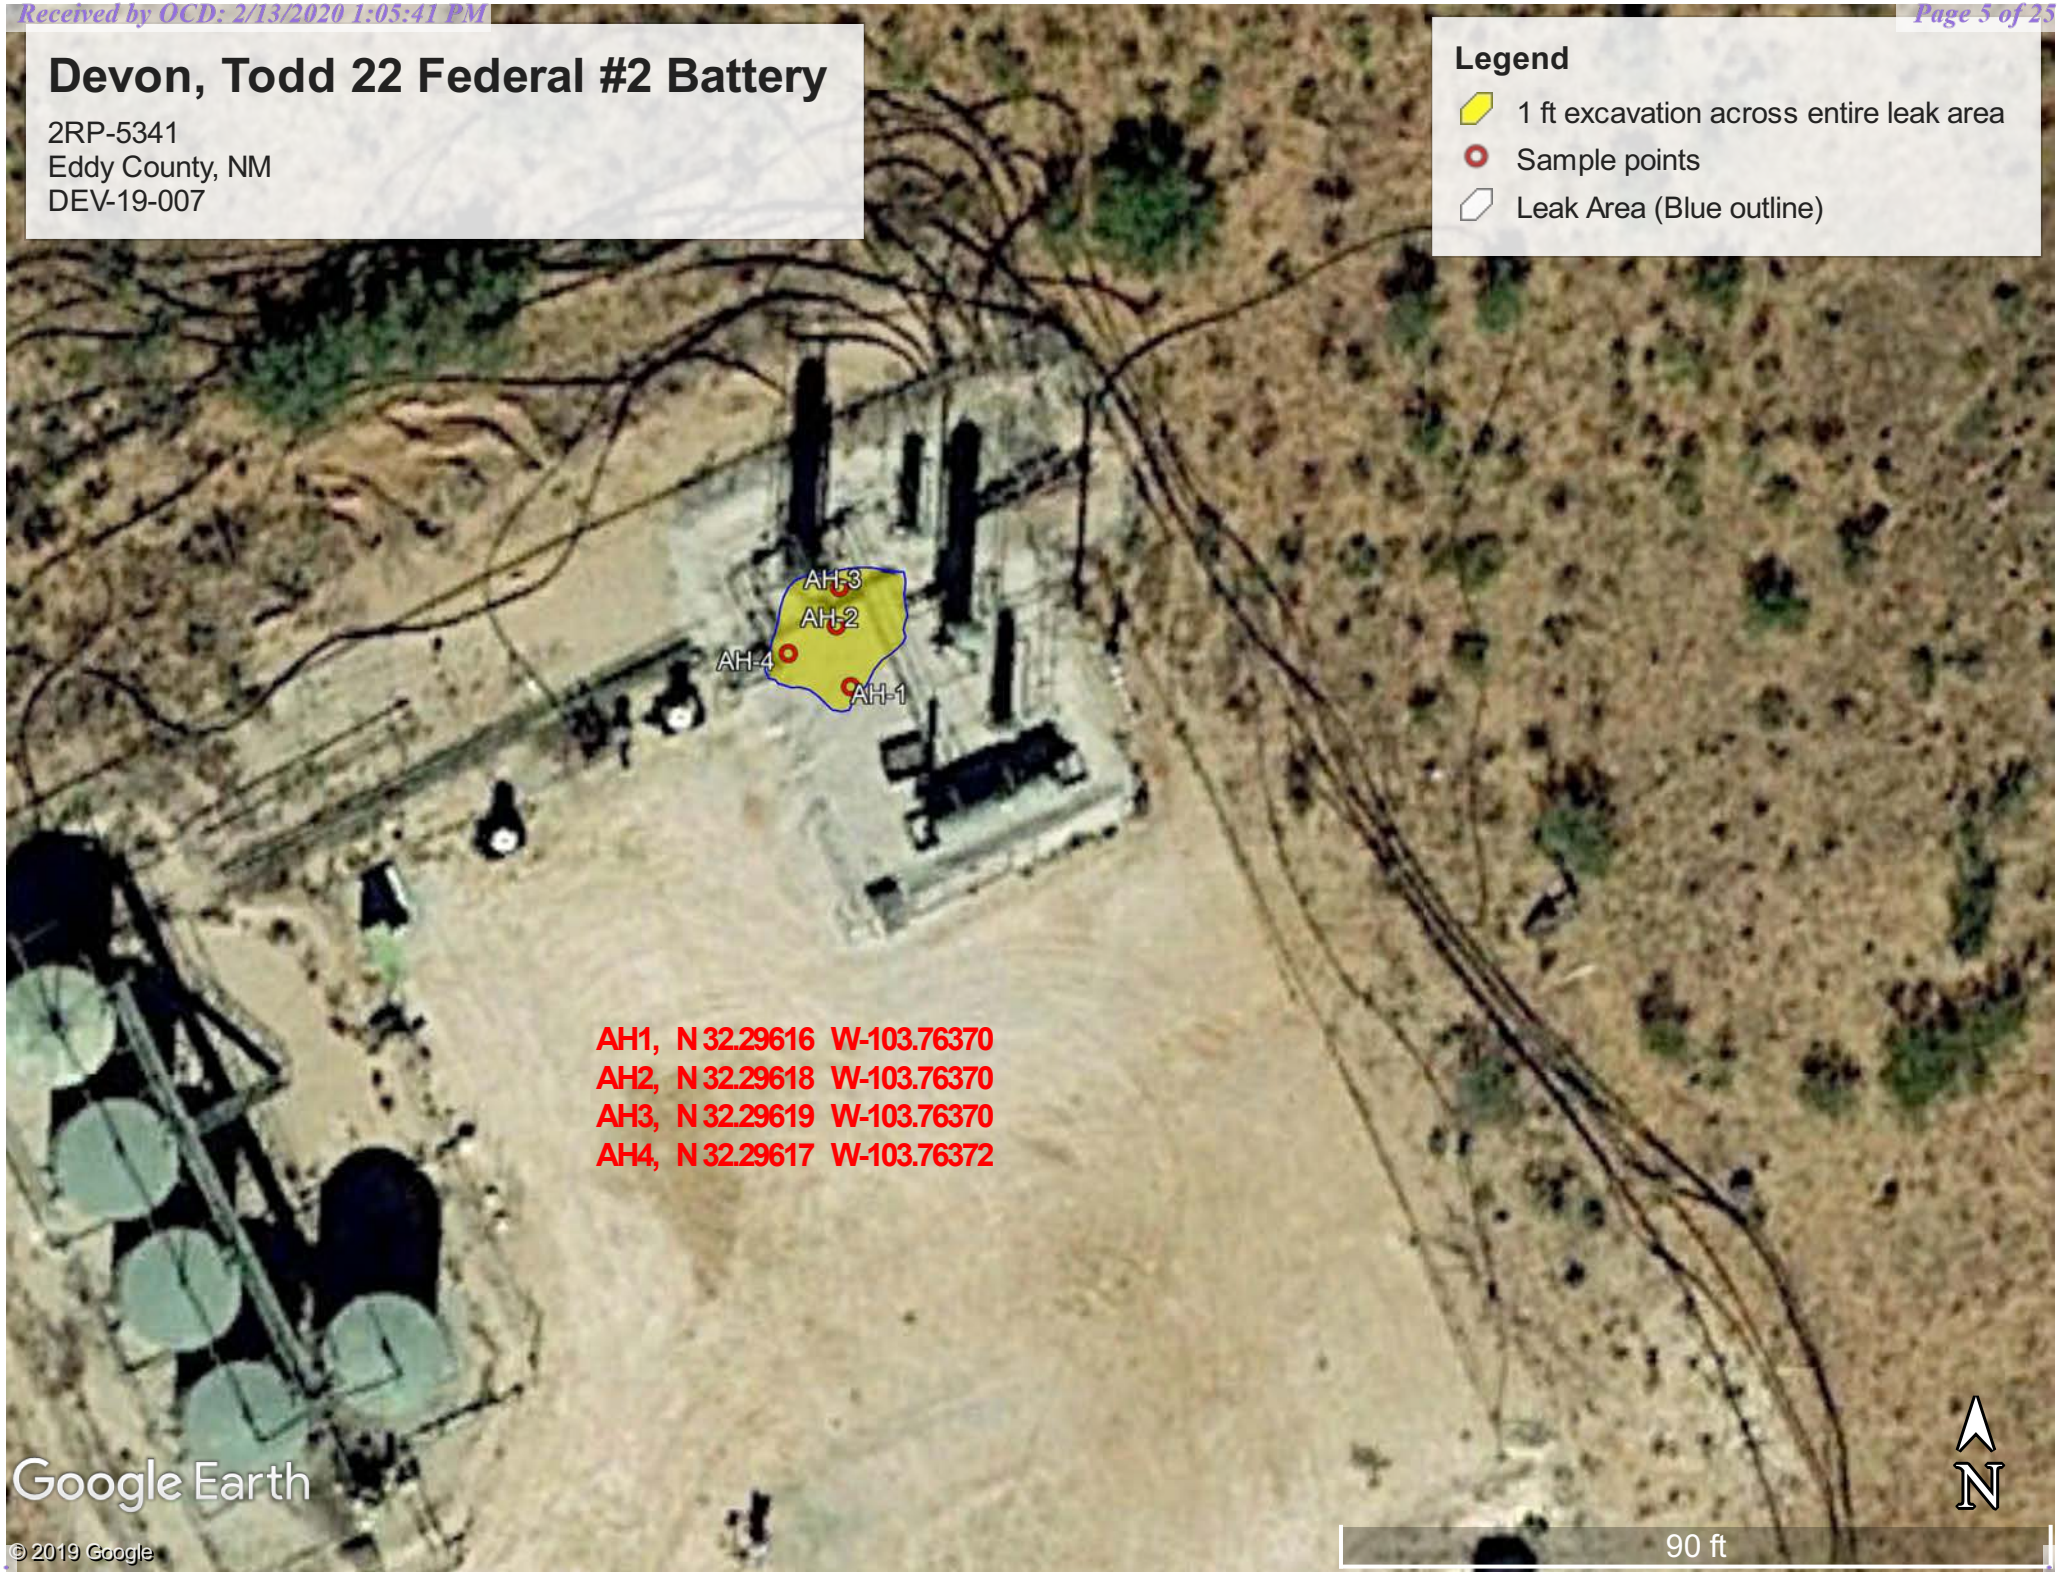
According to the C-141, a 2 foot water line from the heater developed an 1 inch hole due to corrosion which caused 19 bbls of produced water to leak on location.

The site has been fully delineated according to the NMOCD NMAC 19.15.29 published guidelines. At 1 foot bgs, all BTEX are non-detectable. All chloride results were below the required 20,000 ppm at surface and at 1 foot. And, although TPH levels were above 2,500 ppm at the surface, they were well below the standard at 1 foot.

Based on the results of the lab analysis, depth to groundwater, and the additional supplemental information provided in this report, SESI recommends feasible hand removal of the contaminated material to a depth of one foot. Approximately 300 ft3 of material will be removed and disposed in a NMOCD approved facility. Bottom and Sidewall confirmation samples will be obtained and sent to a lab to verify that remediation efforts were successful. Once the lab results verify that removal of the contaminated material is received and closure requirements have been met, the excavated area will be backfilled with clean soil. SESI respectfully submits this work plan and requests approval by both NMCOD and the BLM. Upon approval, remediation efforts will be conducted within 90 days.

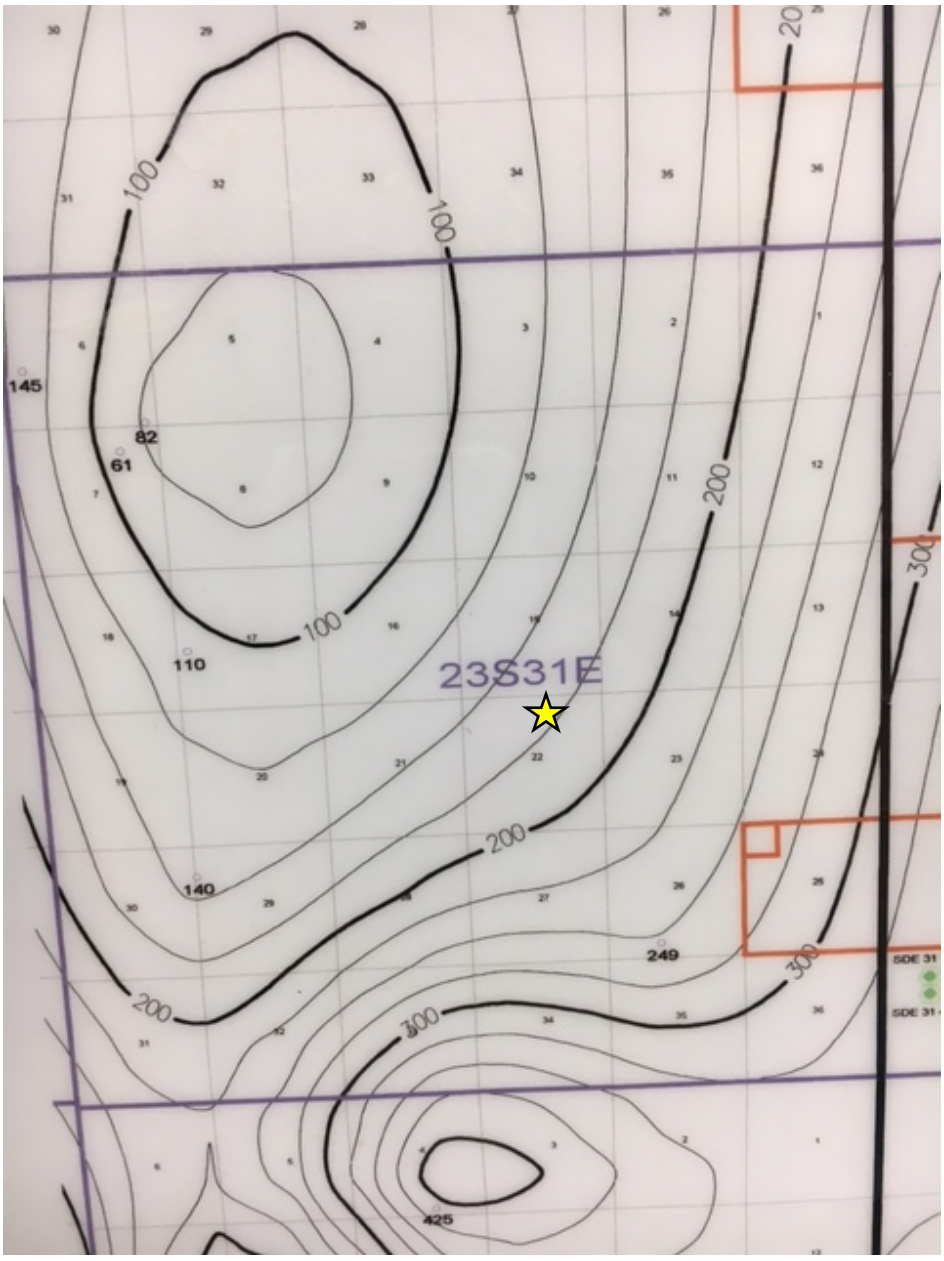
Groundwater: 175’
