Release Notification

Location:	**Remuda South 25 State 167H**	
Spill Date:	**2/29/2020**

RE: Closure Request
Remuda South 25 State 167H
Incident Number NRM2007254419
Eddy County, New Mexico

FIGURE 1
SITE LOCATION MAP
REMUDA SOUTH 25 STATE 167H
UNIT H SEC 25 T23S R29E
EDDY COUNTY, NEW MEXICO
XTO ENERGY, INC.

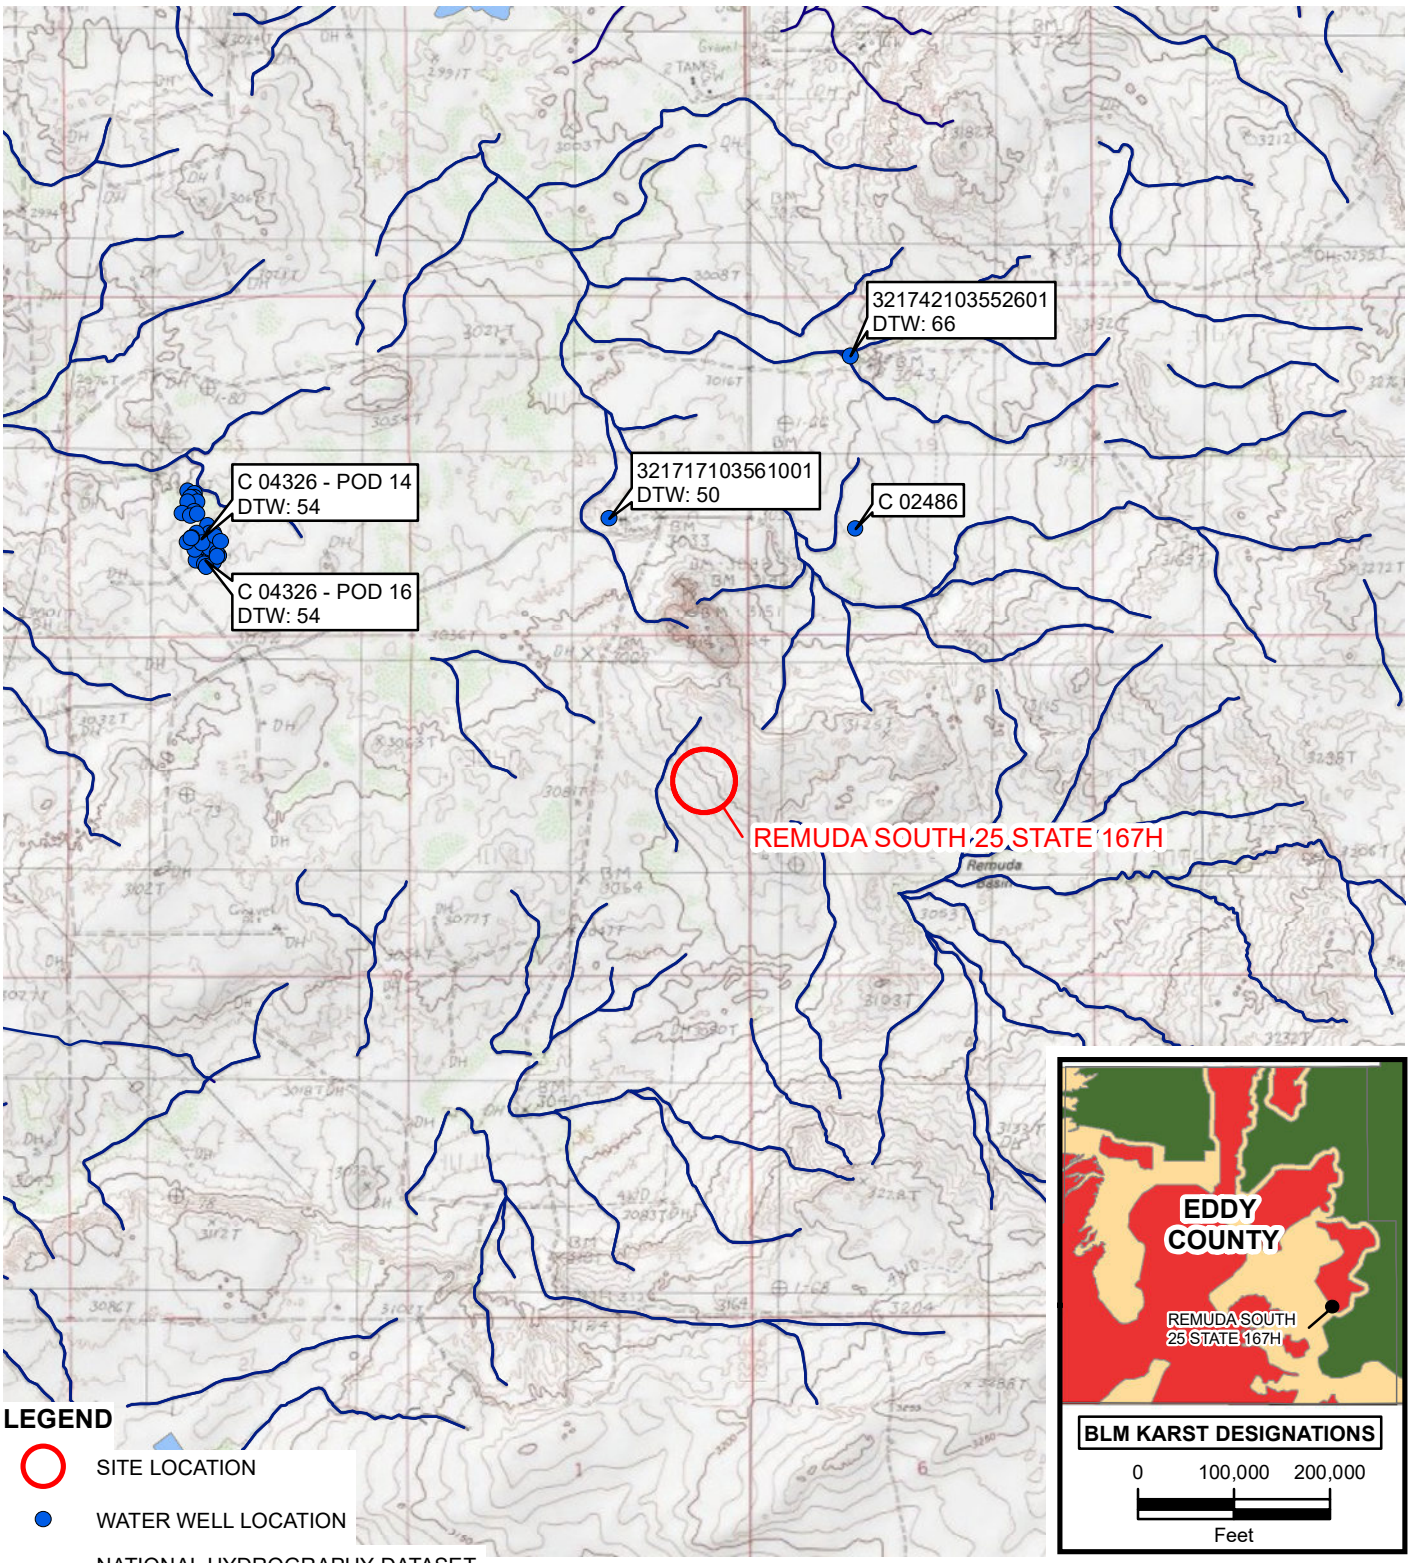
undetermined. Ground surface elevation at the groundwater well location is 3,034 feet above mean sea level (amsl), which is approximately 60 feet lower in elevation than the Site. The closest continuously flowing water or significant watercourse to the Site is an unnamed dry wash, located approximately 630 feet west-northwest of the Site. The Site is greater than 200 feet from a lakebed, sinkhole, or playa lake and greater than 300 feet from an occupied residence, school, hospital, institution, church, or wetland. The Site is greater than 1,000 feet to a freshwater well or spring and is not within a 100-year floodplain or overlying a subsurface mine. The Site is potentially underlain by unstable geology (high potential karst designation area). The Site receptors are identified on Figure 1.

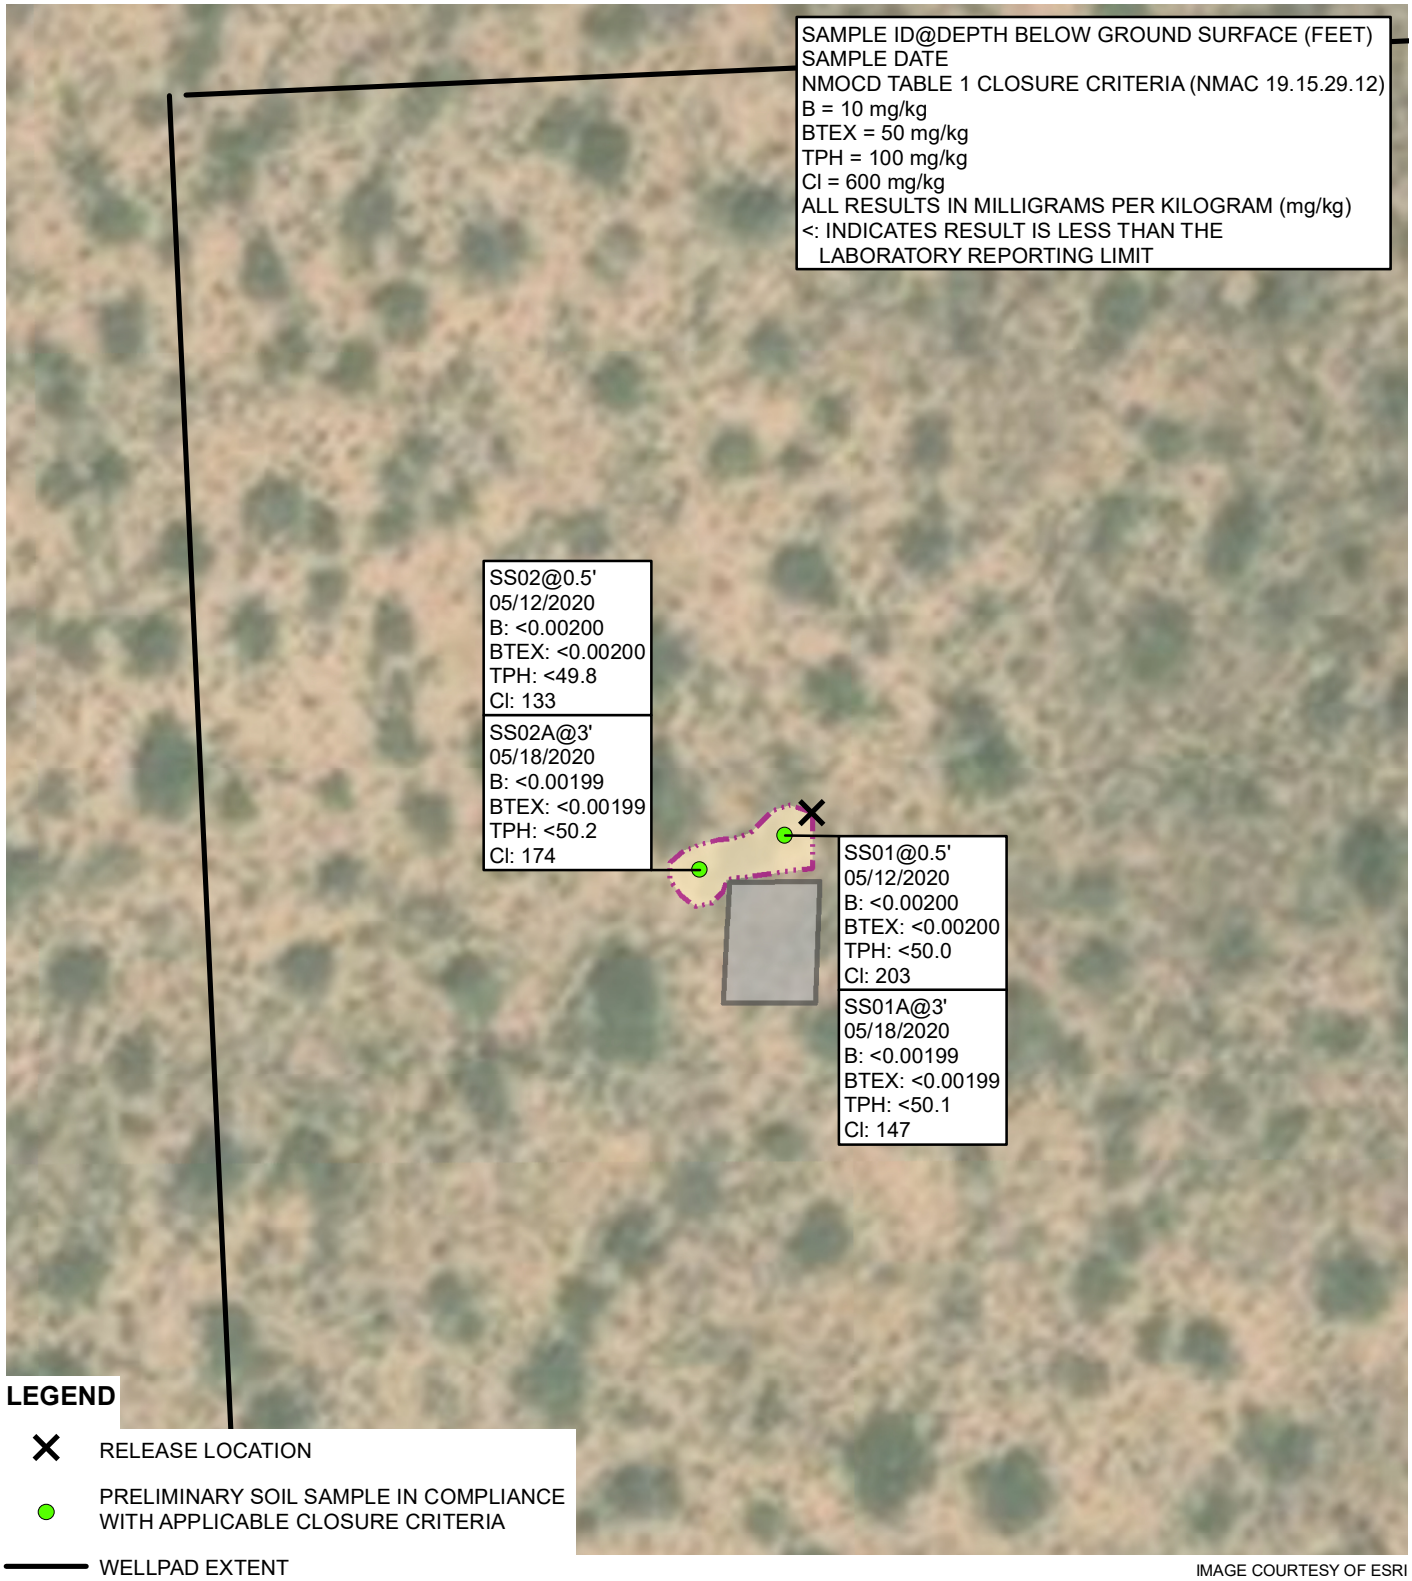
FIGURE 2
PRELIMINARY SOIL SAMPLE LOCATIONS
REMUDA SOUTH 25 STATE 167H
UNIT H SEC 25 T23S R29E
EDDY COUNTY, NEW MEXICO
XTO ENERGY, INC.

Laboratory analytical results for preliminary soil samples SS01 and SS02 indicated that benzene, BTEX, TPH, and chloride concentrations were compliant with the Closure Criteria. Excavation activities did not appear to be warranted; however, further delineation activities were scheduled. Laboratory analytical results for the preliminary soil samples are presented on Figure 2 and summarized in Table 1. The laboratory analytical report is included in Attachment 2.

Laboratory analytical results indicated benzene, BTEX, TPH, and chloride concentrations were compliant with the Closure Criteria in soil samples SS01/SS01A and SS02/SS02A collected within the release extent from depths of 0.5 feet and 3 feet bgs. Laboratory analytical results are summarized in Table 1 and the complete laboratory analytical reports are included as Attachment 2.
