Pit or Below-Grade Tank Registration or Closure

Closure Report

Gila C2 Fee #1H
API # 30-015-35567
Eddy County, NM

Re: Drilling Pit Closure of EOG Resources – Gila C2 Fee #1H
UL 'I' Sec. 2 T16S R24E Eddy County, NM
API # 30-015-35567

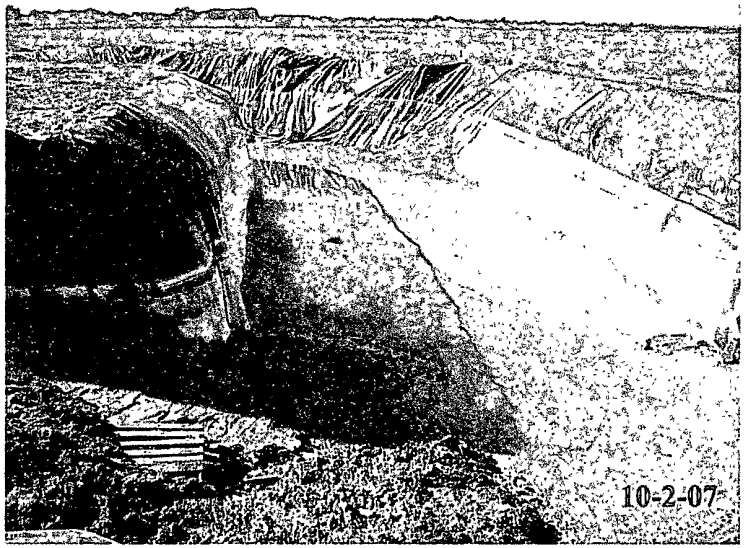
Drilling pit before closure.

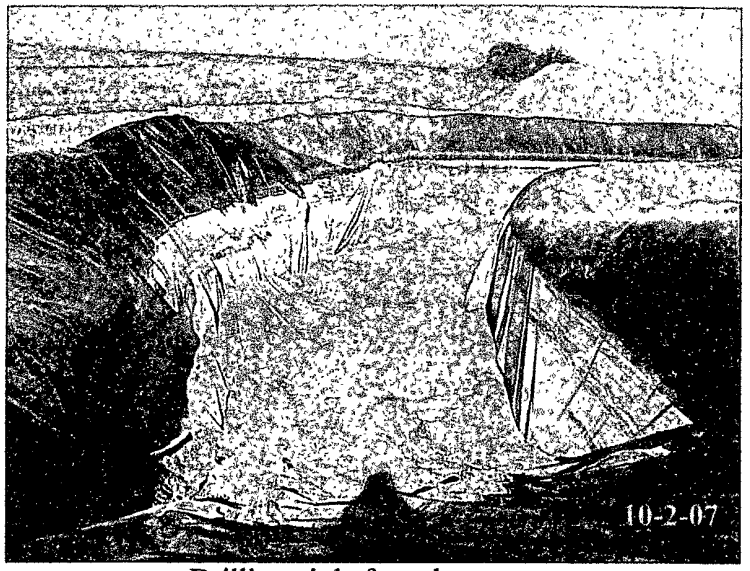
Drilling pit before closure.

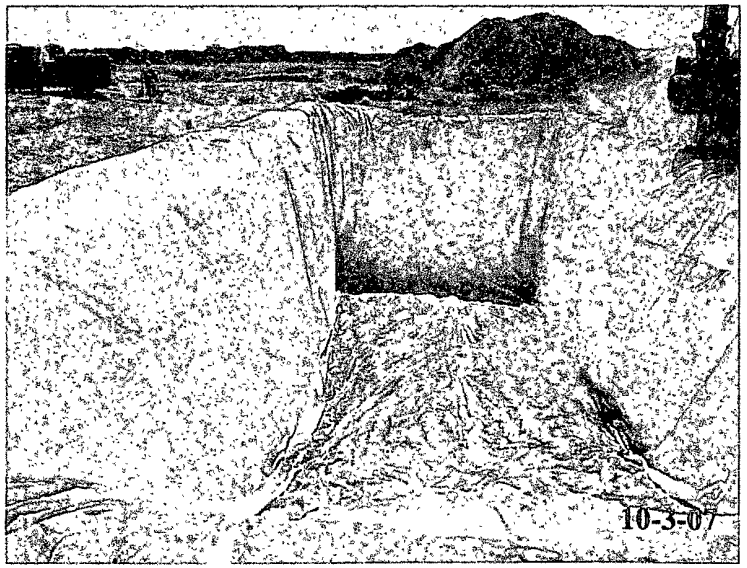
Burial pit lined with a 12 mil impervious liner.

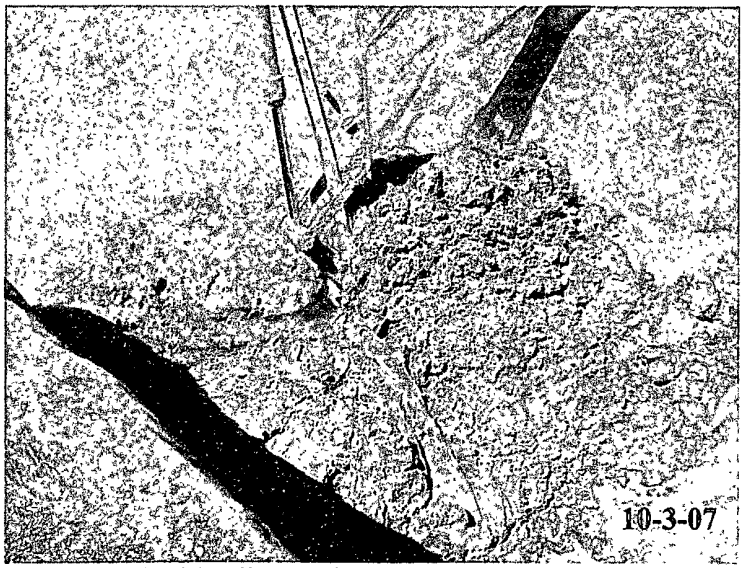
Mixing mud with Elke Environmental Solidification Product.

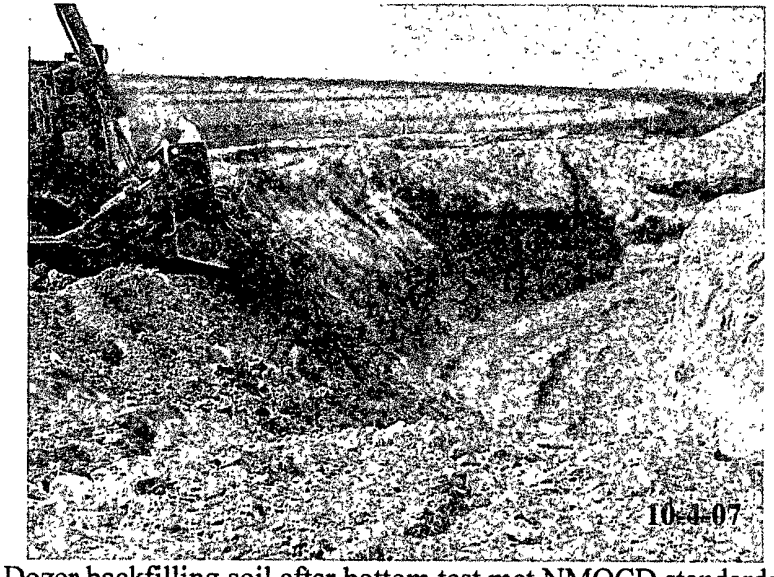
Dozer backfilling soil after bottom test met NMOCD standards.

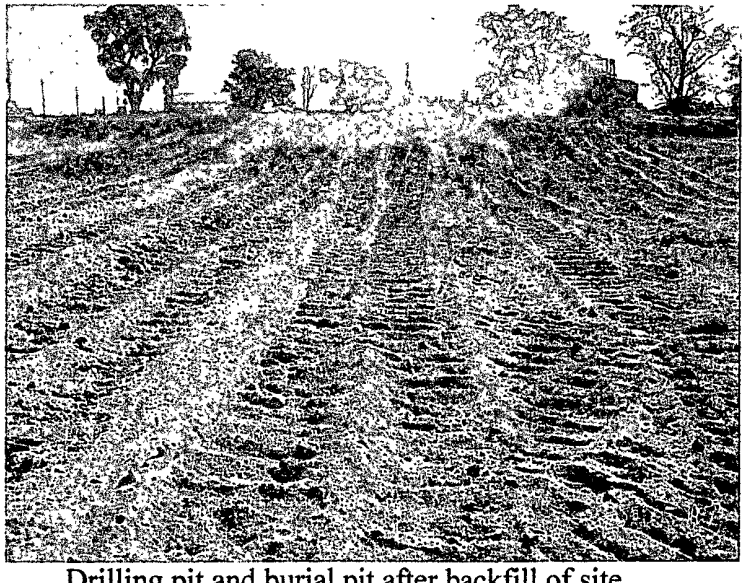
Drilling pit and burial pit after backfill of site.
