Pit, Closed-Loop System, Below-Grade Tank, or Proposed Alternative Method Permit or Closure Plan Application

1
Operator: BOPCO, L.P. OGRID #: 001801
Address: P.O. Box 2760 Midland, TX 79702
Facility or well name Poker Lake Unit #276
API Number: 30-015-35137 OCD Permit Number: 208260
U/L or Qtr/Qtr NESW Section 13 Township 24S Range 29E County: EDDY
Center of Proposed Design: Latitude N 32.219389 Longitude W 103.935917 NAD ☐1927 ☒ 1983
Surface Owner: ☒ Federal ☐ State ☐ Private ☐ Tribal Trust or Indian Allotment

SITE PLAN DENOTING SAMPLE LOCATIONS

Poker Lake Unit #276

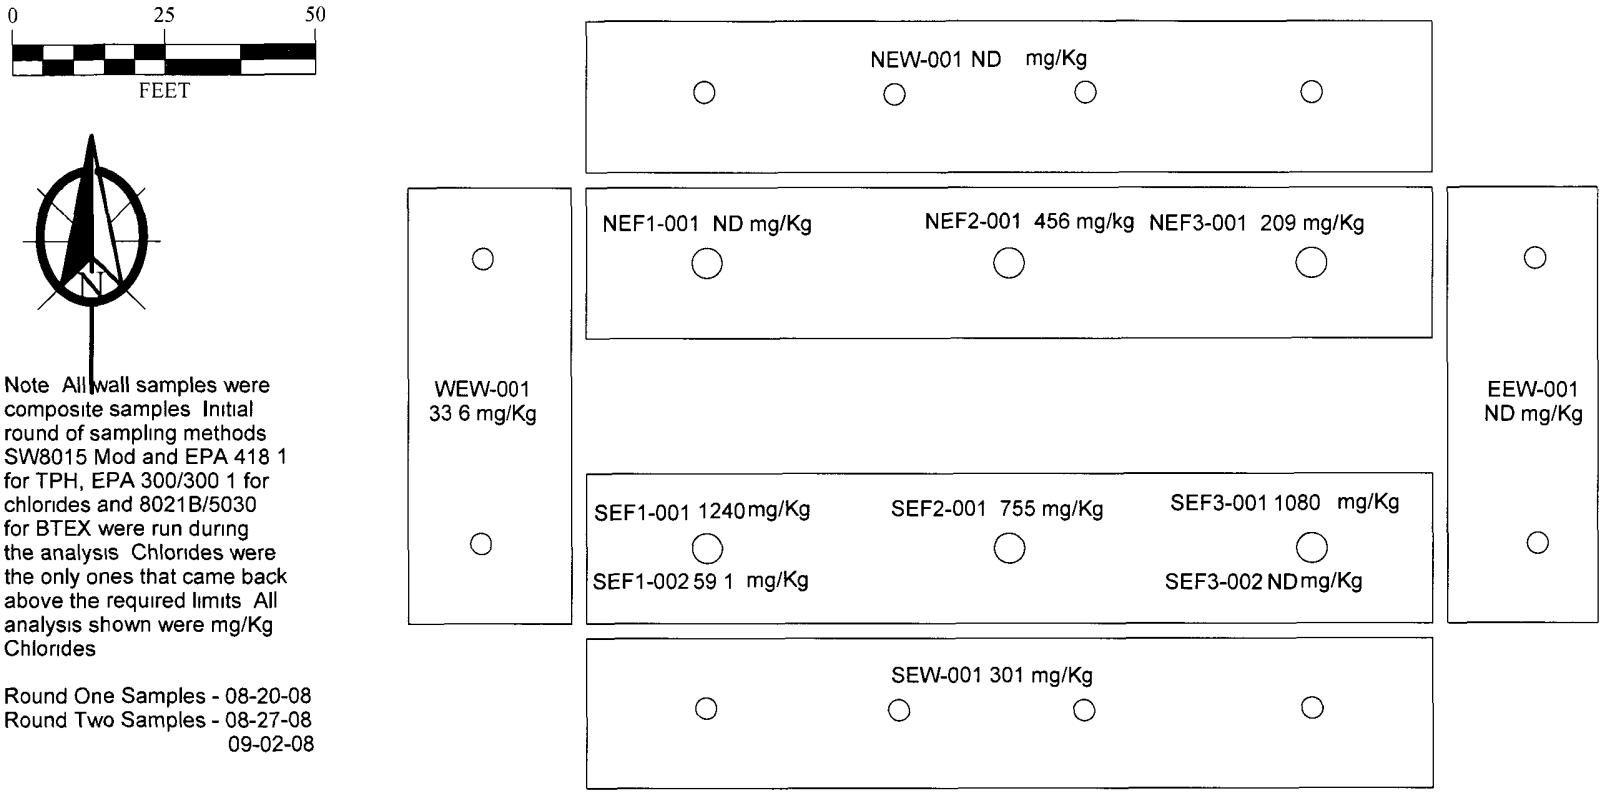
Delineation Sampling Plan

Note All wall samples were composite samples Initial round of sampling methods SW8015 Mod and EPA 418 1 for TPH, EPA 300/300 1 for chlorides and 8021B/5030 for BTEX were run during the analysis Chlorides were the only ones that came back above the required limits All analysis shown were mg/Kg Chlorides
