Pit, Closed-Loop System, Below-Grade Tank, or Proposed Alternative Method Permit or Closure Plan Application

Waste Excavation and Removal Closure Plan

BEPCO, L.P.
dba Bass Enterprises Production Co.
Poker Lake Unit #220
Section 19, T-24-S, R-30-E
Eddy County, New Mexico

Poker Lake Unit #220

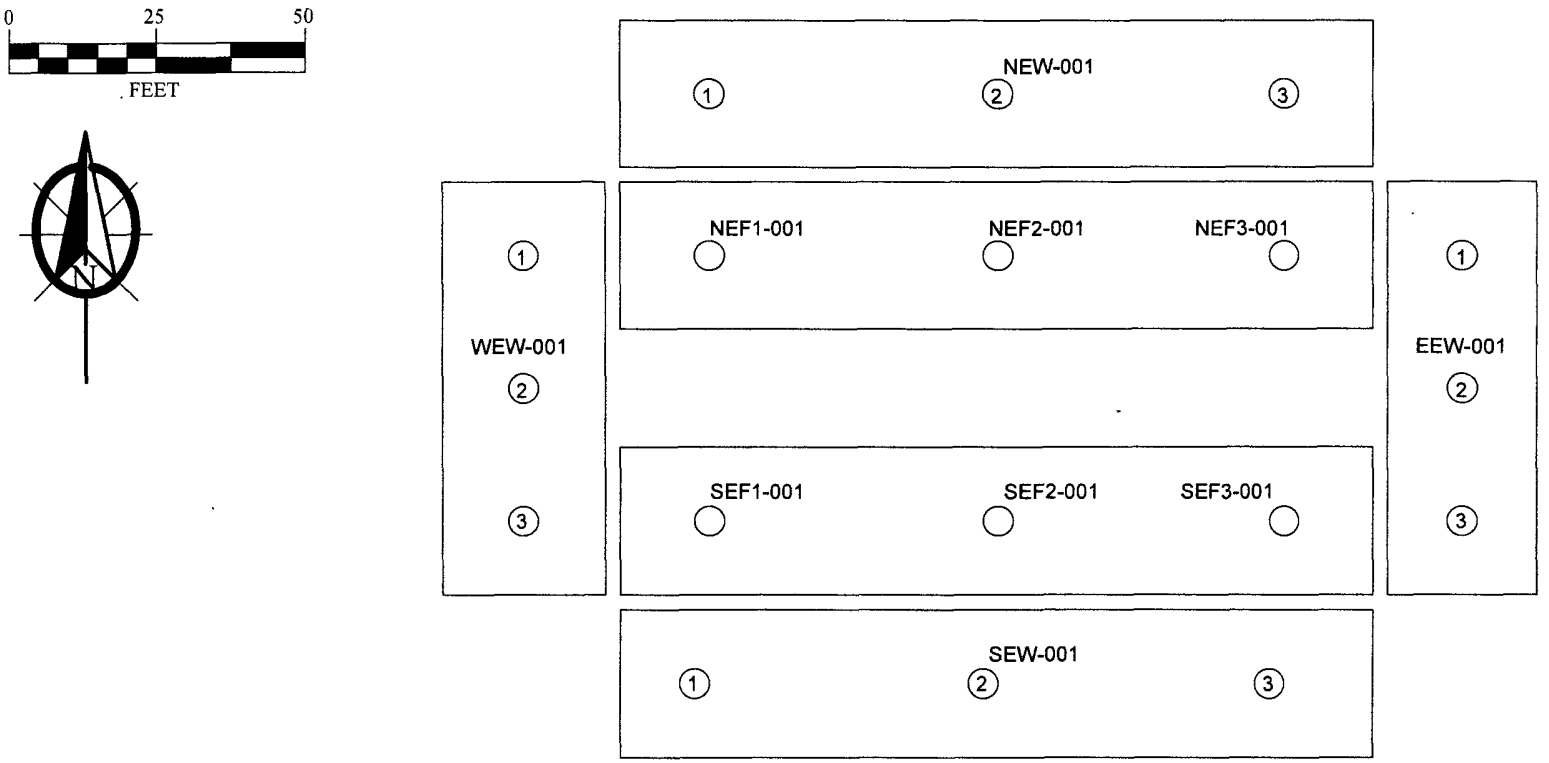
SITE PLAN DENOTING PIT CLOSURE SAMPLING LOCATIONS

- ○ Grab Sample
- ② Composite Sample

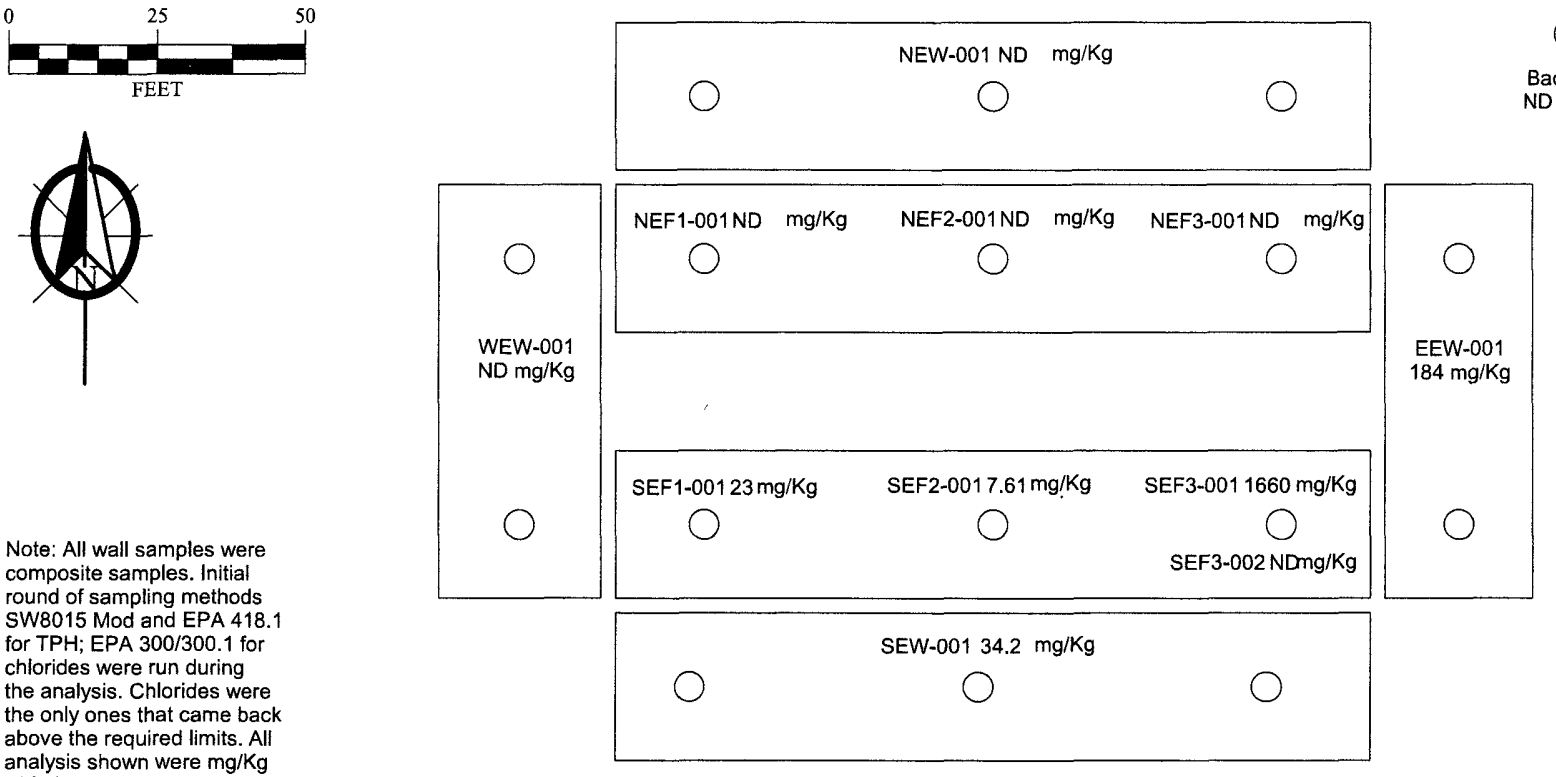
Delineation Sampling Plan

Note: All wall samples were composite samples. Initial round of sampling methods SW8015 Mod and EPA 418.1 for TPH; EPA 300/300.1 for chlorides were run during the analysis. Chlorides were the only ones that came back above the required limits. All analysis shown were mg/Kg Chlorides.

Round One Samples - 09-22-08
Round Two Samples - 10-03-08
