IR-16 8/18/2004

August 18, 2004

Re: Addendum Pipeline Spill Remediation and Investigation Report, Dynegy Midstream Services, L.P., Unit Letter N, Section 29, Township 21 South, Range 37 East, Lea County, New Mexico

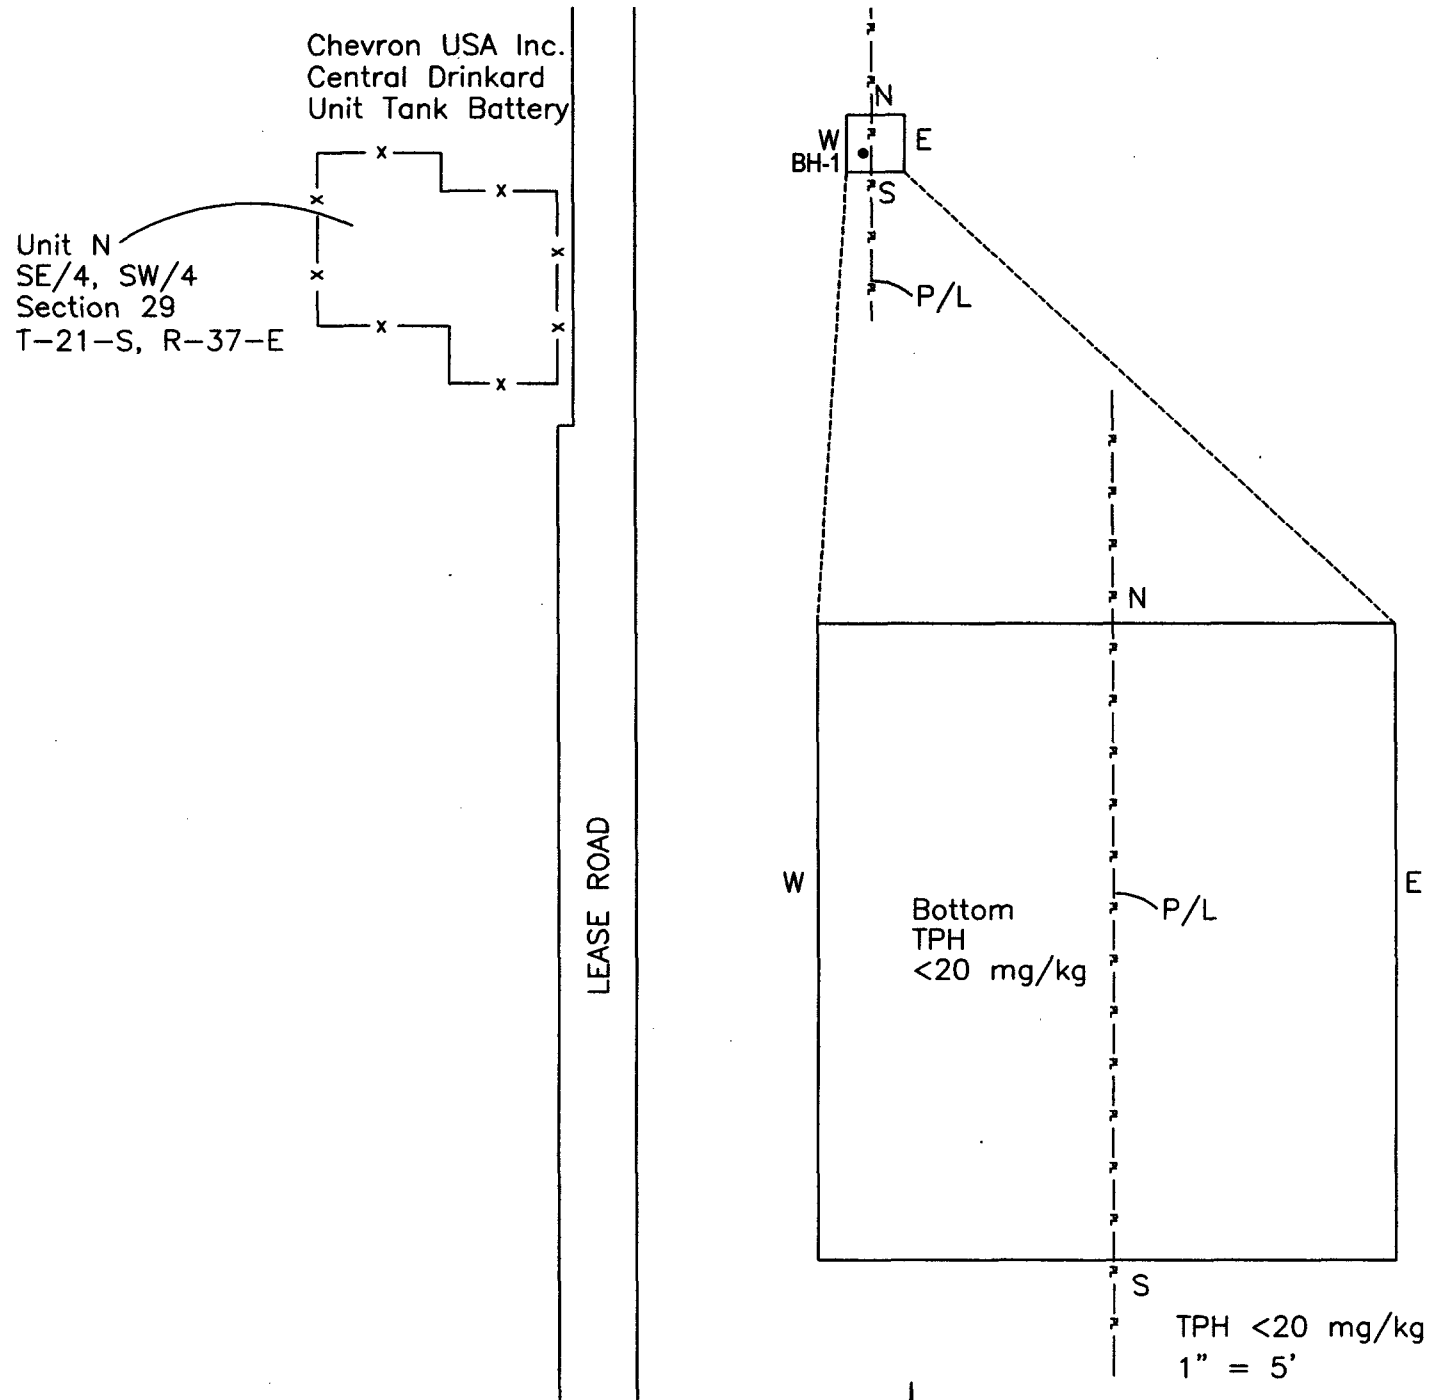
FIGURE #2

Referring to Table 2, TPH was below the RRAL (1,000 mg/Kg) in all soil samples. Chloride was less than 100 mg/Kg in all samples, except BH-1, 8 to 8.2 feet (106 mg/Kg) and BH-1, 10 to 11 feet (1,170 mg/Kg). The sample from BH-1, 10 to 11 feet BGS was analyzed for chloride using the synthetic precipitation leaching procedure (SPLP), and the result was 62 milligrams per liter (mg/L). The boring was plugged in accordance with New Mexico State Engineer requirements. Dynegy requests the NMOCD consider no further action and closure for the Site. Please call Mr. Cal Wrangham with Dynegy at (432) 688-0555 or myself at (432) 687-0901 if you have questions. We may also be contacted by email at cal.wrangham@dynegy.com or mark@Laenvironmental.com.
