RISK ASSESSMENT
AND
SITE CLOSURE PROPOSAL

MONUMENT 6" GATHERING
LINK REF: #2002-10197
UL-A NE¼ OF THE NE¼ OF SECTION 5 T20S R37E
1 MILE SOUTH OF MONUMENT
LEA COUNTY, NEW MEXICO
LATITUDE: N32° 36' 32.381" LONGITUDE: W103° 15' 55.502"

MARCH 4, 2004

Subject: Link Monument 6" Gathering 2002-10197 - Risk Assessment and Site Closure Proposal

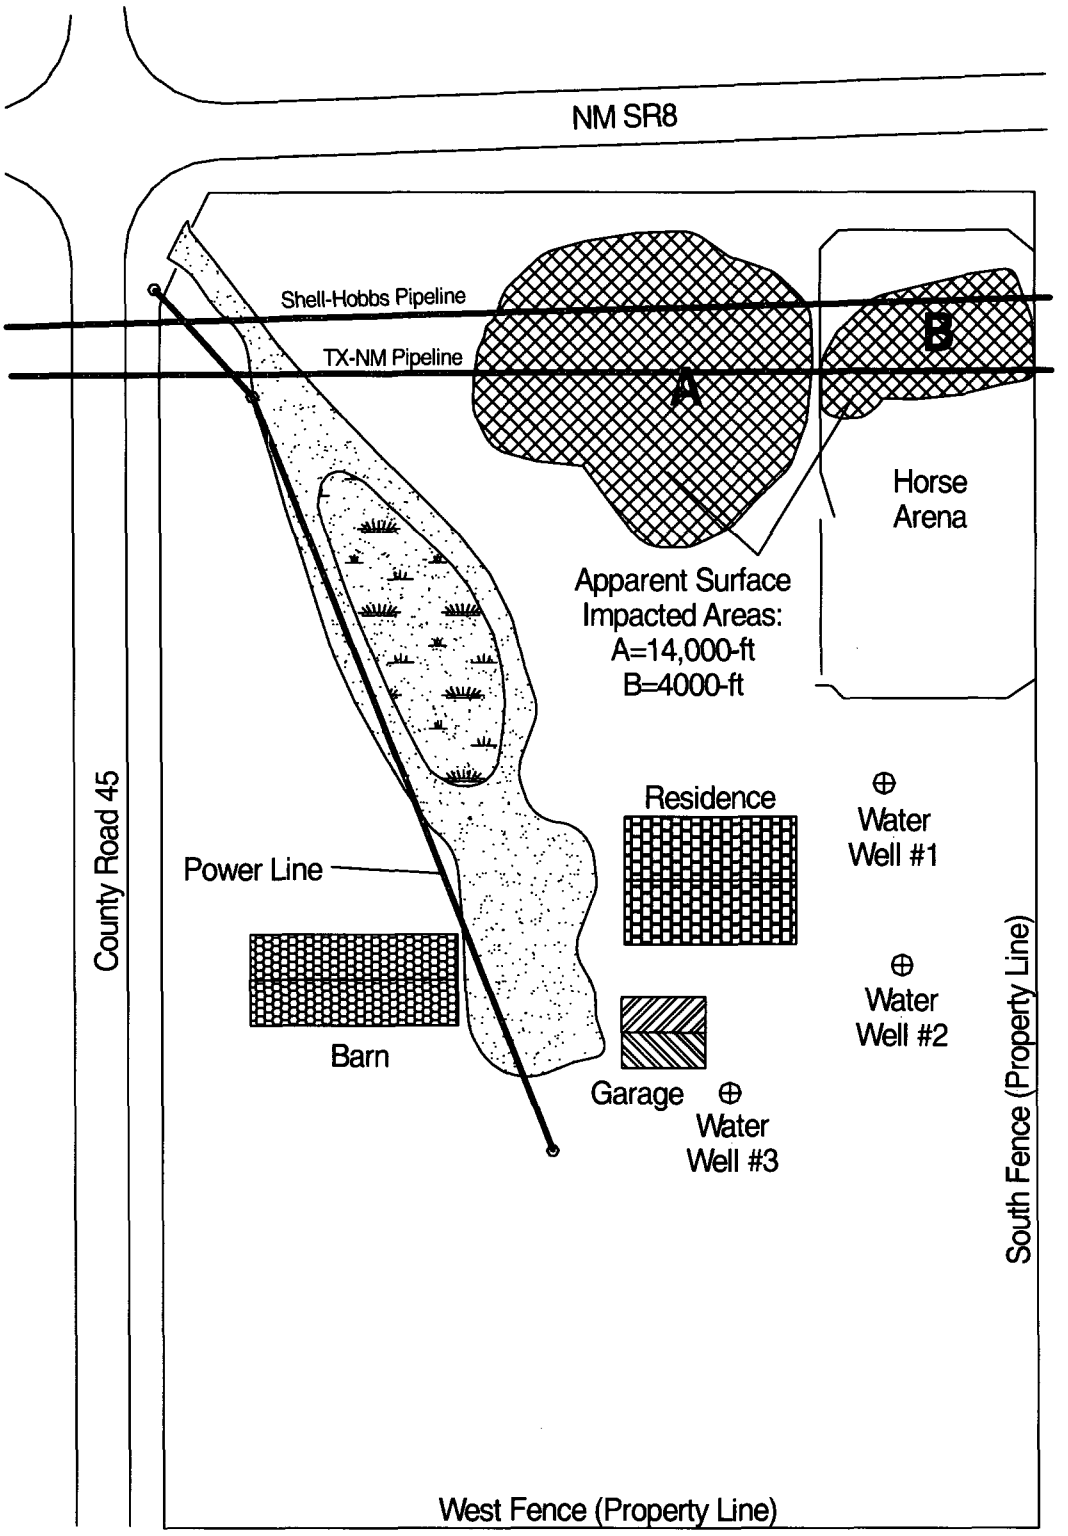
NM SR8
Shell-Hobbs Pipeline
TX-NM Pipeline
A
B
Horse Arena
Apparent Surface Impacted Areas:
A=14,000-ft
B=4000-ft
Residence
Water Well #1
Water Well #2
Power Line
Barn
Garage
Water Well #3
County Road 45
South Fence (Property Line)
West Fence (Property Line)
N
REVISED: Feb - 2004
DWG BY: John Good August - 2002
SCALE: 0 200 Feet
Lea County, New Mexico
UL-A Section 5 T20S R37E
N32° 36' 33" W103° 15' 56"
Elevation: 3560-ft amsl
Plate 3 - Initial Release Site
GPS Demarcation
LINK Energy LLC
Monument 6-Inch 2002-10197

- Excavate approximately 1300-yd^3 of soil from the near-surface (2-ft bgs) within the original visually affected areas A and B *(Plates 3-5, Attachments)*. Approximately 400-yd^3 of contaminated soil taken from the 5500-ft^2 area associated with BH6/MW1 will be disposed of at Link's Lea Station land farm. The remaining 900-yd^3 will be low TPH impacted soil and will be stockpiled for use as backfill (described below).

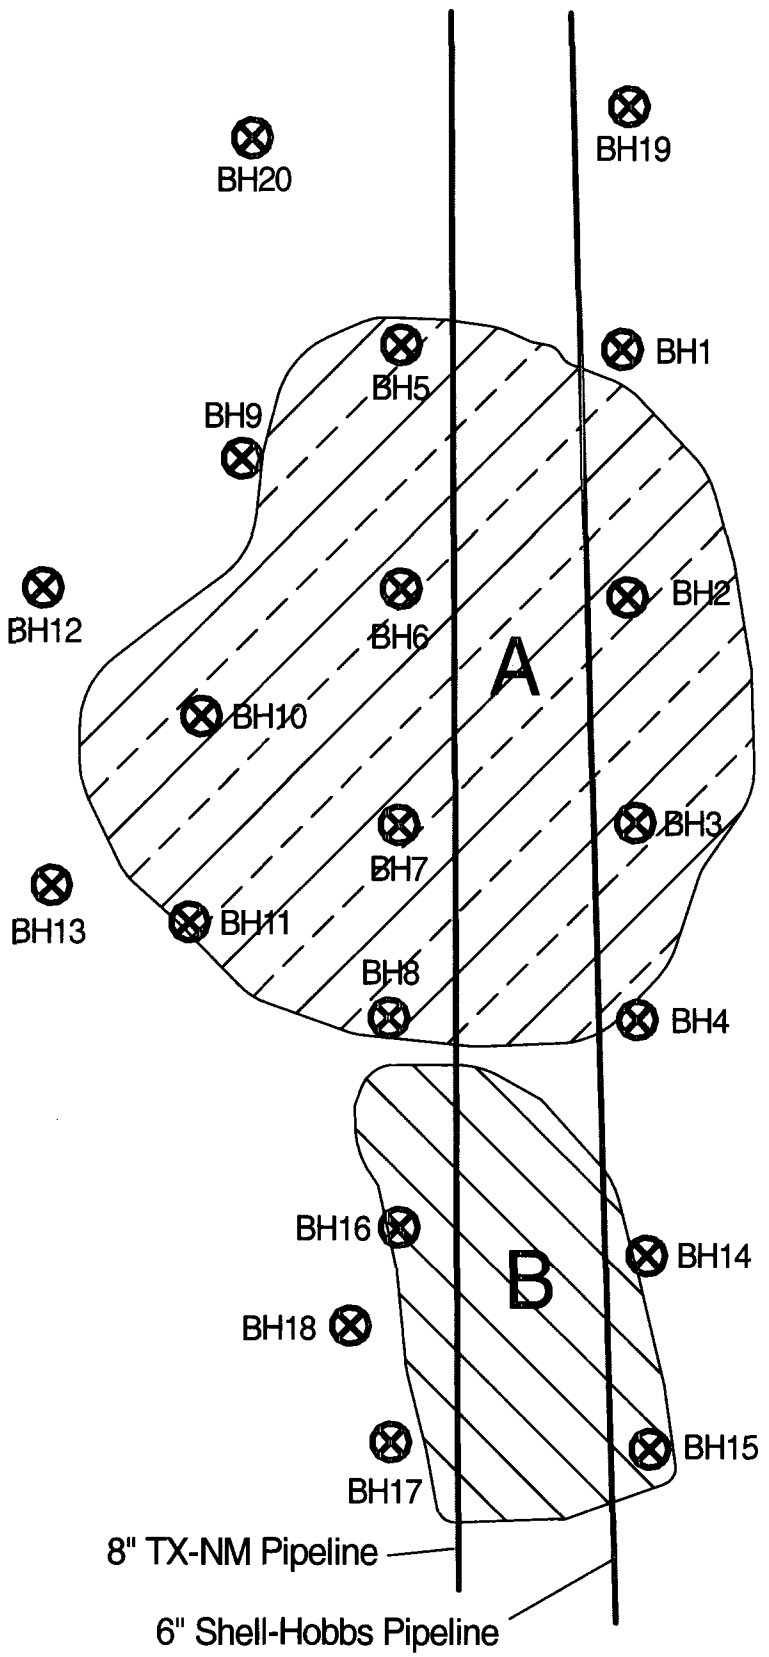
Plate 4 - GPS Locations of
Boreholes 1-20
LINK Energy LLC
Monument 6-Inch 2002-10197

- GPS demarcation of the release site and relevant surface features *(Plates 3 and 5, Attachments)*.
- Drilling and sampling of 20 boreholes (BH1 – BH20) down to 20-ft below ground surface (bgs) within and at the extents of the visibly affected surface area *(Plate 4 – Attachments)*. These boreholes were drilled and sampled during the period July 29 – August 5, 2002.

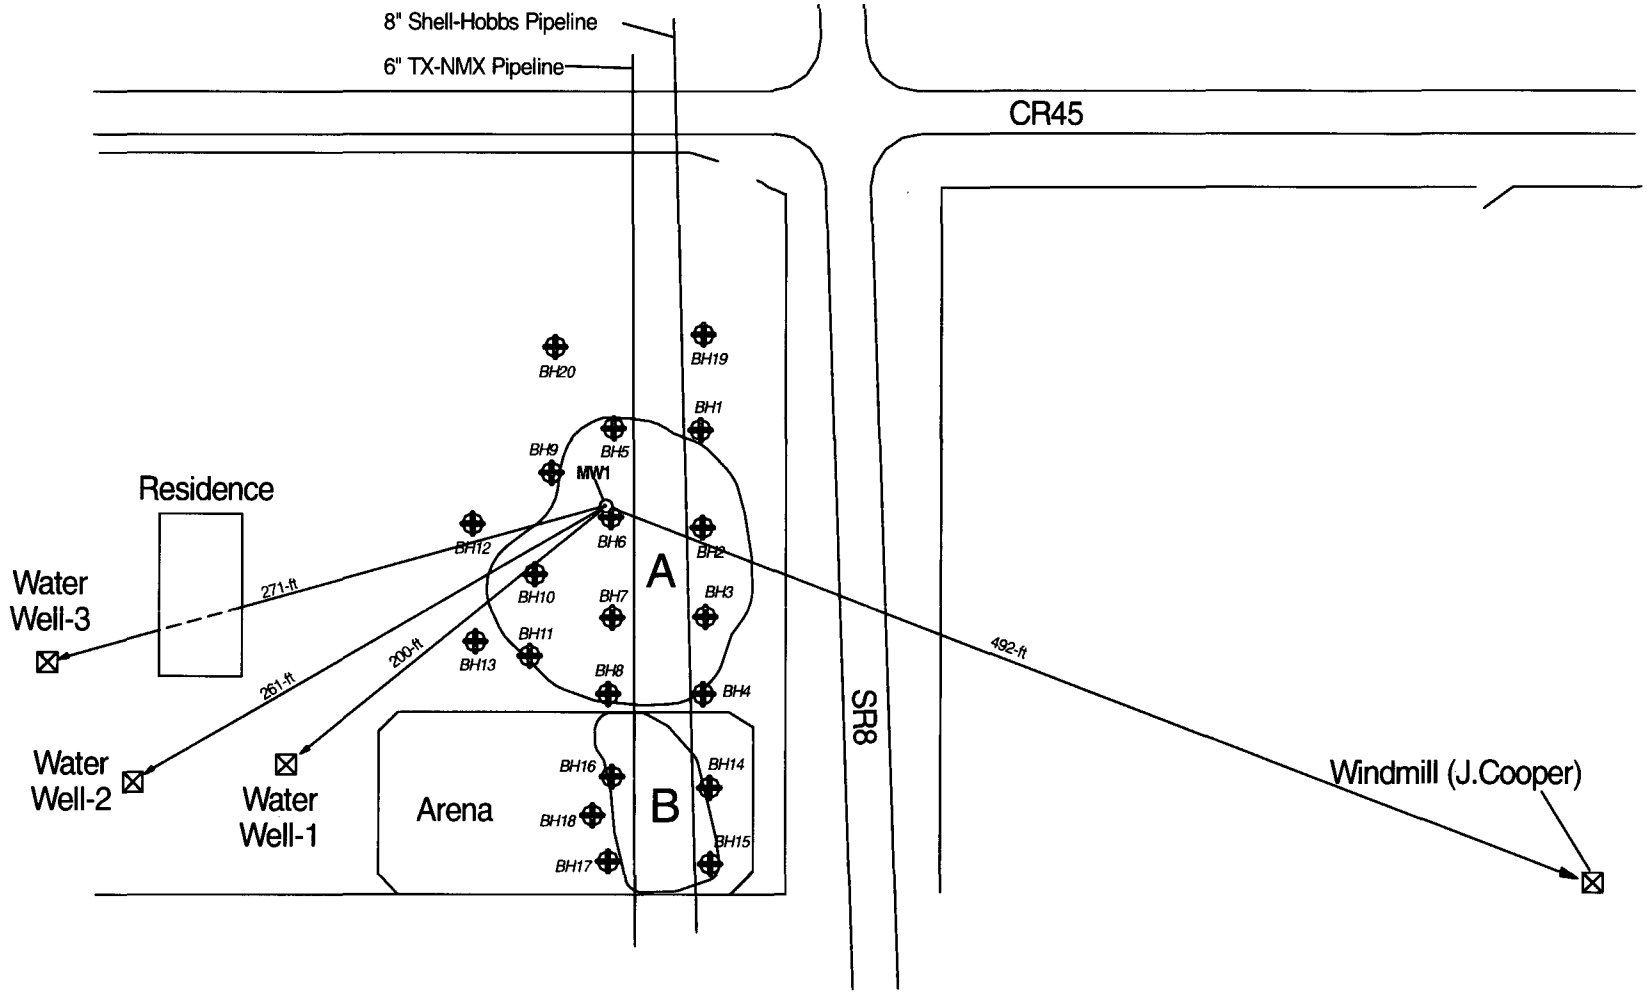
Plate 5 - Ex[amded GPS Map Showing Water Well Locations LINK Energy LLC Monument 6-Inch 2002-10197	Lea County, New Mexico UL-A Section 5 T20S R37E N32° 36' 33" W103° 15' 56" Elevation: 3560-ft amsl	DWG BY: John Good September - 2002 SCALE: 1" = 92.88' 0 Feet 200	REVISED: Feb - 2004

located 271-ft (bearing 253°) from MW1. A water well (windmill) is located 492-ft (bearing 114°) from MW1 on property owned by Jimmy Cooper. This windmill driven water well is utilized to provide water for a stock watering tank. *(Plate 5, Attachments).*

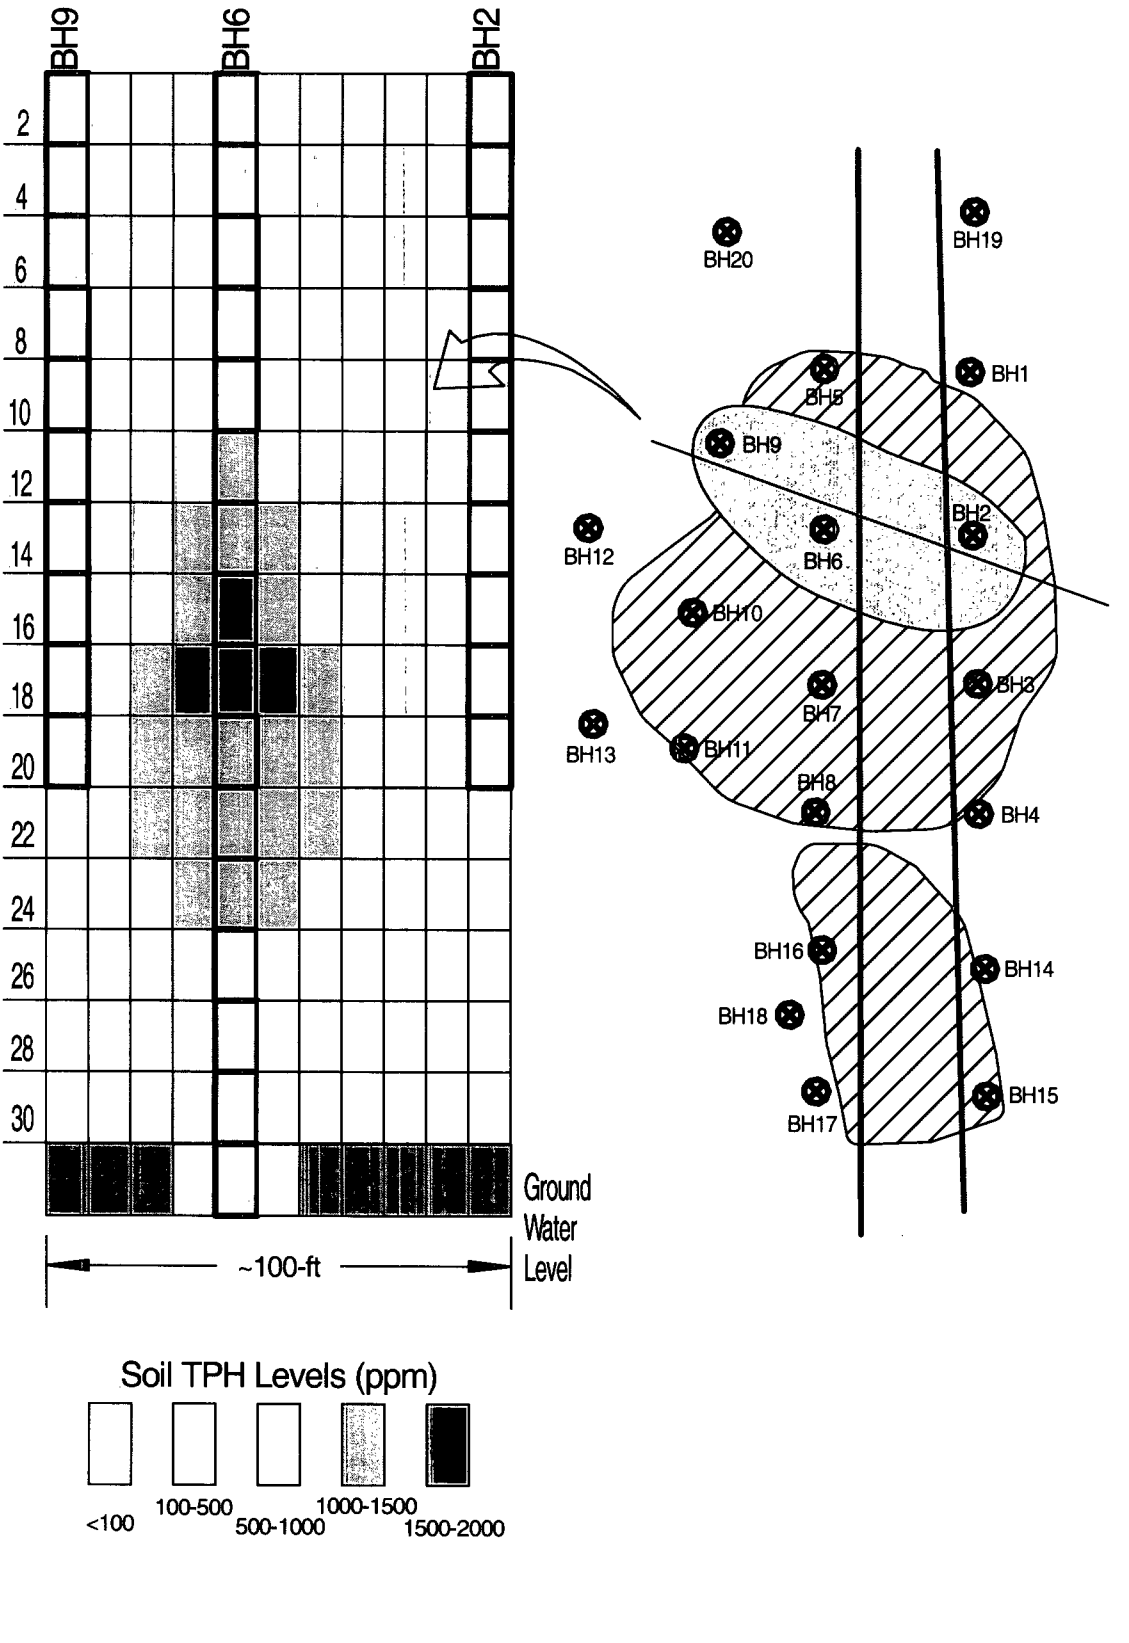
Plate 9 - Vertical Cross-Section
BH2 - BH6 - BH9
LINK Energy LLC
Monument 6-Inch 2002-10197

The analytical results of the soil samples for the initial 20 boreholes and the "non-detect" results of the subsequent 5 monitor wells were utilized to create a "Surfer" projection of the horizontal and vertical extents of TPH contamination above 100-mg/kg throughout the site. This "Surfer" projection is presented in three-dimensional and two-dimensional format *(Plates 10 and 11, Attachments).* A summary table of the borehole analytical results *(Plates 6 and 7)* and graphical representations *(Plates 8 and 9)* of the soil analytical data are provided in the attachments.

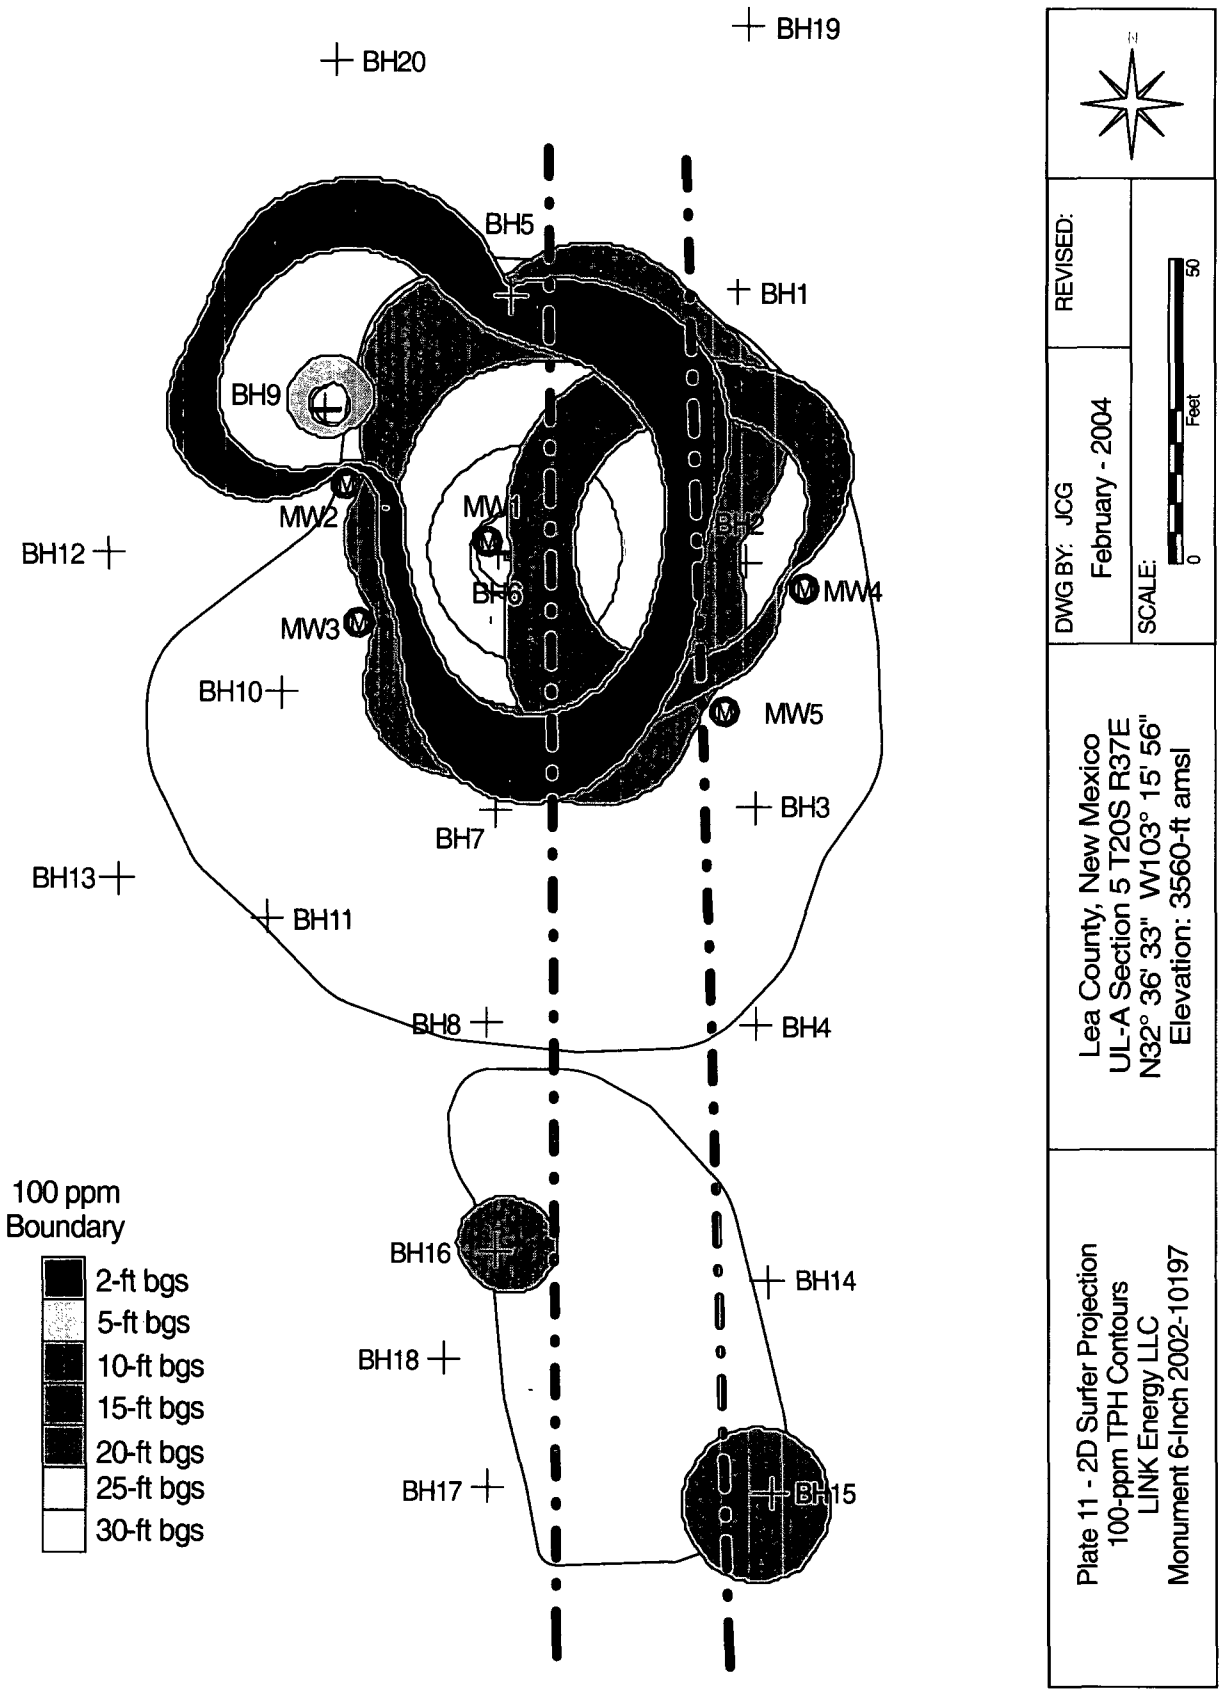
BH19
BH20
BH5
BH1
BH9
MW2
MW1
BH2
BH12
BH6
MW4
MW3
BH10
MW5
BH3
BH7
BH13
BH11
BH8
BH4
BH16
BH14
BH18
BH17
BH15
100 ppm Boundary
2-ft bgs
5-ft bgs
10-ft bgs
15-ft bgs
20-ft bgs
25-ft bgs
30-ft bgs
N
REVISED:
DWG BY: JCG
February - 2004
SCALE:
0
50
Feet
Lea County, New Mexico
UL-A Section 5 T20S R37E
N32° 36' 33" W103° 15' 56"
Elevation: 3560-ft amsl
Plate 11 - 2D Surfer Projection
100-ppm TPH Contours
LINK Energy LLC
Monument 6-Inch 2002-10197

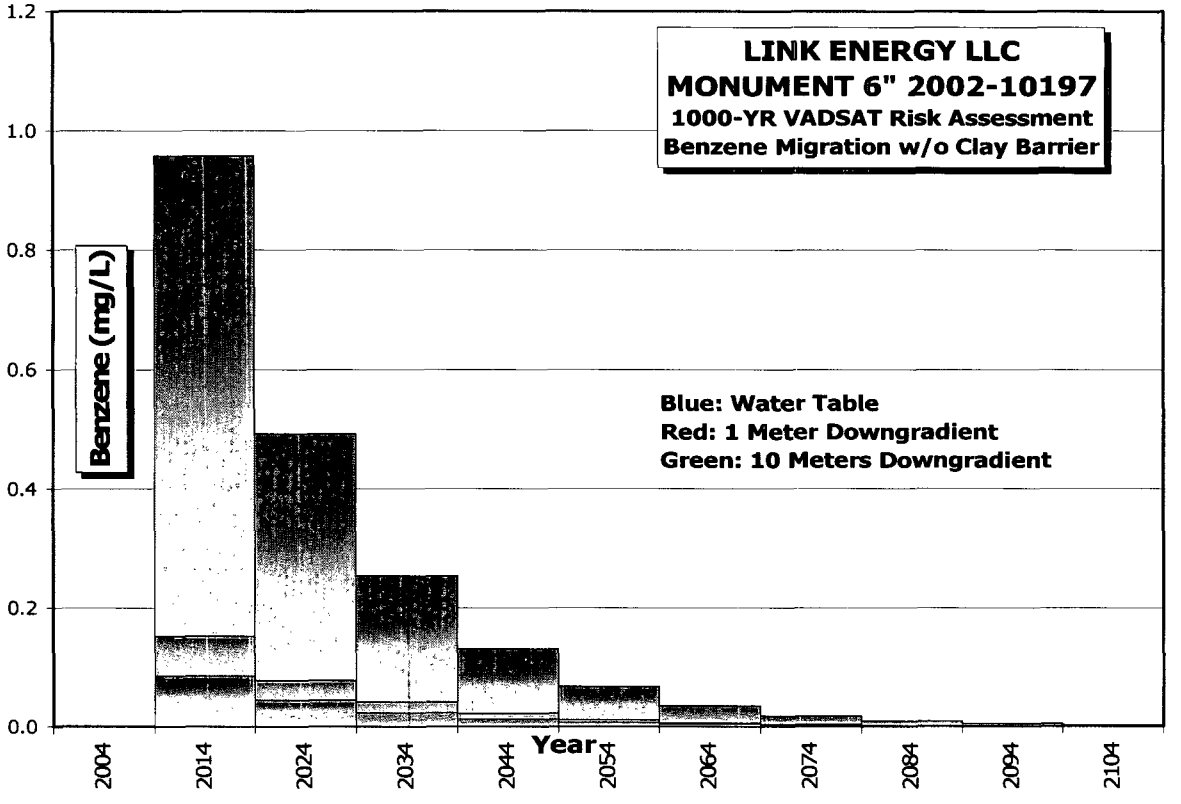
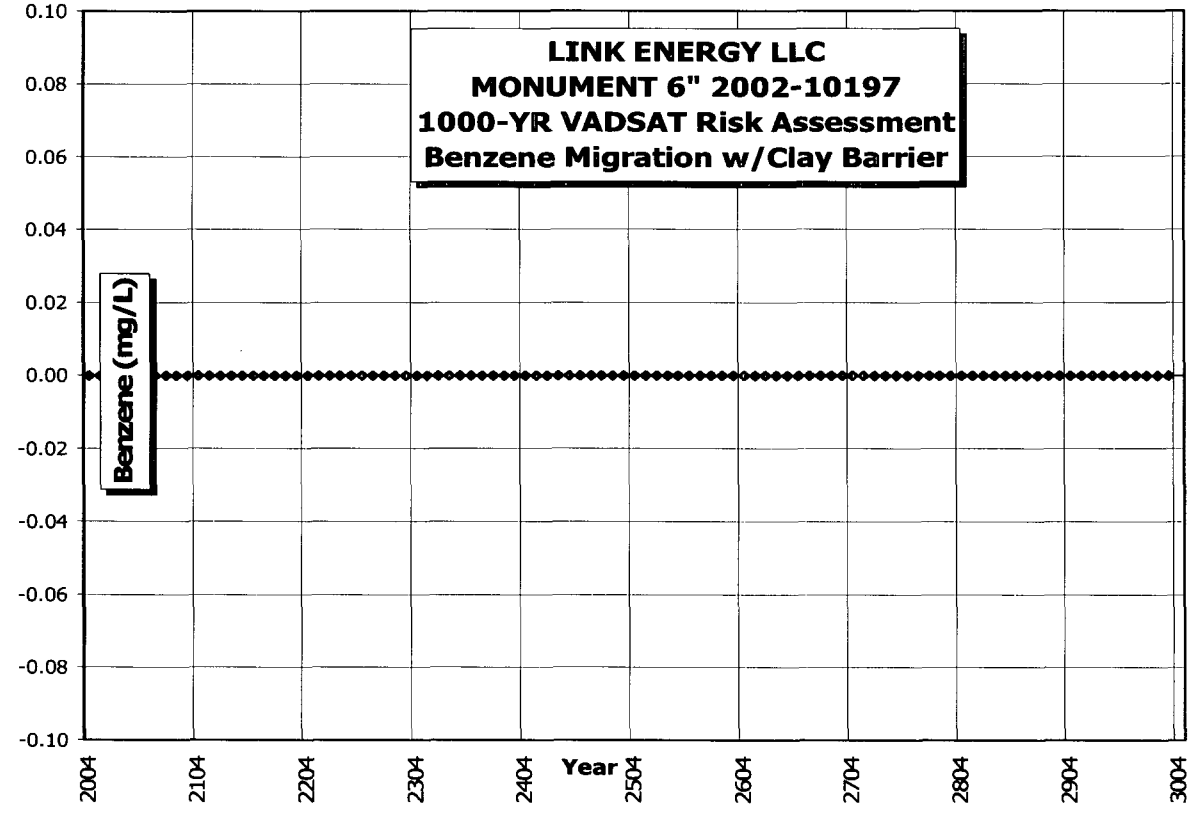
Plate 15 – VADSAT Risk Assessments

The results of the computer risk assessment modeling for the site without a clay barrier in place indicate that benzene, if present, would reach the top of the aquifer directly under the site in approximately 10-years at a peak concentration of 0.958 mg/L. From this peak concentration in the year 2014, the concentration would decline to a level of 2.46×10^{-29} mg/L in the year 3004. The

computer risk assessment modeling of the site with the clay barrier in place shows a flat-line of 0 values for the 1000-year period modeled, thus the contaminant migration would never reach the aquifer.

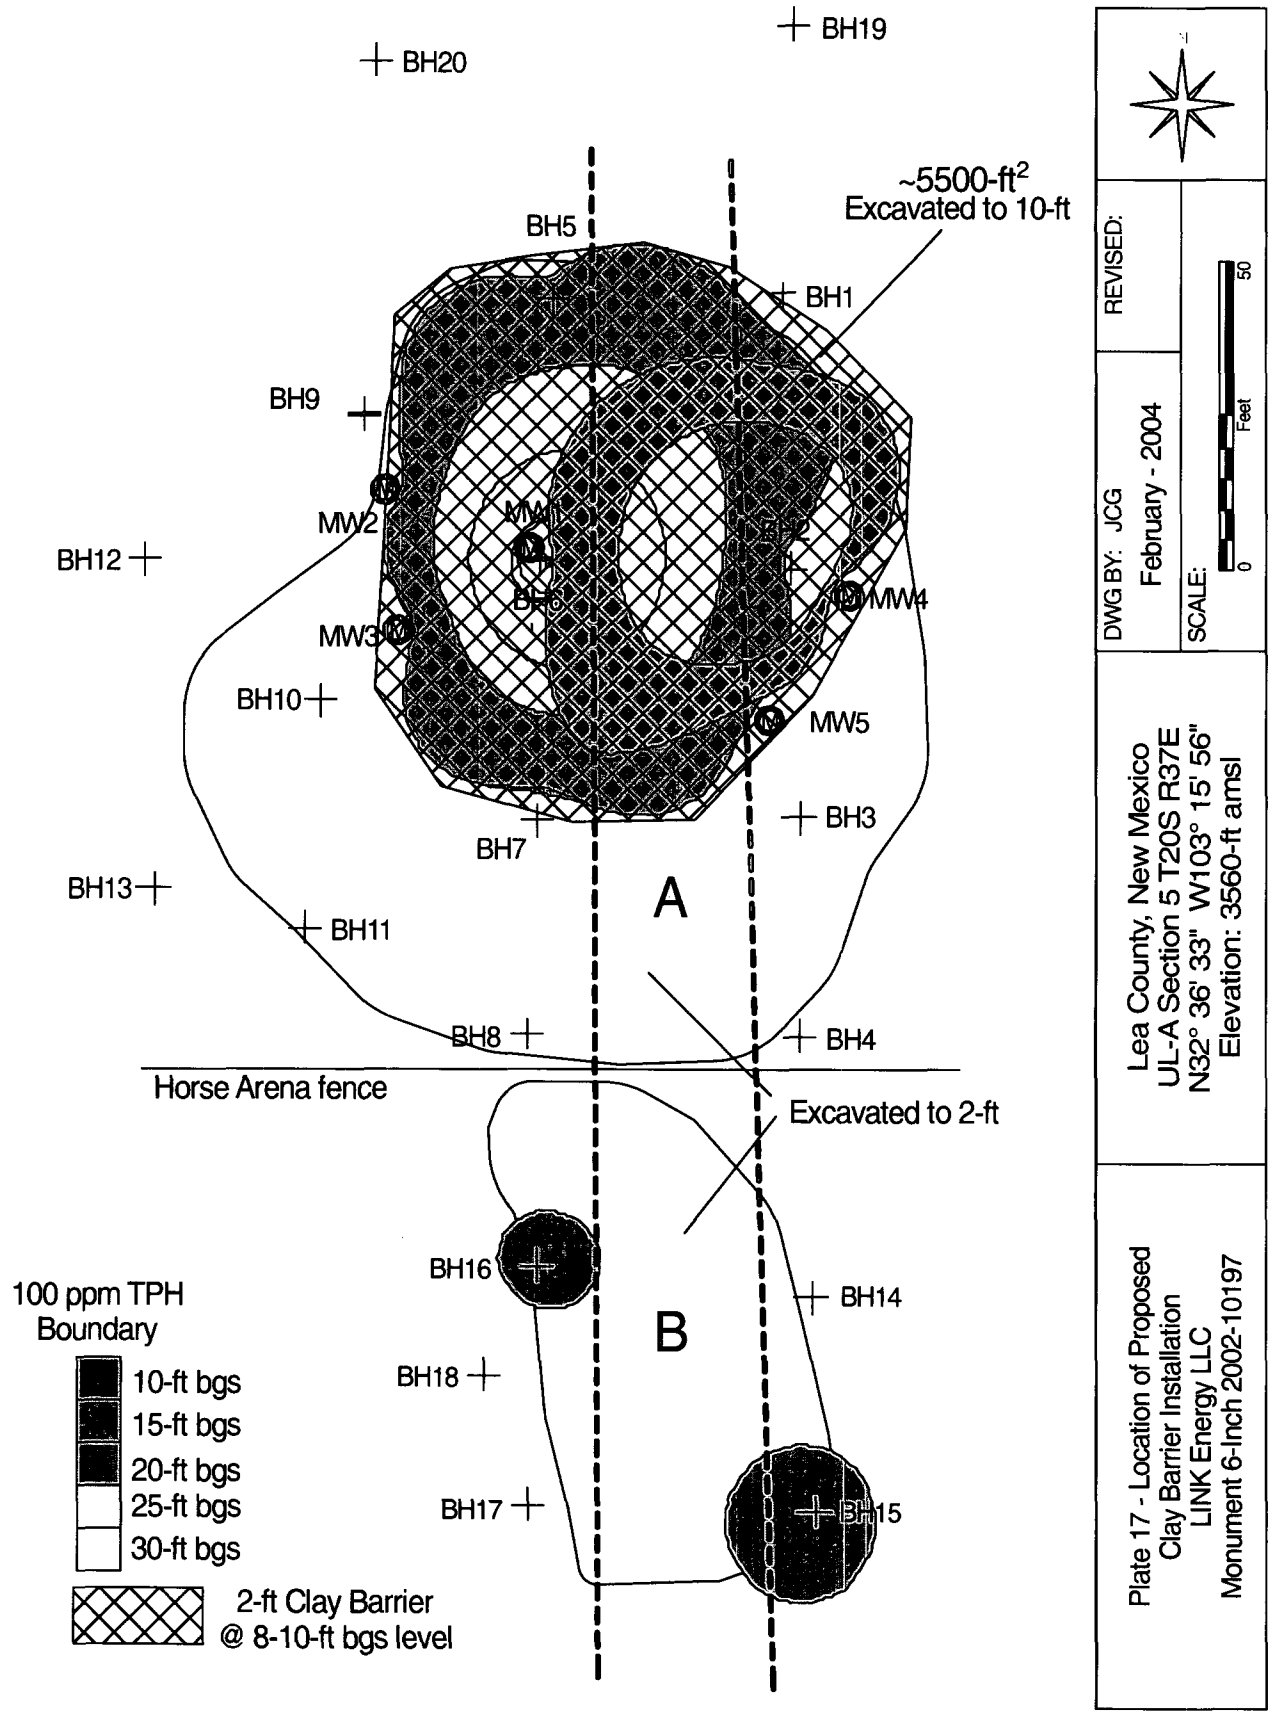
BH19
BH20
~5500-ft²
Excavated to 10-ft
BH5
BH1
BH9
MW2
MW1
BH12
BH6
MW4
MW3
BH10
MW5
BH3
BH7
BH13
A
BH11
BH8
BH4
Horse Arena fence
Excavated to 2-ft
BH16
BH14
B
BH18
BH17
BH15
100 ppm TPH Boundary
10-ft bgs
15-ft bgs
20-ft bgs
25-ft bgs
30-ft bgs
2-ft Clay Barrier @ 8-10-ft bgs level
REVISED:
DWG BY: JCG
February - 2004
SCALE:
0
50
Feet
Lea County, New Mexico
UL-A Section 5 T20S R37E
N32° 36' 33" W103° 15' 56"
Elevation: 3560-ft amsl
Plate 17 - Location of Proposed
Clay Barrier Installation
LINK Energy LLC
Monument 6-Inch 2002-10197

- The 5500-ft^2 deep-contaminated area associated with Boreholes 1, 2, 5, 6 and 9 *(cross-hatch area, Plate 17, Attachments)* will be further excavated from the 2-ft bgs level down to 10-ft bgs. This contaminated soil (~1600-yd^3) will be disposed of at Link's Lea Station land farm. Once this 10-ft bgs excavation is completed, the perimeter of the hole will be evaluated for TPH to determine if adequate overlap for a clay barrier installation has been achieved. If required, the excavation will be expanded laterally to provide adequate overlap.

- Upon confirmation of an adequate overlap area, the 2-ft compacted clay barrier will be installed over the contaminated soil left in-place in the 10-ft to 30-ft bgs interval. The clay barrier will be placed in two stages, 1-ft thickness in each stage. After each 1-ft layer of clay is placed, it will be compacted and tested for compaction percentage by Pettigrew and Associates, Hobbs, NM.

- After the clay barrier is installed (occupying the 8-ft to 10-ft interval) and certified for compaction, the 900-yd^3 of stockpiled soil will be placed on top of the clay barrier. This volume of backfill will fill the excavation up to the 3½-ft level, leaving adequate space on top for placement of clean topsoil. Approximately 1630-yd^3 of clean topsoil and 488-yd^3 of clay will be required for completion of the project.

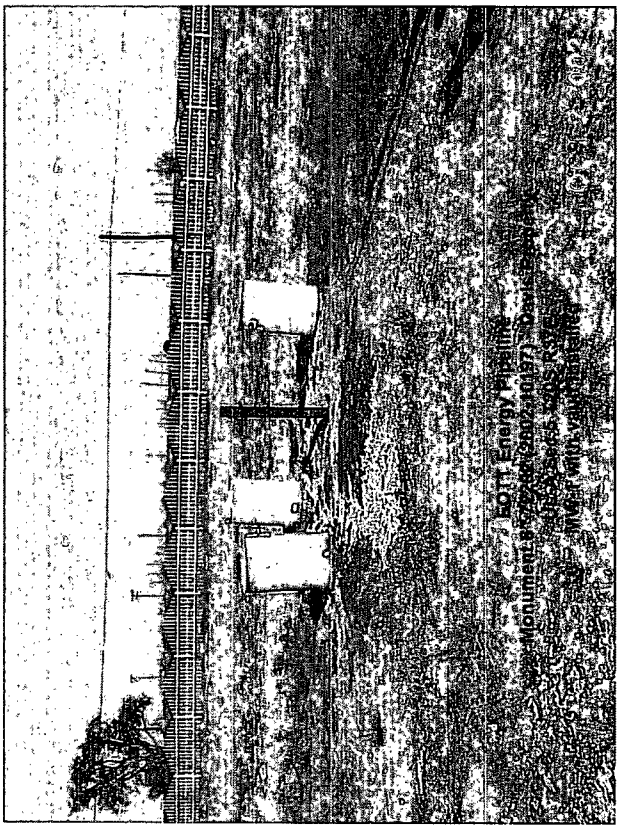
EOTT Energy Pipeline
Monument 6" 72202 (2002-10197) - Davis Property
UL-A Sec 5 T20S R37E
MW-2 with vault installed

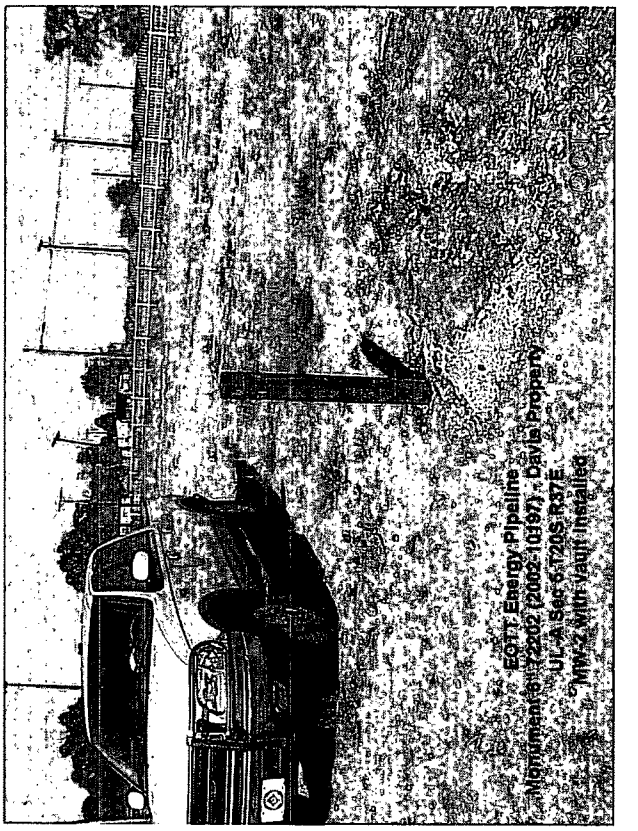
EOTT Energy Pipeline
Monument 6" 72202 (2002-10197) - Davis Property
UL-A Sec 5 T20S R37E
MW-2 with vault installed

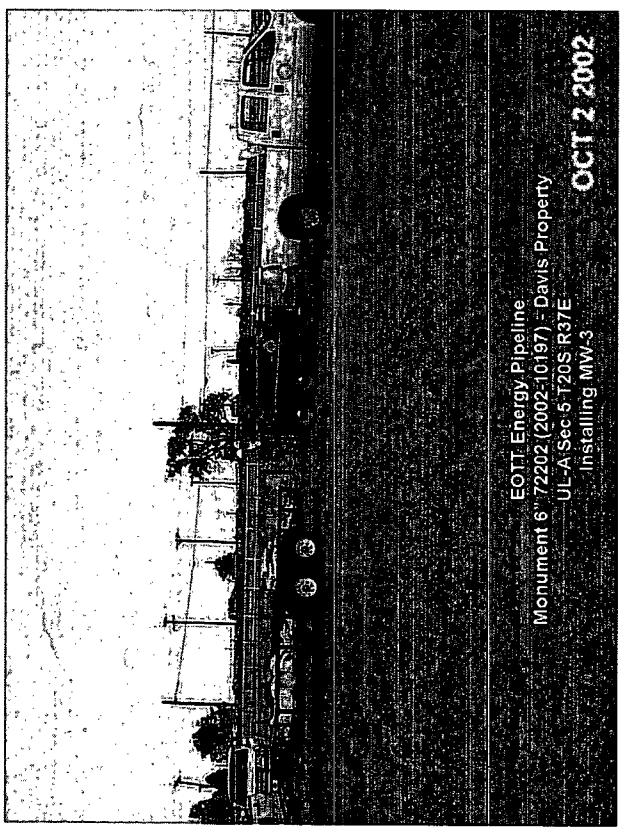
EOTT Energy Pipeline
Monument 6" 72202 (2002-10197) - Davis Property
UL-A Sec 5 T20S R37E
Installing MW-3
OCT 2 2002

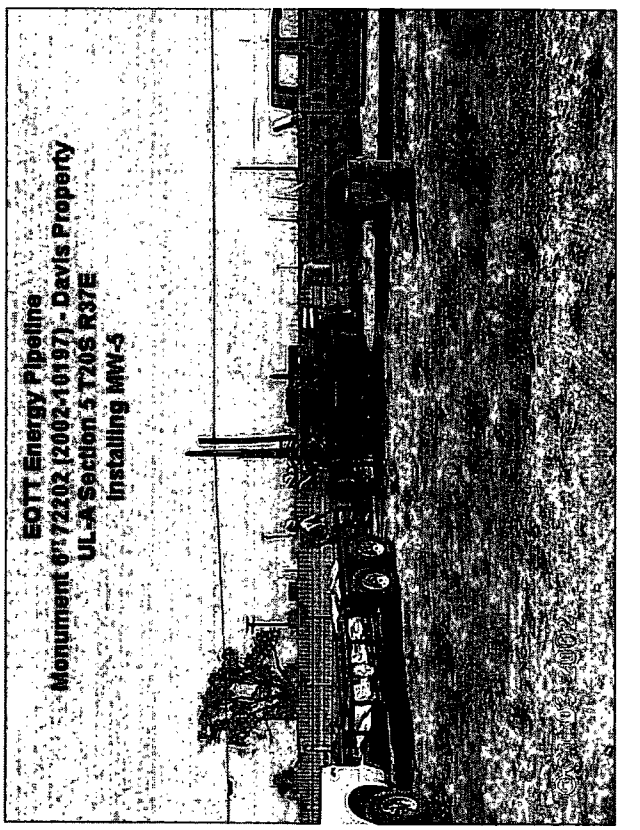
EOTT Energy Pipeline
Monument 6" 72202 (2002-10197) - Davis Property
UL-A Section 5 T20S R37E
Installing MW-5
