Re: Flow Line Leak Remediation Report, John H. Hendrix Corporation, Walter Lynch #1 Well, Unit Letter K (NE/4, SW/4), Section 1, Township 22 South, Range 37 East, Lea County, New Mexico

Table 1
Summary of Laboratory Analysis of Soil Samples After Remediation
John H. Hendrix Corporation, Walter Lynch #1 Flow Line Leak
Unit Letter K (NE/4, SW/4), Section 1, Township 22 South, Range 37 East
Lea County, New Mexico

SPILL SITE DRAWING

SPILL SITE DETAILS

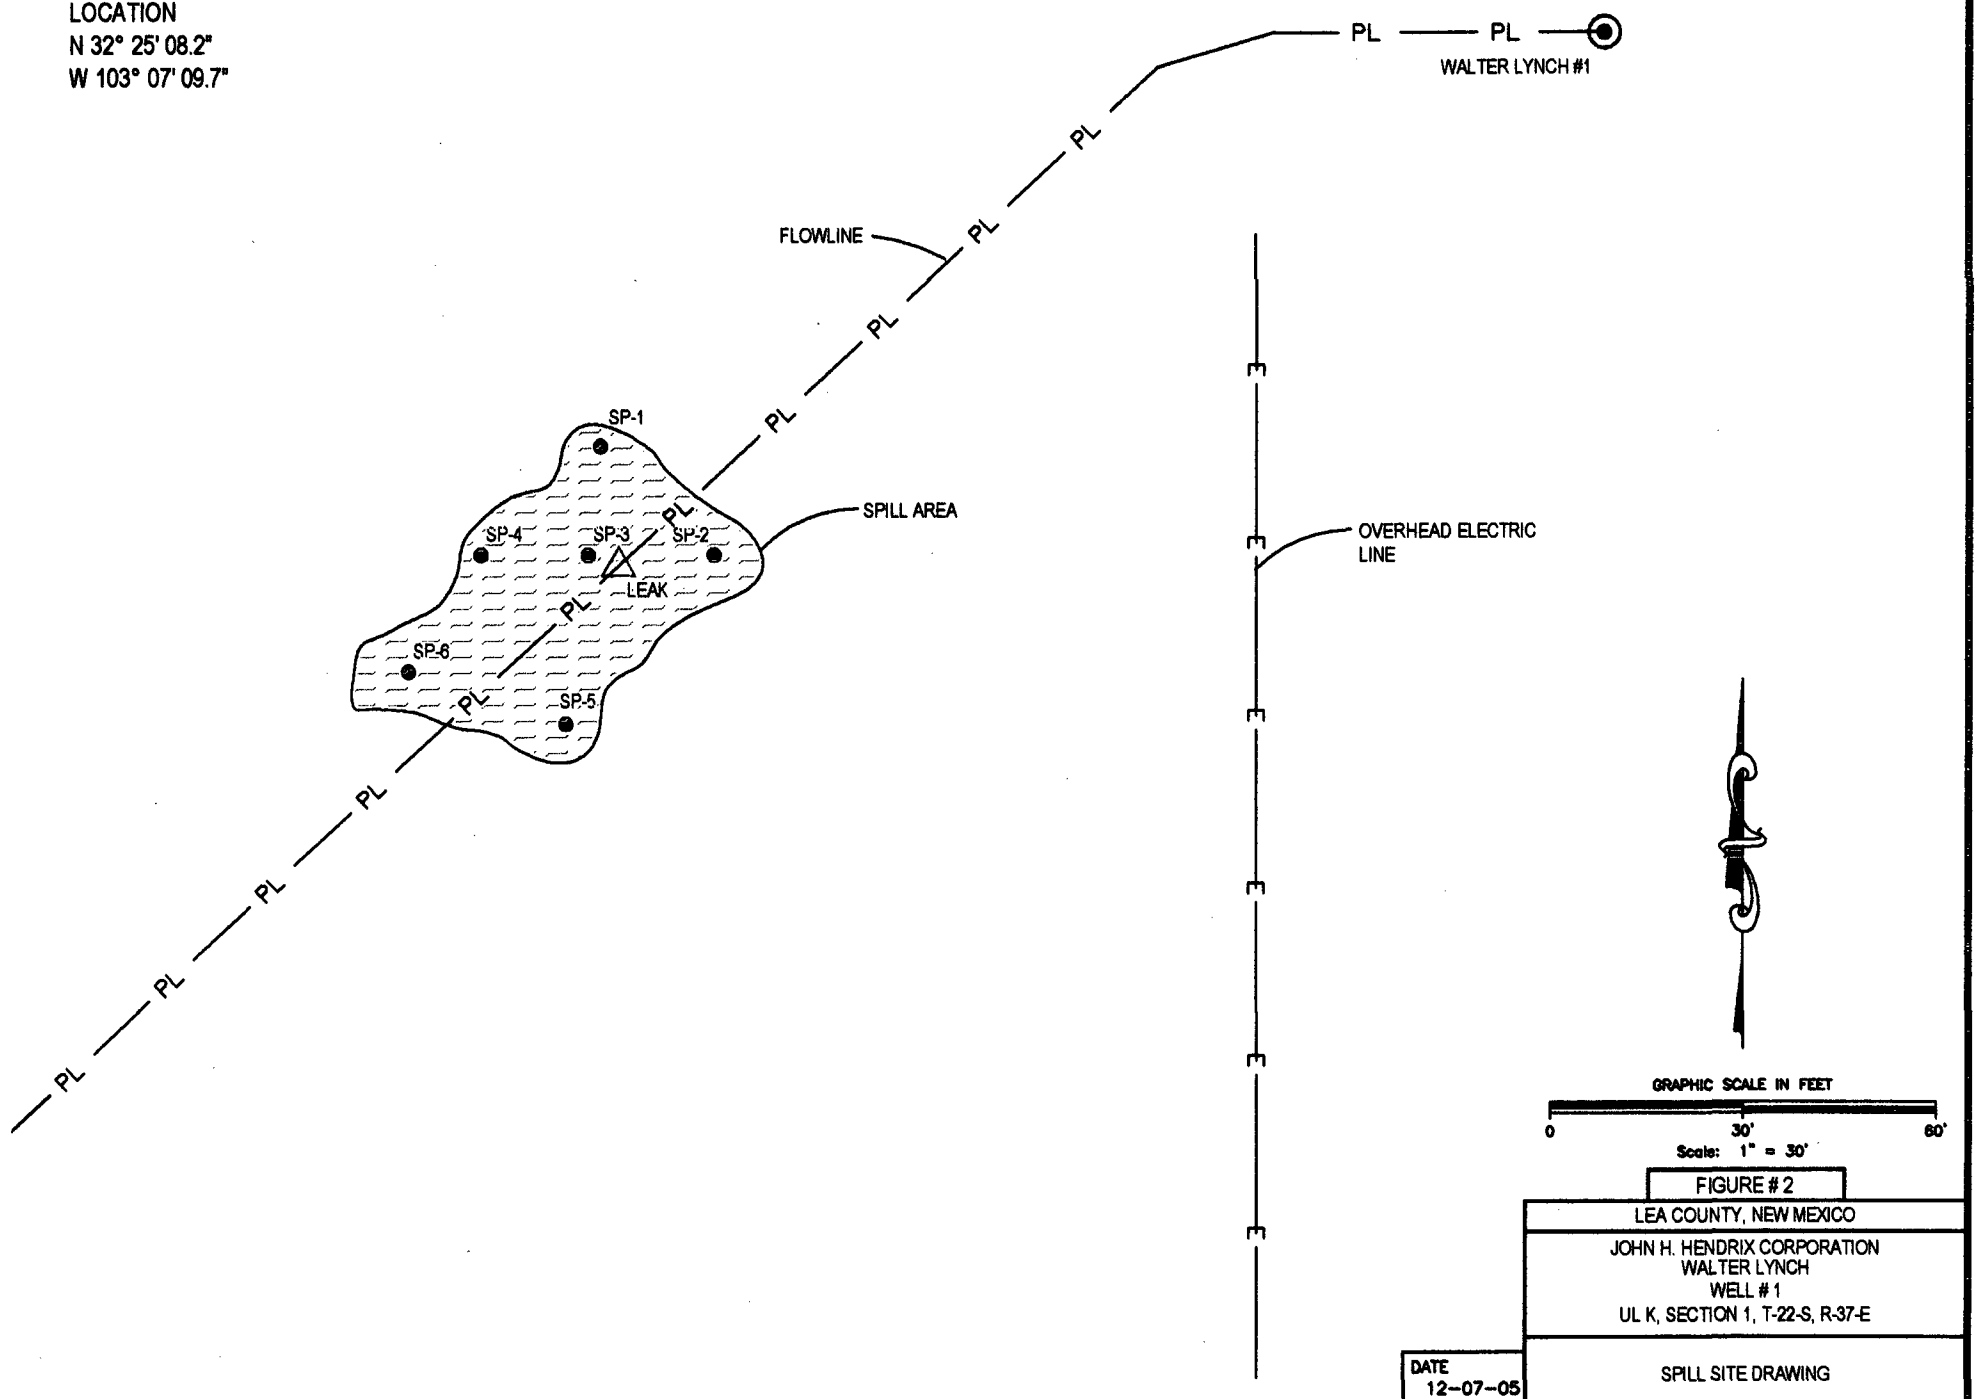
FIGURE # 2

SAMPLE NUMBER	LOCATION	DEPTH (FEET BGS)
1	EAST / END	5'
1B	EAST / END	5'
2	NORTHEAST / SIDE	5'
3	SOUTHEAST / SIDE	5'
4	EAST / BOTTOM	8'
4B	EAST / BOTTOM	11'
5	MIDDLE / BOTTOM	8'
6	NORTHWEST / SIDE	5'
7	SOUTHWEST / SIDE	5'
8	WEST / BOTTOM	4'
9	WEST / BOTTOM	4'
10	WEST / END	2'

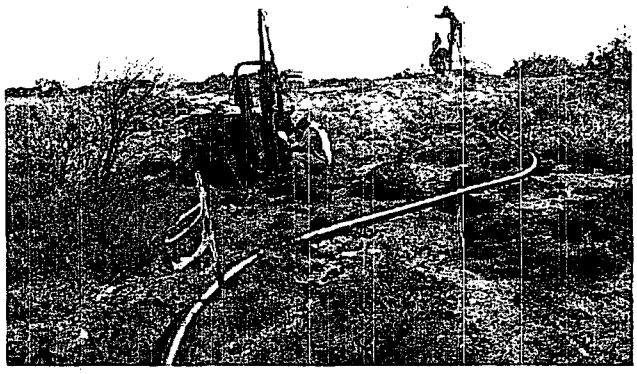
1. Direct push sampling at line

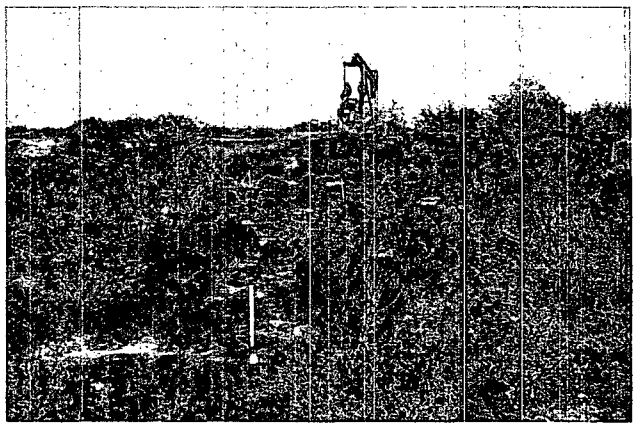
2. Flowline spill, looking northeast

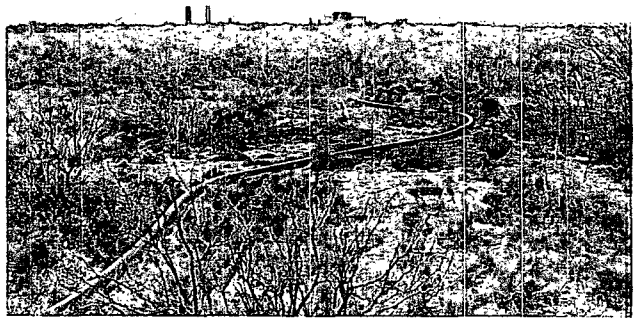
3. Flowline spill, looking southwest

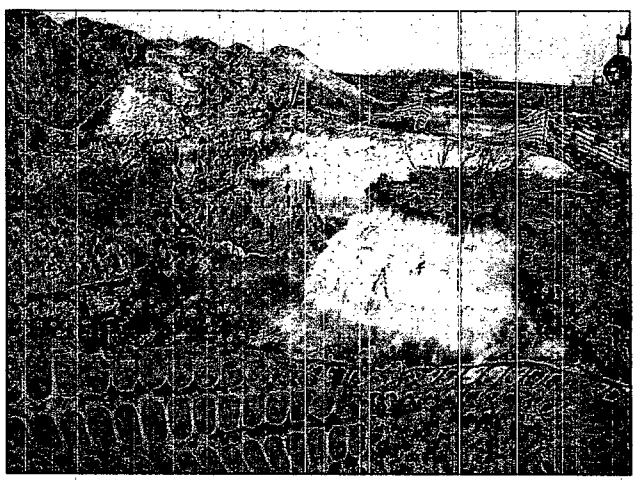
6. Remediation, Looking West, February 22, 2006

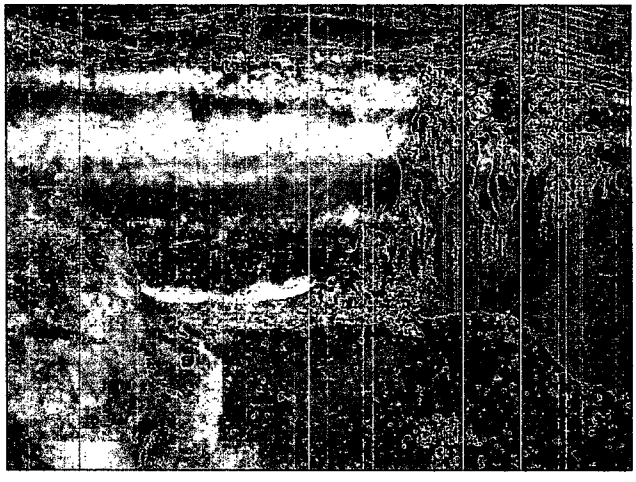
8. Remediation, Looking East, February 22, 2006
