Release Notification and Corrective Action

Name of Company: CHEVRON U.S.A. Inc.	Contact: Edem Sededji
Address: 56 Texas Camp Road, Lovington, NM 88260	Telephone No.: Office: (575) 396-4414 Mobile: (432) 234-4437
Facility Name: West Vacuum Unit #68	Facility Type: Produced Water Transfer Line

Subject:
Site Assessment Report
West Vacuum Unit #68
Lea County, New Mexico

Date:
July 29, 2014

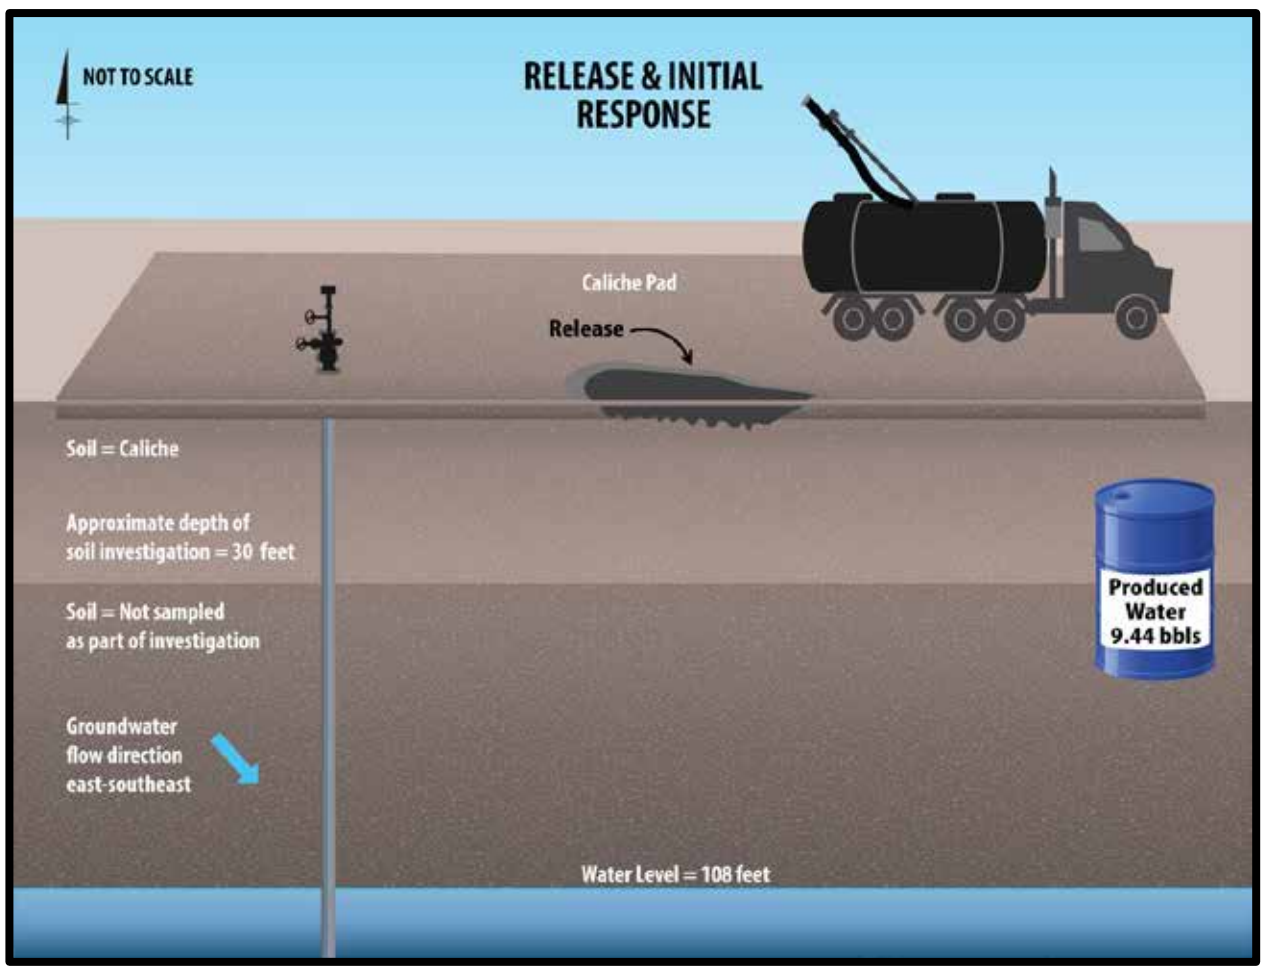
A release of approximately 9.44 bbls of produced water at the site on March 13, 2012 due to corrosion causing a pinhole leak on an injector inlet. Chevron personnel from the MidContinent Business Unit (MCBU) stopped the release and recovered approximately 9 bbls of fluids using a vacuum truck. Chevron MCBU personnel excavated visually impacted soil in the area to a depth of approximately 2 feet bgs and collected a four point composite confirmation soil sample from the base of the excavation on April 23, 2012. After collecting the soil sample, the excavated area was reportedly backfilled with imported soil. Analyte concentrations in the confirmation soil sample were above regulatory criteria, which prompted additional site assessment activities.

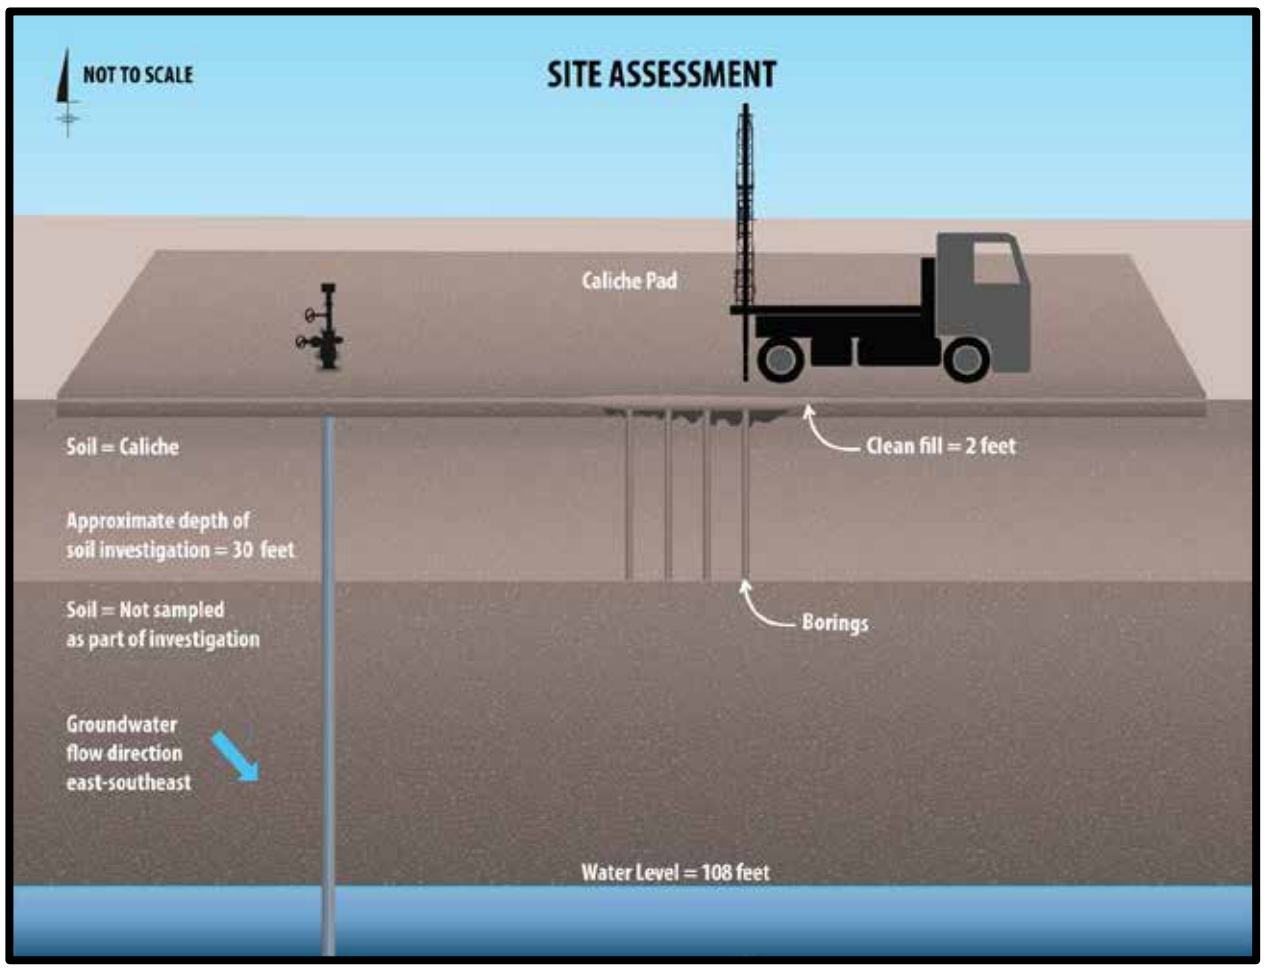
In May 2013, ARCADIS conducted site assessment activities to characterize the lateral and vertical extents of soil impacts at the site. Soil boring locations were selected based on the results of confirmation soil sampling completed at the site in April 2012, locations of pipelines and other equipment at the site, and the extent of the release as documented by Chevron MCBU personnel during the initial response activities. Analyte concentrations in samples collected during the 2013 assessment were reported below site-specific criteria. Site assessment activities demonstrate that remaining soil concentrations associated with the release do not pose significant risk to groundwater resources or other receptors.

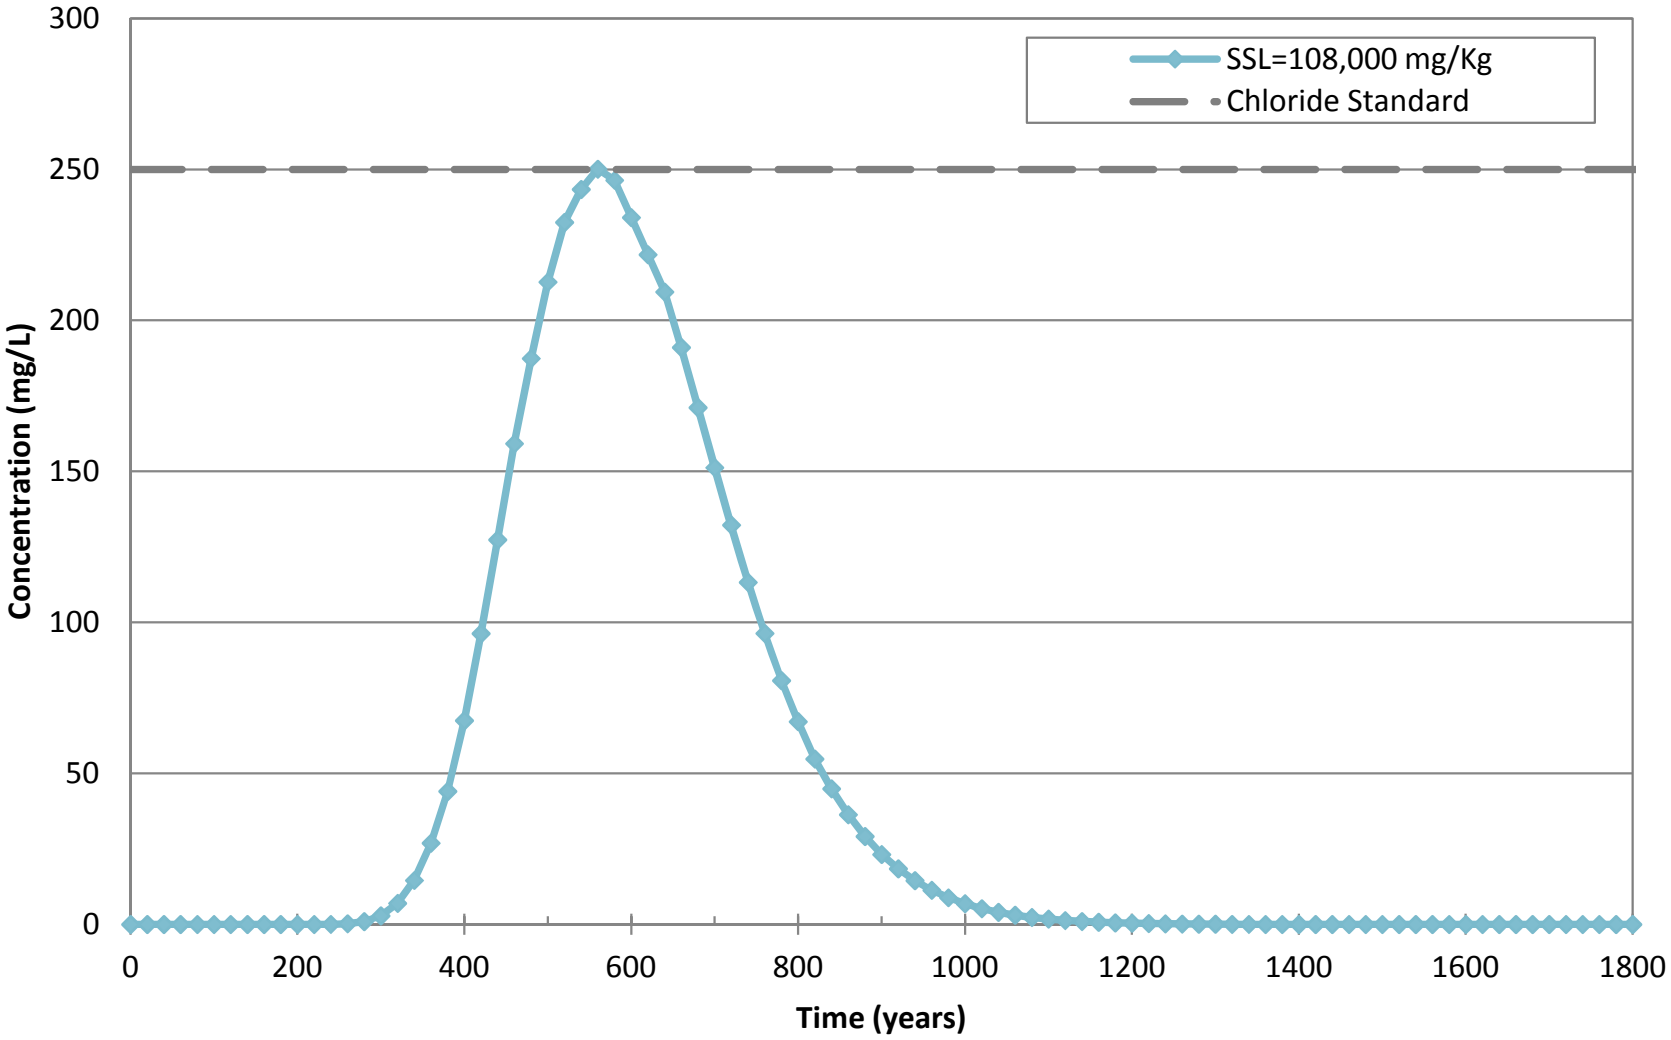
Figure 1
MULTIMED Simulated Chloride Concentration Vs Time in Groundwater
(Source = 20m, Chloride 0-1m, & Depth to Groundwater = 20m)

The predicted groundwater concentrations versus time are illustrated on Figures 1 through 8. The peak arrival times varied between 540 and 860 years. The simulations indicate the site SSLs for the protection of groundwater ranged from 8,525 to 266,100 mg/kg (Table 2) depending on the scenario and are protective of the New Mexico chloride groundwater standard of 250 mg/L.
