Re : Chevron Special Projects – NM State AN 5 (RP# 3254)

Please find enclosed for your records, a copy of the final report documenting the assessment activities at the New Mexico State AN No. 5 (RP # 3254).

SITE ASSESSMENT REPORT

VACUUM/LOVINGTON FUNCTIONAL MANAGEMENT TEAM UNITS
LEA COUNTY, NEW MEXICO
SITE ASSESSMENT REPORT

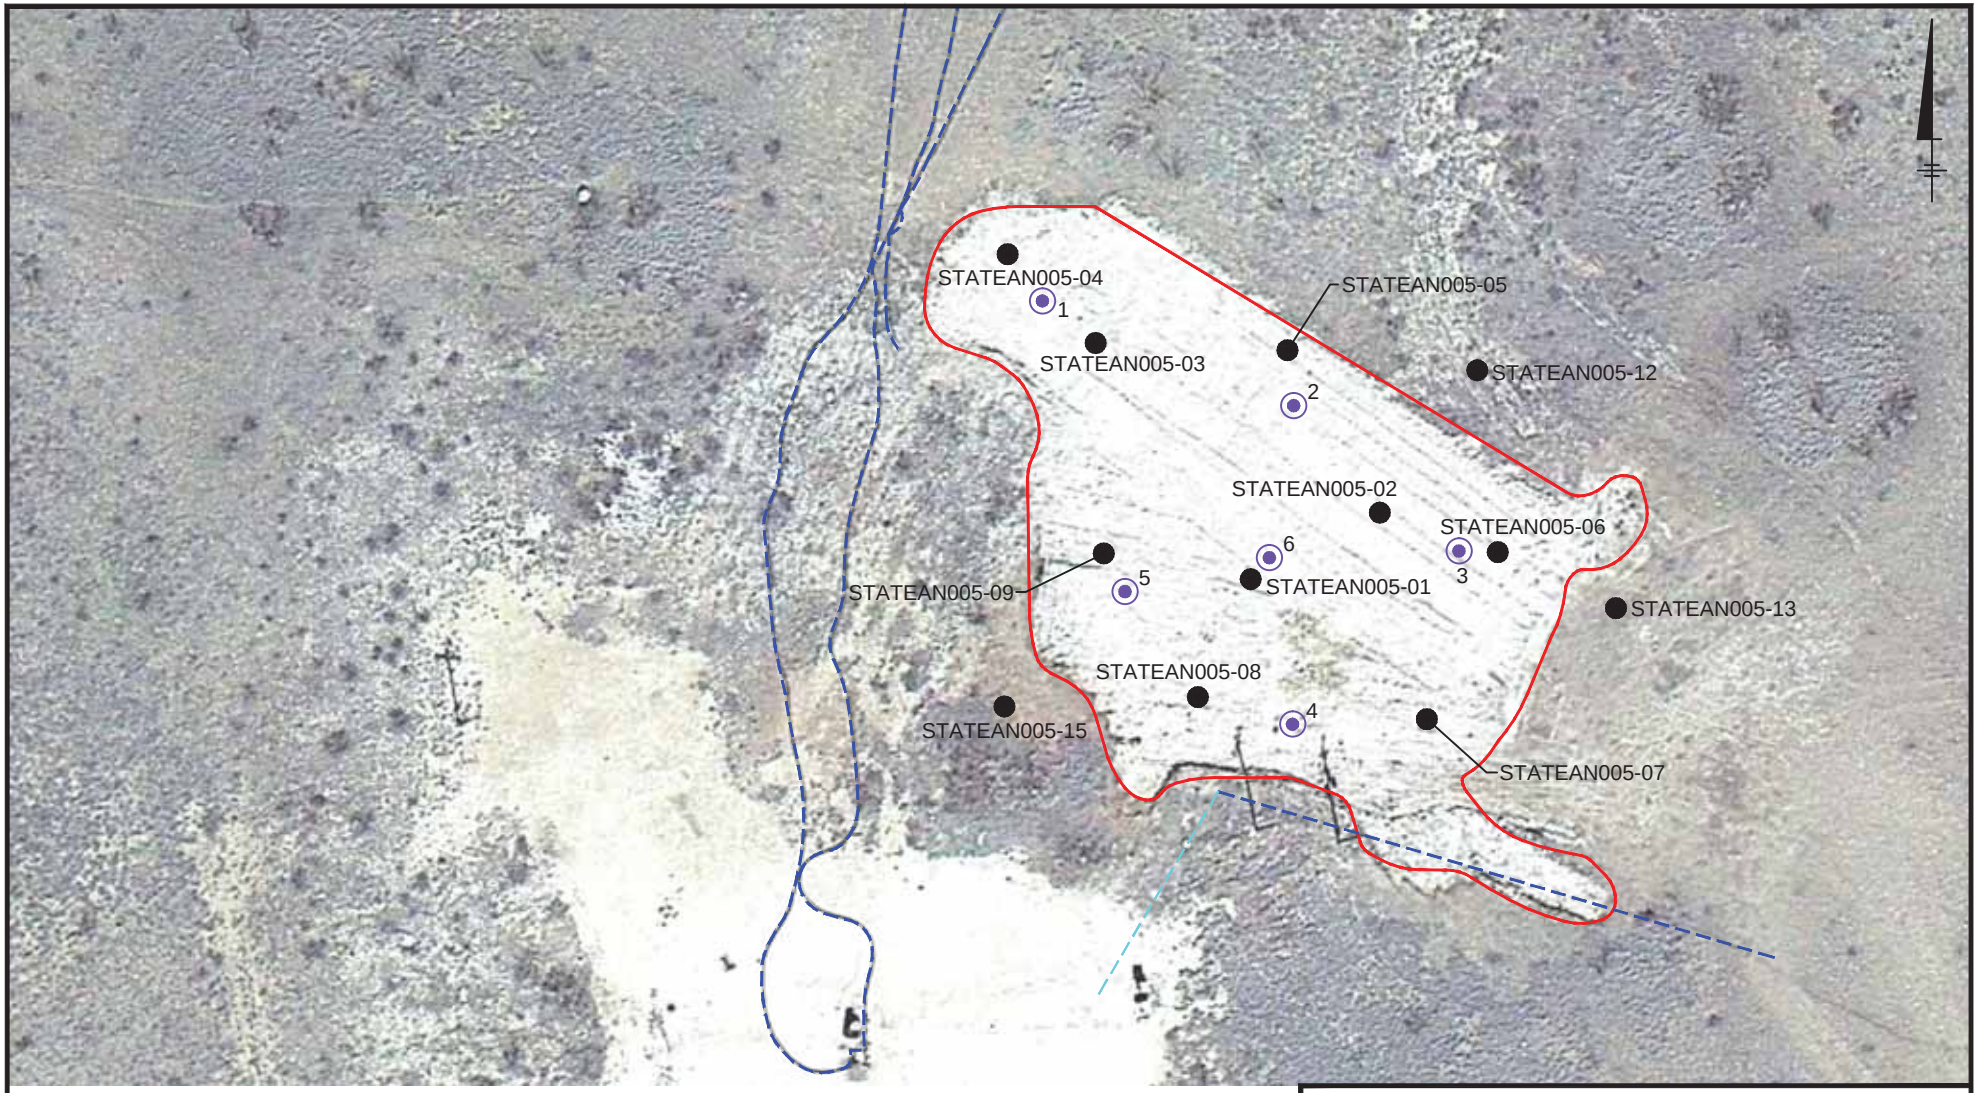
FIGURE
2

To evaluate the extent of potential impacts to soil at the site, ARCADIS advanced 12 soil borings (STATE AN005-1, STATE AN005-2, STATE AN005-3, STATE AN005-4, STATE AN005-5, STATE AN005-6, STATE AN005-7, STATE AN005-8, STATE AN005-9, STATE AN005-12, STATE AN005-13, and STATE AN005-15) on May 6 and 7, 2013. Soil sample locations are shown on Figure 2.

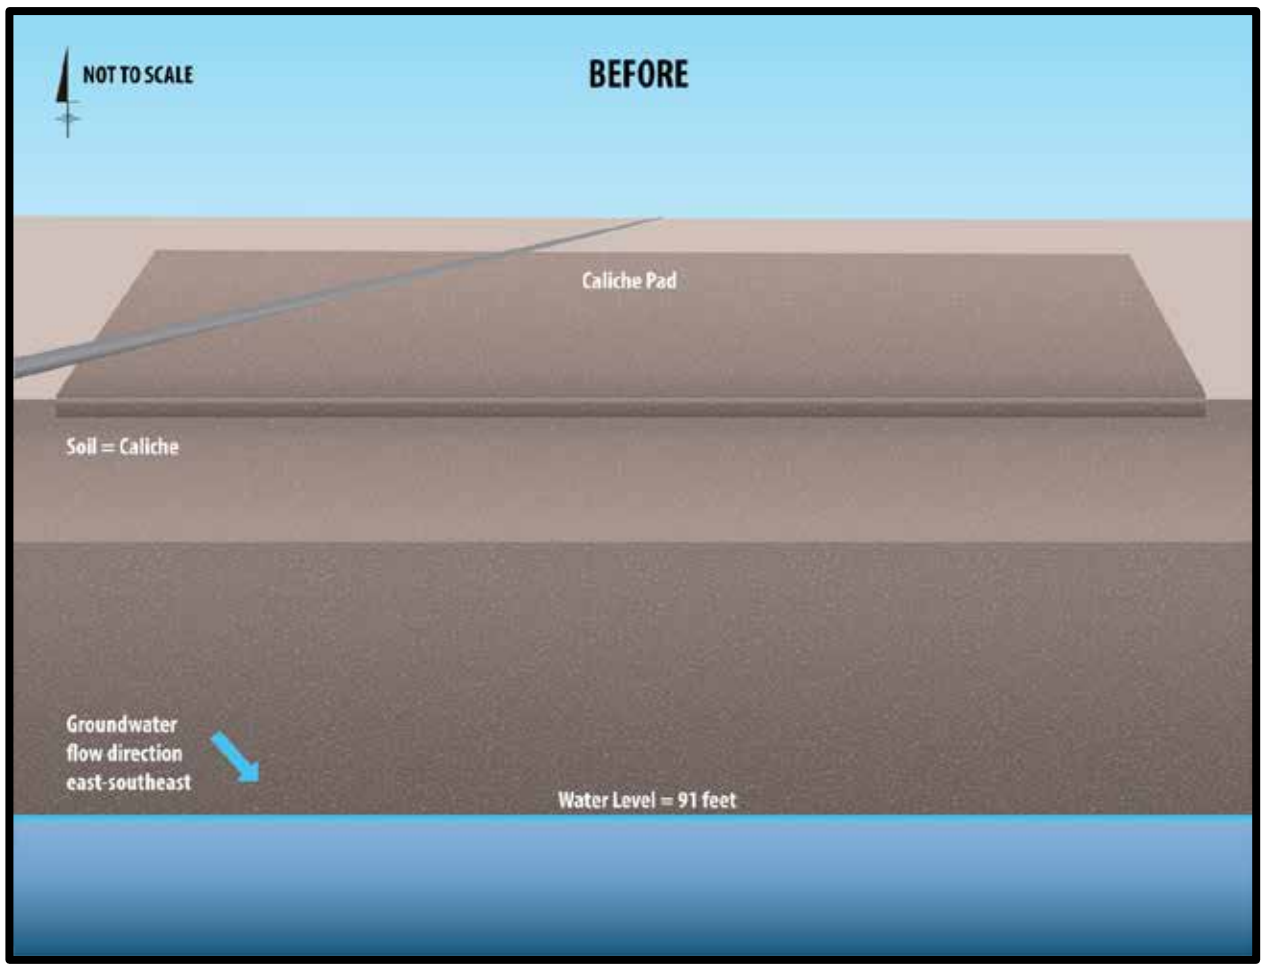
The site is located in the western edge of the Permian Basin with Lovington (the closest town) located approximately 14 miles northeast of the site. Due to the arid climate, the site experiences low precipitation and high evapotranspiration rates. According to information obtained from the NMOSE online database, groundwater near the site is encountered at a depth of approximately 91 feet bgs.

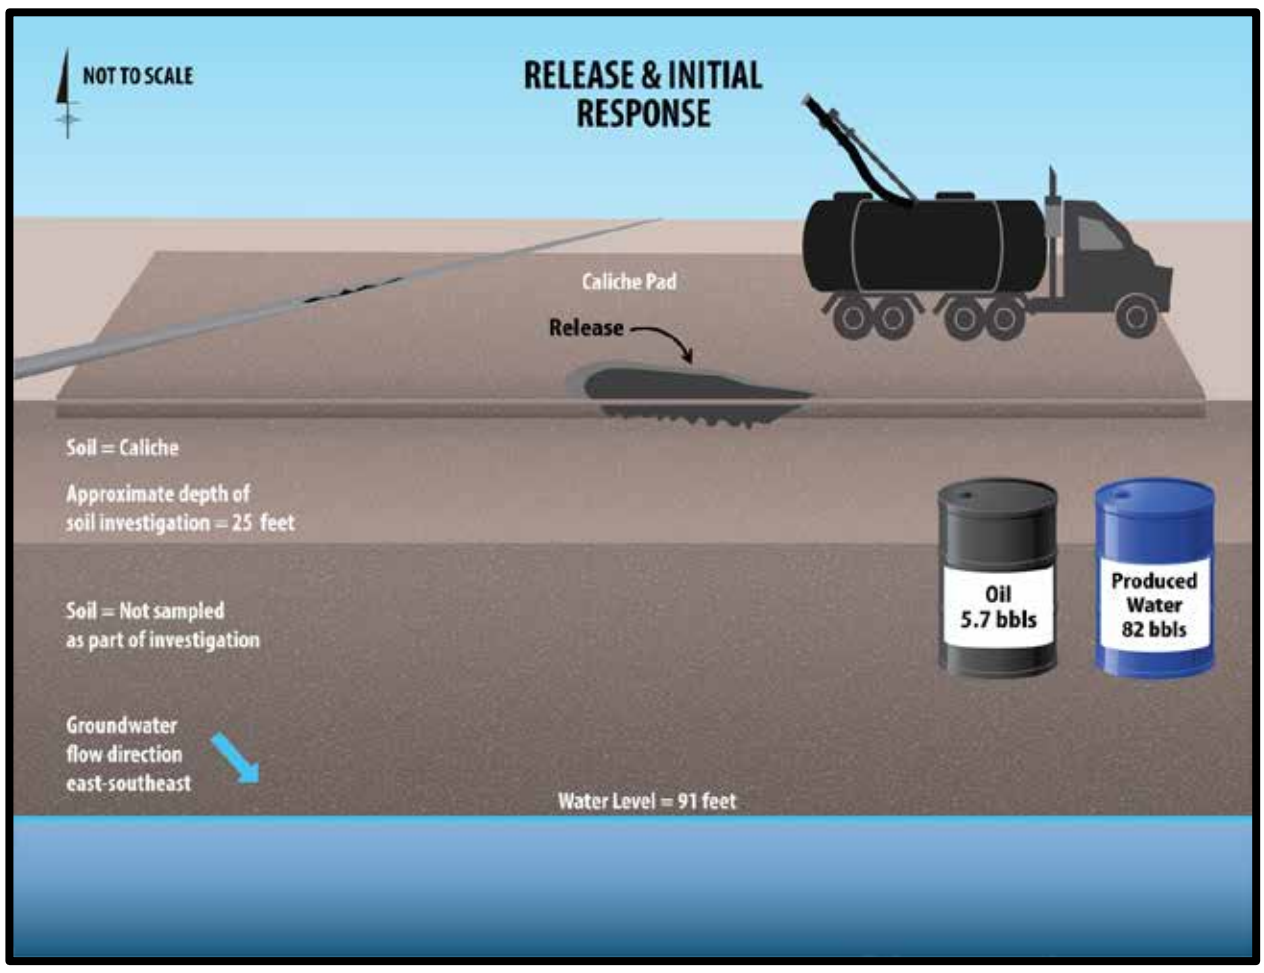
A release of approximately 82 bbls of produced water and 5.7 bbls of oil occurred at the site on July 29, 2011 due to the failure of a surface flow line. Chevron personnel from the Mid-Continent Business Unit (MCBU) stopped the release and recovered approximately 65 bbls of fluids using a vacuum truck. Chevron MCBU personnel excavated visually impacted soil in the area to a depth of approximately 2 feet bgs and collected six discrete confirmation soil samples from the base of the excavation on October 12, 2011. After collecting the soil samples, the excavated area was reportedly backfilled with imported soil. Analyte concentrations in one or more confirmation soil samples were above regulatory criteria, which prompted additional site assessment activities.

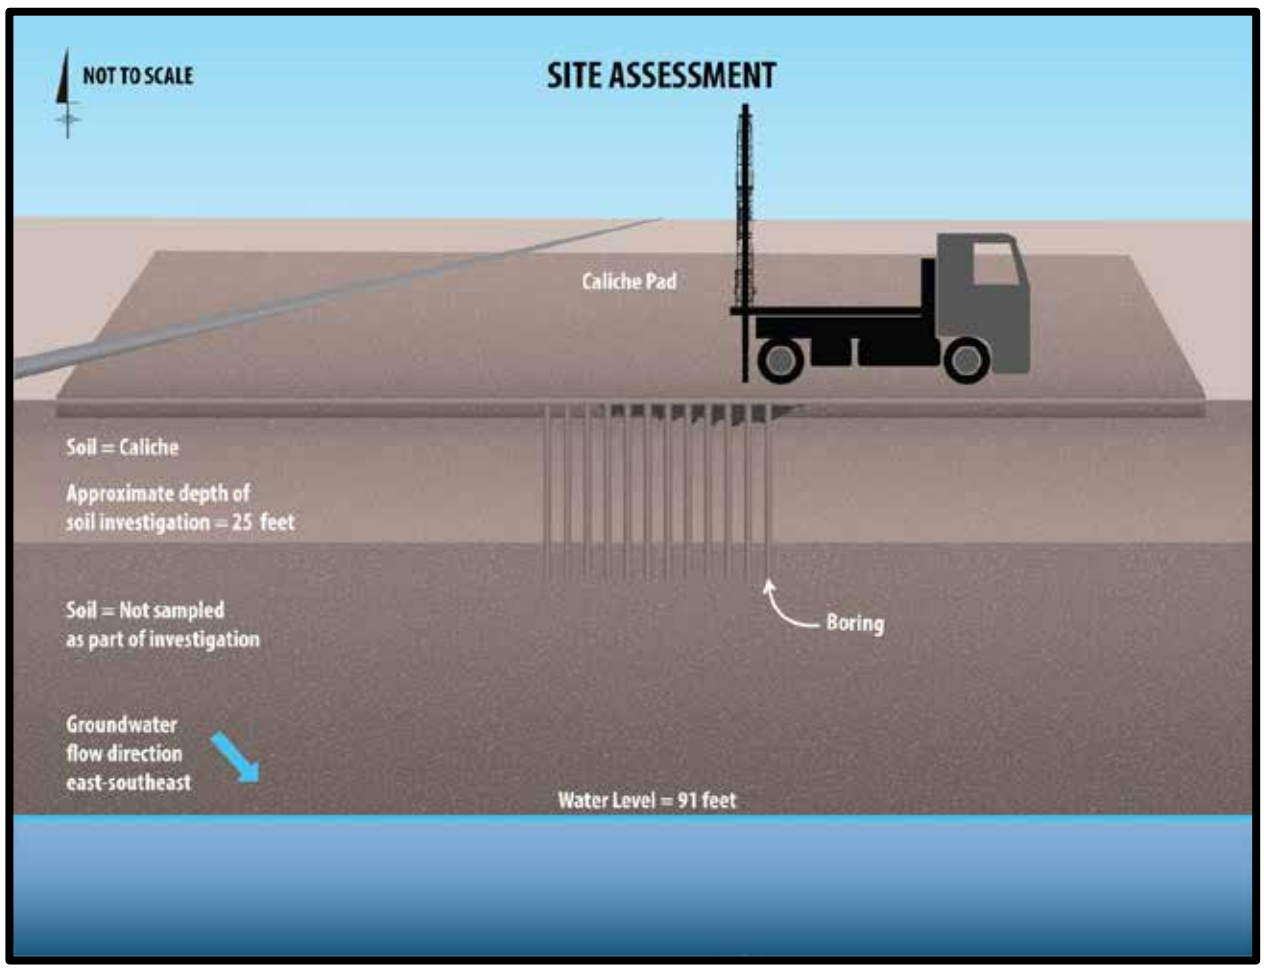
In May 2013, ARCADIS conducted site assessment activities to characterize the lateral and vertical extents of soil impacts at the site. Soil boring locations were selected based on the results of confirmation soil sampling completed at the site in October 2011, locations of pipelines and other equipment at the site, and the extent of the release as documented by Chevron MCBU personnel during the initial response activities. Analyte concentrations in samples collected during the 2013 assessment were reported below site-specific criteria. Site assessment activities demonstrate that remaining soil concentrations associated with the release do not pose significant risk to groundwater resources or other receptors.

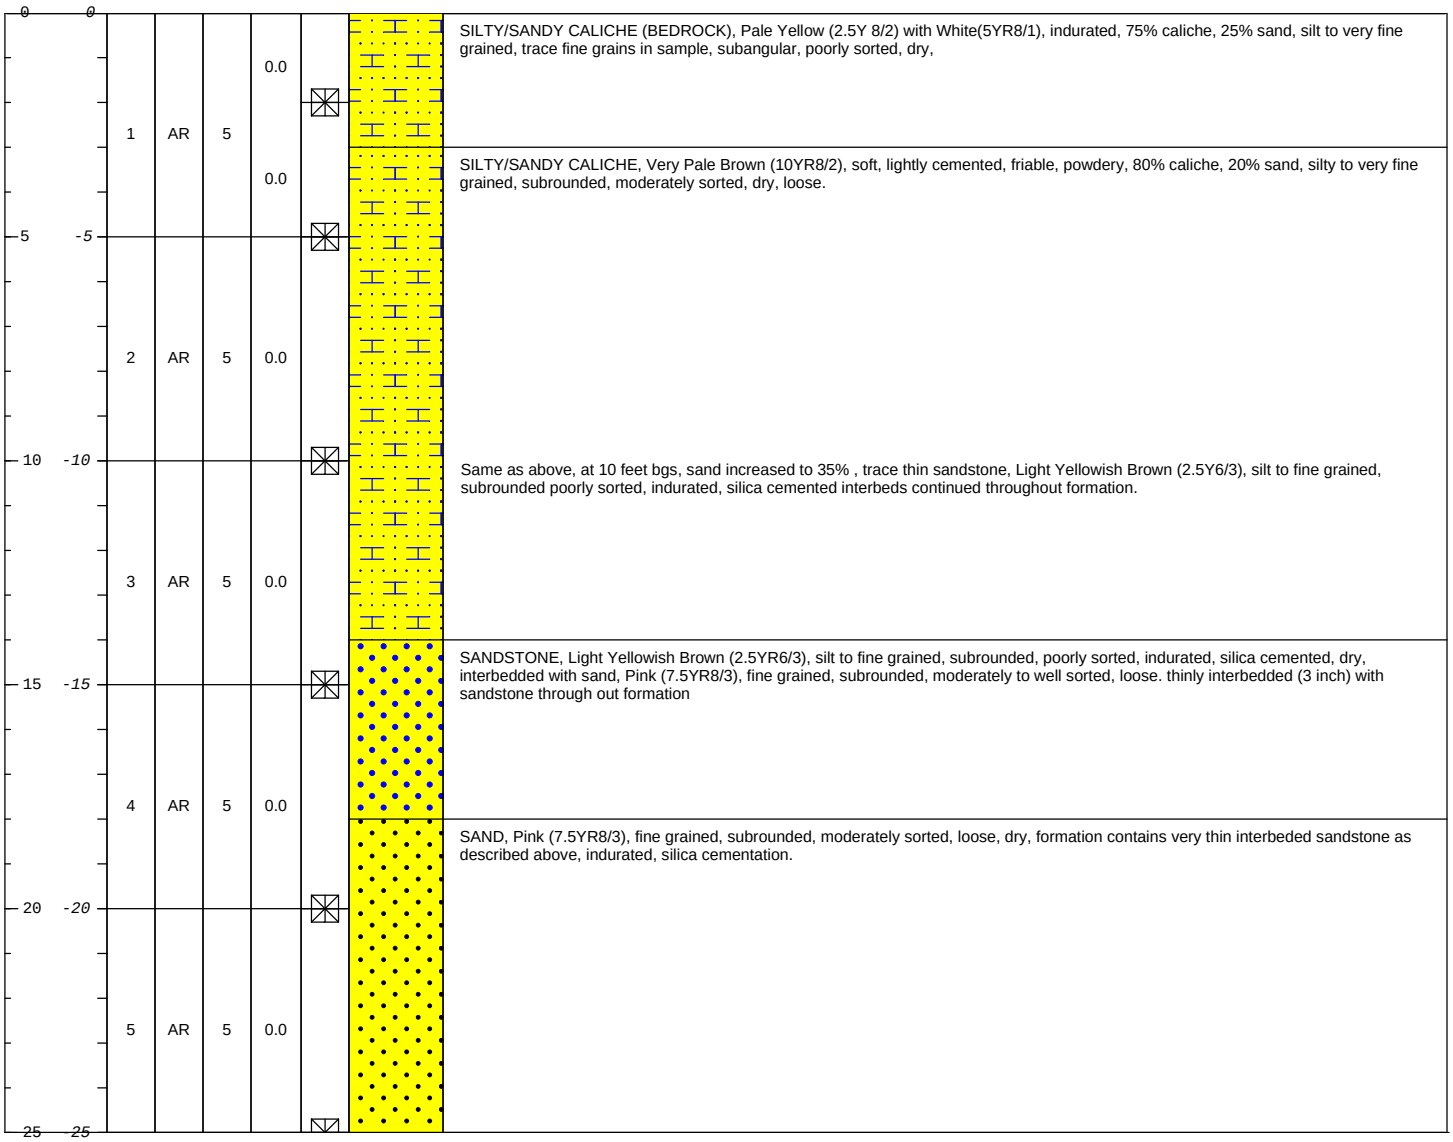
Well/Boring ID: **STATE AN005-6**

DEPTH	ELEVATION	Sample Run Number	Sample/Int/Type	Recovery (feet)	PID Headspace (ppm)	Analytical Sample	Geologic Column	Stratigraphic Description
0	0	1	AR	5	0.0	☒		SILTY/SANDY CALICHE (BEDROCK), Pale Yellow (2.5Y 8/2) with White(5YR8/1), indurated, 75% caliche, 25% sand, silt to very fine grained, trace fine grains in sample, subangular, poorly sorted, dry,
5	-5	2	AR	5	0.0	☒		SILTY/SANDY CALICHE, Very Pale Brown (10YR8/2), soft, lightly cemented, friable, powdery, 80% caliche, 20% sand, silty to very fine grained, subrounded, moderately sorted, dry, loose.
10	-10	3	AR	5	0.0	☒		Same as above, at 10 feet bgs, sand increased to 35% , trace thin sandstone, Light Yellowish Brown (2.5Y6/3), silt to fine grained, subrounded poorly sorted, indurated, silica cemented interbeds continued throughout formation.
15	-15	4	AR	5	0.0	☒		SANDSTONE, Light Yellowish Brown (2.5YR6/3), silt to fine grained, subrounded, poorly sorted, indurated, silica cemented, dry, interbedded with sand, Pink (7.5YR8/3), fine grained, subrounded, moderately to well sorted, loose. thinly interbedded (3 inch) with sandstone through out formation

20	-20	5	AR	5	0.0	☒		SAND, Pink (7.5YR8/3), fine grained, subrounded, moderately sorted, loose, dry, formation contains very thin interbeded sandstone as described above, indurated, silica cementation.
25	-25

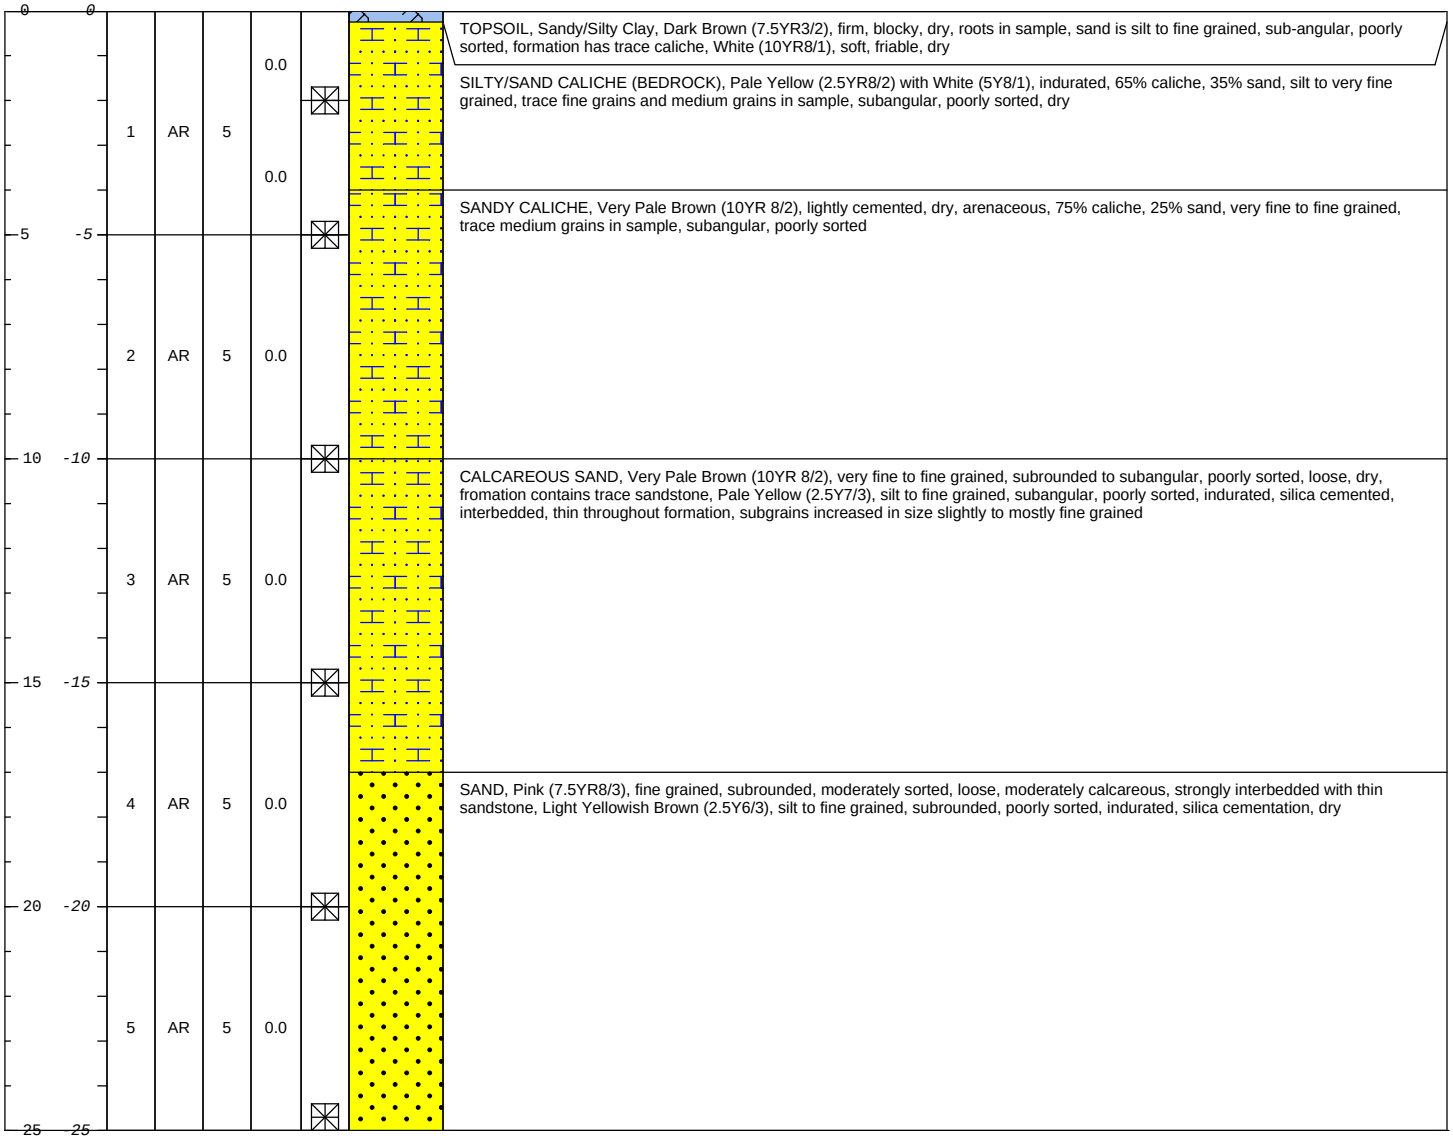
Well/Boring ID: **STATE AN005-12**

DEPTH	ELEVATION	Sample Run Number	Sample/Int/Type	Recovery (feet)	PID Headspace (ppm)	Analytical Sample	Geologic Column	Stratigraphic Description
0	0							
		1	AR	5	0.0			TOPSOIL, Sandy/Silty Clay, Dark Brown (7.5YR3/2), firm, blocky, dry, roots in sample, sand is silt to fine grained, sub-angular, poorly sorted, formation has trace caliche, White (10YR8/1), soft, friable, dry

0.0			SILTY/SAND CALICHE (BEDROCK), Pale Yellow (2.5YR8/2) with White (5Y8/1), indurated, 65% caliche, 35% sand, silt to very fine grained, trace fine grains and medium grains in sample, subangular, poorly sorted, dry
5	-5	2	AR	5	0.0			SANDY CALICHE, Very Pale Brown (10YR 8/2), lightly cemented, dry, arenaceous, 75% caliche, 25% sand, very fine to fine grained, trace medium grains in sample, subangular, poorly sorted
10	-10	3	AR	5	0.0			CALCAREOUS SAND, Very Pale Brown (10YR 8/2), very fine to fine grained, subrounded to subangular, poorly sorted, loose, dry, fromation contains trace sandstone, Pale Yellow (2.5Y7/3), silt to fine grained, subangular, poorly sorted, indurated, silica cemented, interbedded, thin throughout formation, subgrains increased in size slightly to mostly fine grained
15	-15	4	AR	5	0.0			SAND, Pink (7.5YR8/3), fine grained, subrounded, moderately sorted, loose, moderately calcareous, strongly interbedded with thin sandstone, Light Yellowish Brown (2.5Y6/3), silt to fine grained, subrounded, poorly sorted, indurated, silica cementation, dry

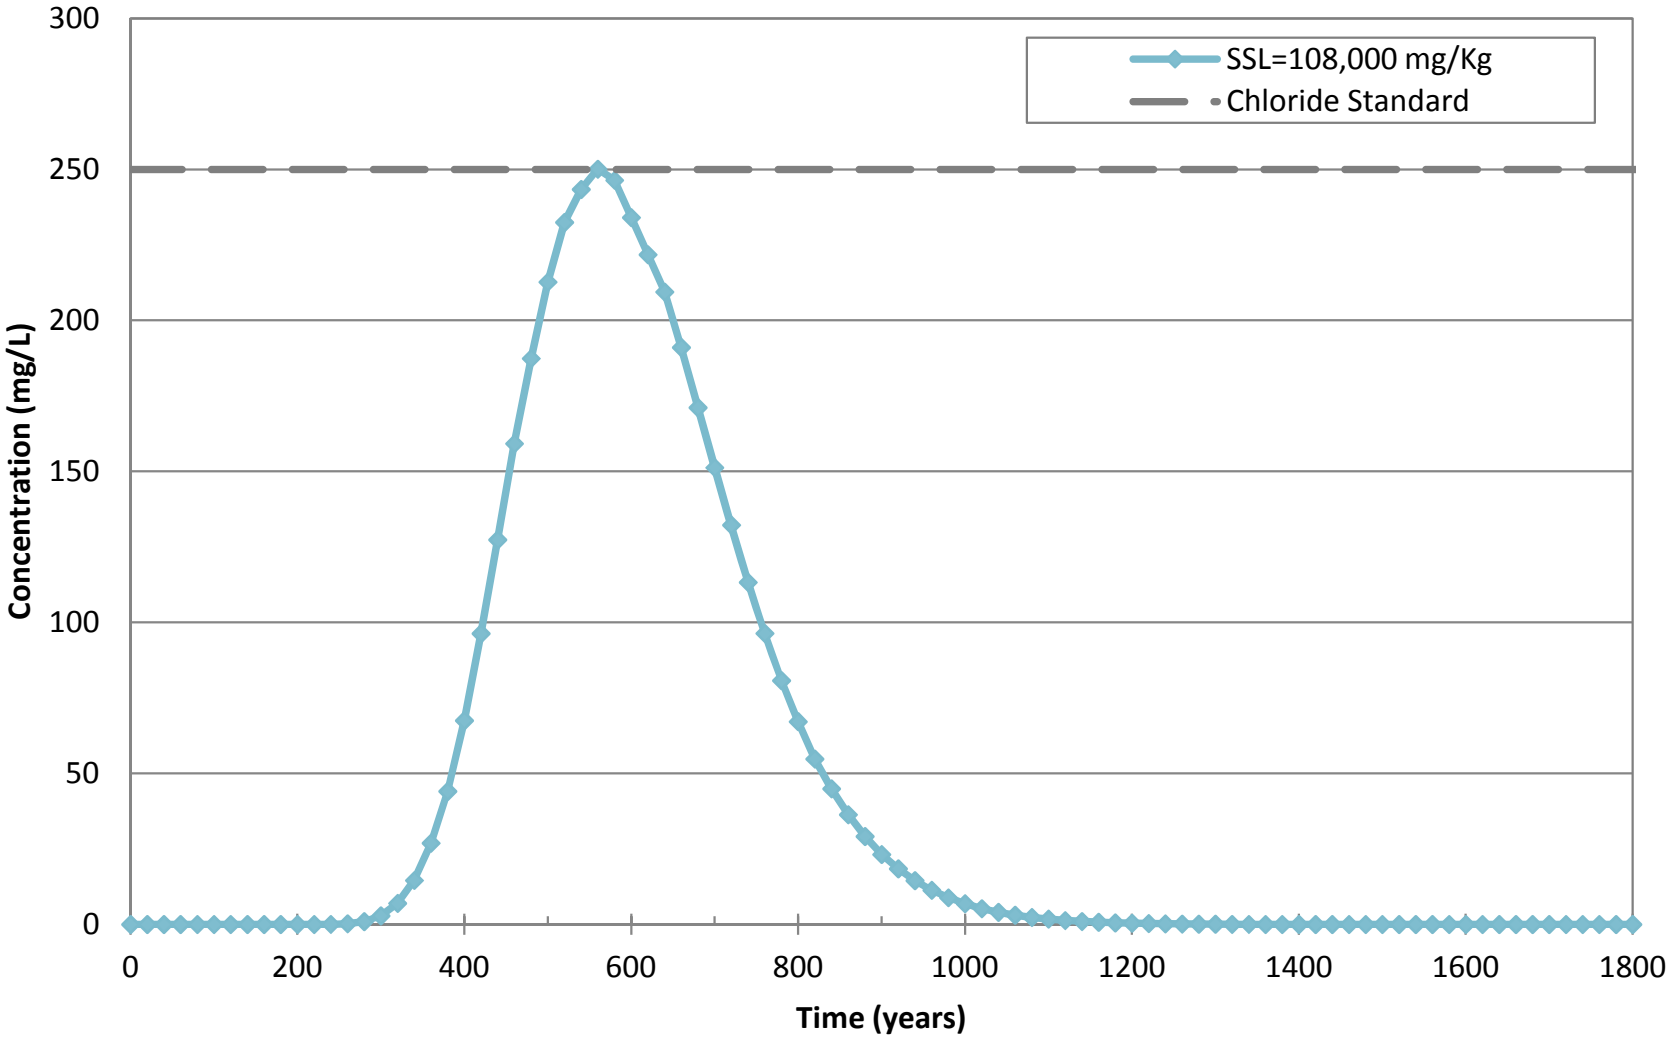
Figure 1
MULTIMED Simulated Chloride Concentration Vs Time in Groundwater
(Source = 20m, Chloride 0-1m, & Depth to Groundwater = 20m)

The predicted groundwater concentrations versus time are illustrated on Figures 1 through 8. The peak arrival times varied between 540 and 860 years. The simulations indicate the site SSLs for the protection of groundwater ranged from 8,525 to 266,100 mg/kg (Table 2) depending on the scenario and are protective of the New Mexico chloride groundwater standard of 250 mg/L.
