Report Type: Work Plan

General Site Information:					
Site:	**Eunice Yard**				
Company:	**Globe Energy Services**				
Section, Township and Range	**Unit I**	**Sec. 34**	**T 21S**	**R 37E**	
Lease Number:					
County:	**Lea County**				
GPS:	**32.433563° N**			**103.144684° W**	
Surface Owner:	Chevron USA, Inc.				
Mineral Owner:					
Directions:	From intersection of Texas Ave & 4th St in Eunice, NM travel SOUTH on 4th St for approx 0.25 mi, turn EAST onto lease road for approx 0.15 mi. SW Corner of Globe Energy Yard is approx 125 feet north of lease road.

RE: Work Plan for the Globe Energy Services, Produced Water Release Located in Unit I, Section 34, Township 21 South, Range 37 East, Lea County, New Mexico. RP #3960

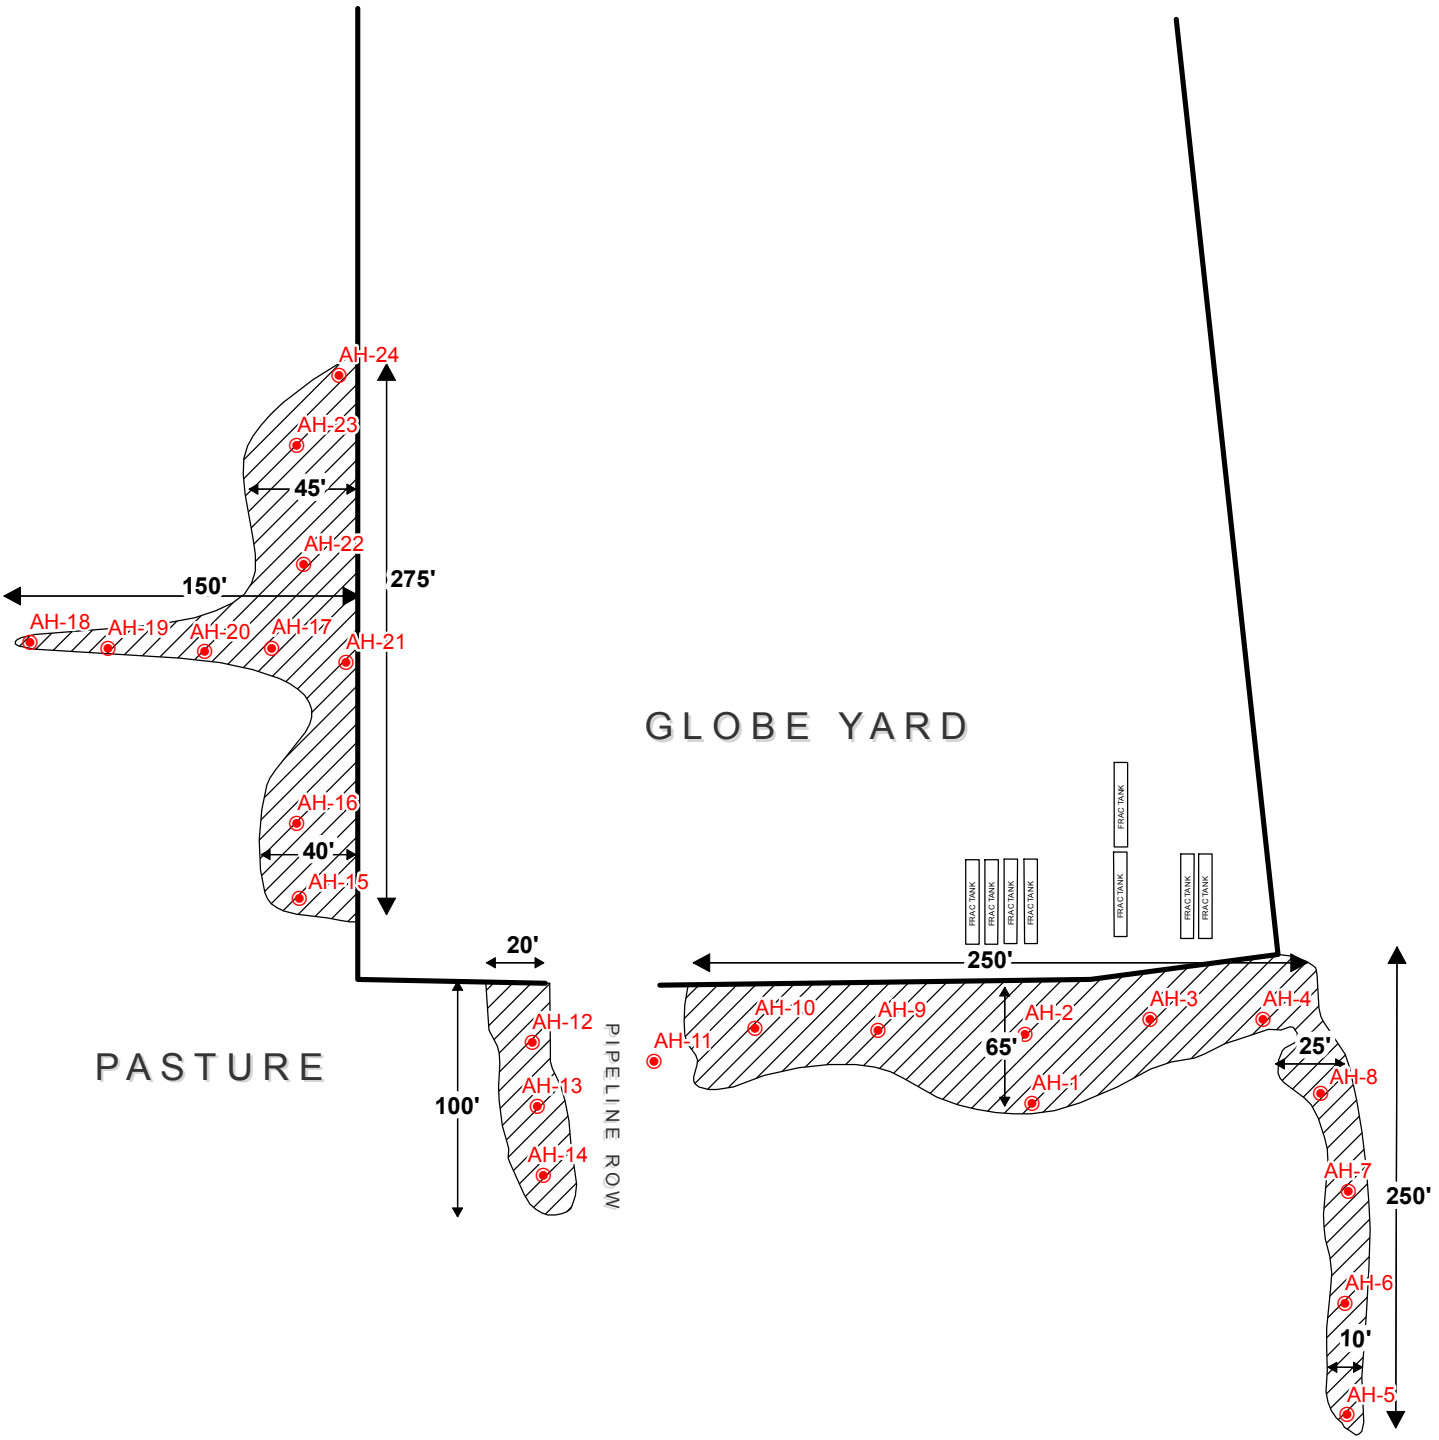
Figure 3

On November 19, 2015, Tetra Tech personnel inspected and sampled the spill area. The impacted areas were located outside the Globe facility along the west and south fence line. A total of twenty-four (24) auger holes (AH-1 through AH-24) were installed using a stainless steel hand auger to assess the impacted soils. Soil samples were collected to depths ranging from 1.0' to 2.5'-3.0' below surface. Deeper samples were not collected due to the dense caliche formation at the site. Soil samples were analyzed for TPH analysis by EPA method 8015 modified, BTEX by EPA Method 8021B and chloride by EPA method 300.0. Copies of laboratory analysis and chain-of-custody documentation are included in *Appendix D*. The sampling results are summarized in *Table 1*. The auger hole locations are shown on *Figure 3.*

Referring to *Table 1*, all of the auger hole samples selected for BTEX analysis were below the RRAL. The areas of AH-1, AH-16 and AH-21 showed TPH concentrations above the RRAL with concentrations of 350 mg/kg, 387 mg/kg and 320 mg/kg, respectively. However, these impact area were vertically defined in the shallow soils at a depth of approximately 1-1.5' below surface. In addition, auger holes (AH-3, AH-4, AH-8, AH-15, AH-17, AH-19, AH-20 and AH-22) exceeded the TPH RRAL and were not vertically defined. The remaining auger holes (AH-2, AH-5, AH-6, AH-7, AH-9, AH-10, AH-11, AH12, AH-13, AH-14, AH-18, AH-23 and AH-24) did not show any TPH concentrations above the RRAL.

The areas of auger holes (AH-9 and AH-23) showed chloride concentrations of 1,370 mg/kg and 345 mg/kg at 0-1', but vertically were defined at 1-1.5' and 2-2.5', respectively. The areas of auger holes (AH-1, AH-2, AH-3, AH-4, AH-6, AH-7, AH-12, AH-13, AH-14, AH-17 and AH-21) showed chloride concentrations above the RRAL, or delineation concentration of 250 mg/kg, and were not vertically defined. The remaining auger holes (AH-5, AH-8, AH-10, AH-11, AH-15, AH-16, AH-18, AH-19, AH-20, AH-22 and AH-24) did not show any chloride concentrations in the soils above 250 mg/kg.

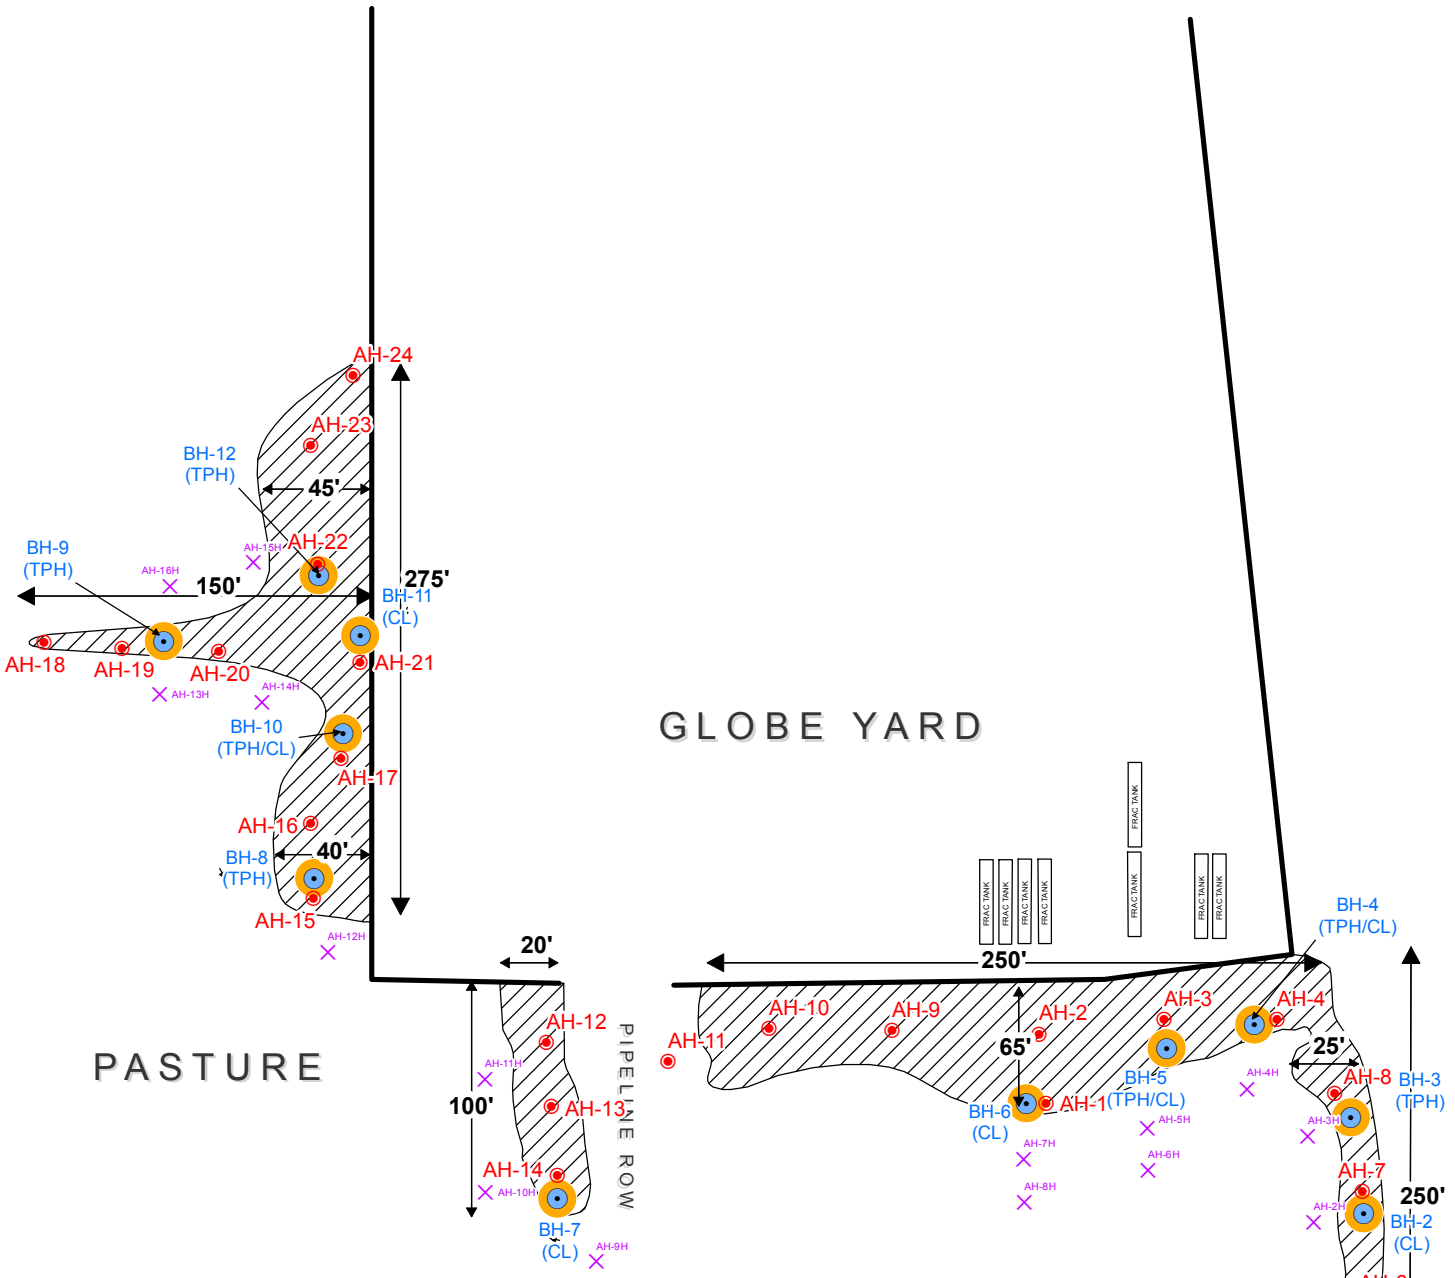
Figure 4

Referring to *Table 1*, all of the soil samples collected from the boreholes BH-3 (AH-8), BH-4 (AH-4), BH-5 (AH-3), BH-8 (AH-15), BH-9 (AH-19 and AH-20), BH-10 (AH-17) and BH-12 (AH-22) did not show any TPH concentrations above the laboratory reporting limit.

In addition, soil samples collected at BH-7 (AH-14) did not show any chloride concentrations above 250 mg/kg. Soil samples collected at BH-10 (AH-17) and BH-11 (AH-21) did show chloride spikes of 4,210 mg/kg and 4,170 mg/kg at 2.0'-3.0' below surface, respectively. However, the chloride concentrations declined with depth to 50.8 mg/kg (BH-10) and 69.5 mg/kg (BH-11) at 19'-20' below surface.

The remaining boreholes; BH-1 (AH-6), BH-2 (AH-7), BH-4 (AH-4), BH-5 (AH-3), and BH-6 (AH-1) did not show chloride concentrations decline below 250 mg/kg at a depth of 24'-25', with concentrations of 286 mg/kg, 455 mg/kg, 1,320 mg/kg, 426 mg/kg, and 370 mg/kg, respectively. Due to shallow groundwater in the area, no samples were collected deeper than 24'-25' below surface.

Referring to *Table 2*, none of the samples collected at auger holes (AH-1H through AH-3H), and (AH-6H through AH-16H) showed chloride concentrations above 250 mg/kg. However, the area of auger hole (AH-4H) showed a chloride concentration of 531 mg/kg at 0'-1' below surface and deeper samples were not collected due to a dense caliche formation in the area. Additionally, the samples collected at auger hole (AH-5H) showed chloride concentrations increasing with depth from <2.00 mg/kg at 0'-1' to 316 mg/kg at 2.0'-2.5' below surface. Based on the field data, an additional step out (AH-8H) was installed for delineation, which showed chloride concentrations <250 mg/kg.
