TIMBERWOLF ENVIRONMENTAL

Re: Proposed Work Plan for Site Characterization
Dolly No. 1 Facility Flowline Release
Bagley North Oil Field, Lea County, New Mexico
NW1/4 NWSE1/4, Sec. 17, T11S, R33E
NMOCD Case No. 1R-4705

Project No.:	ISR-170051	**Client:**	Jay Management
Project Name:	Dolly No. 1 Flowline Release	**Site Location:**	Lea County, New Mexico
Task Description:	Initial Site Assessment	**Date:**	05/22/17

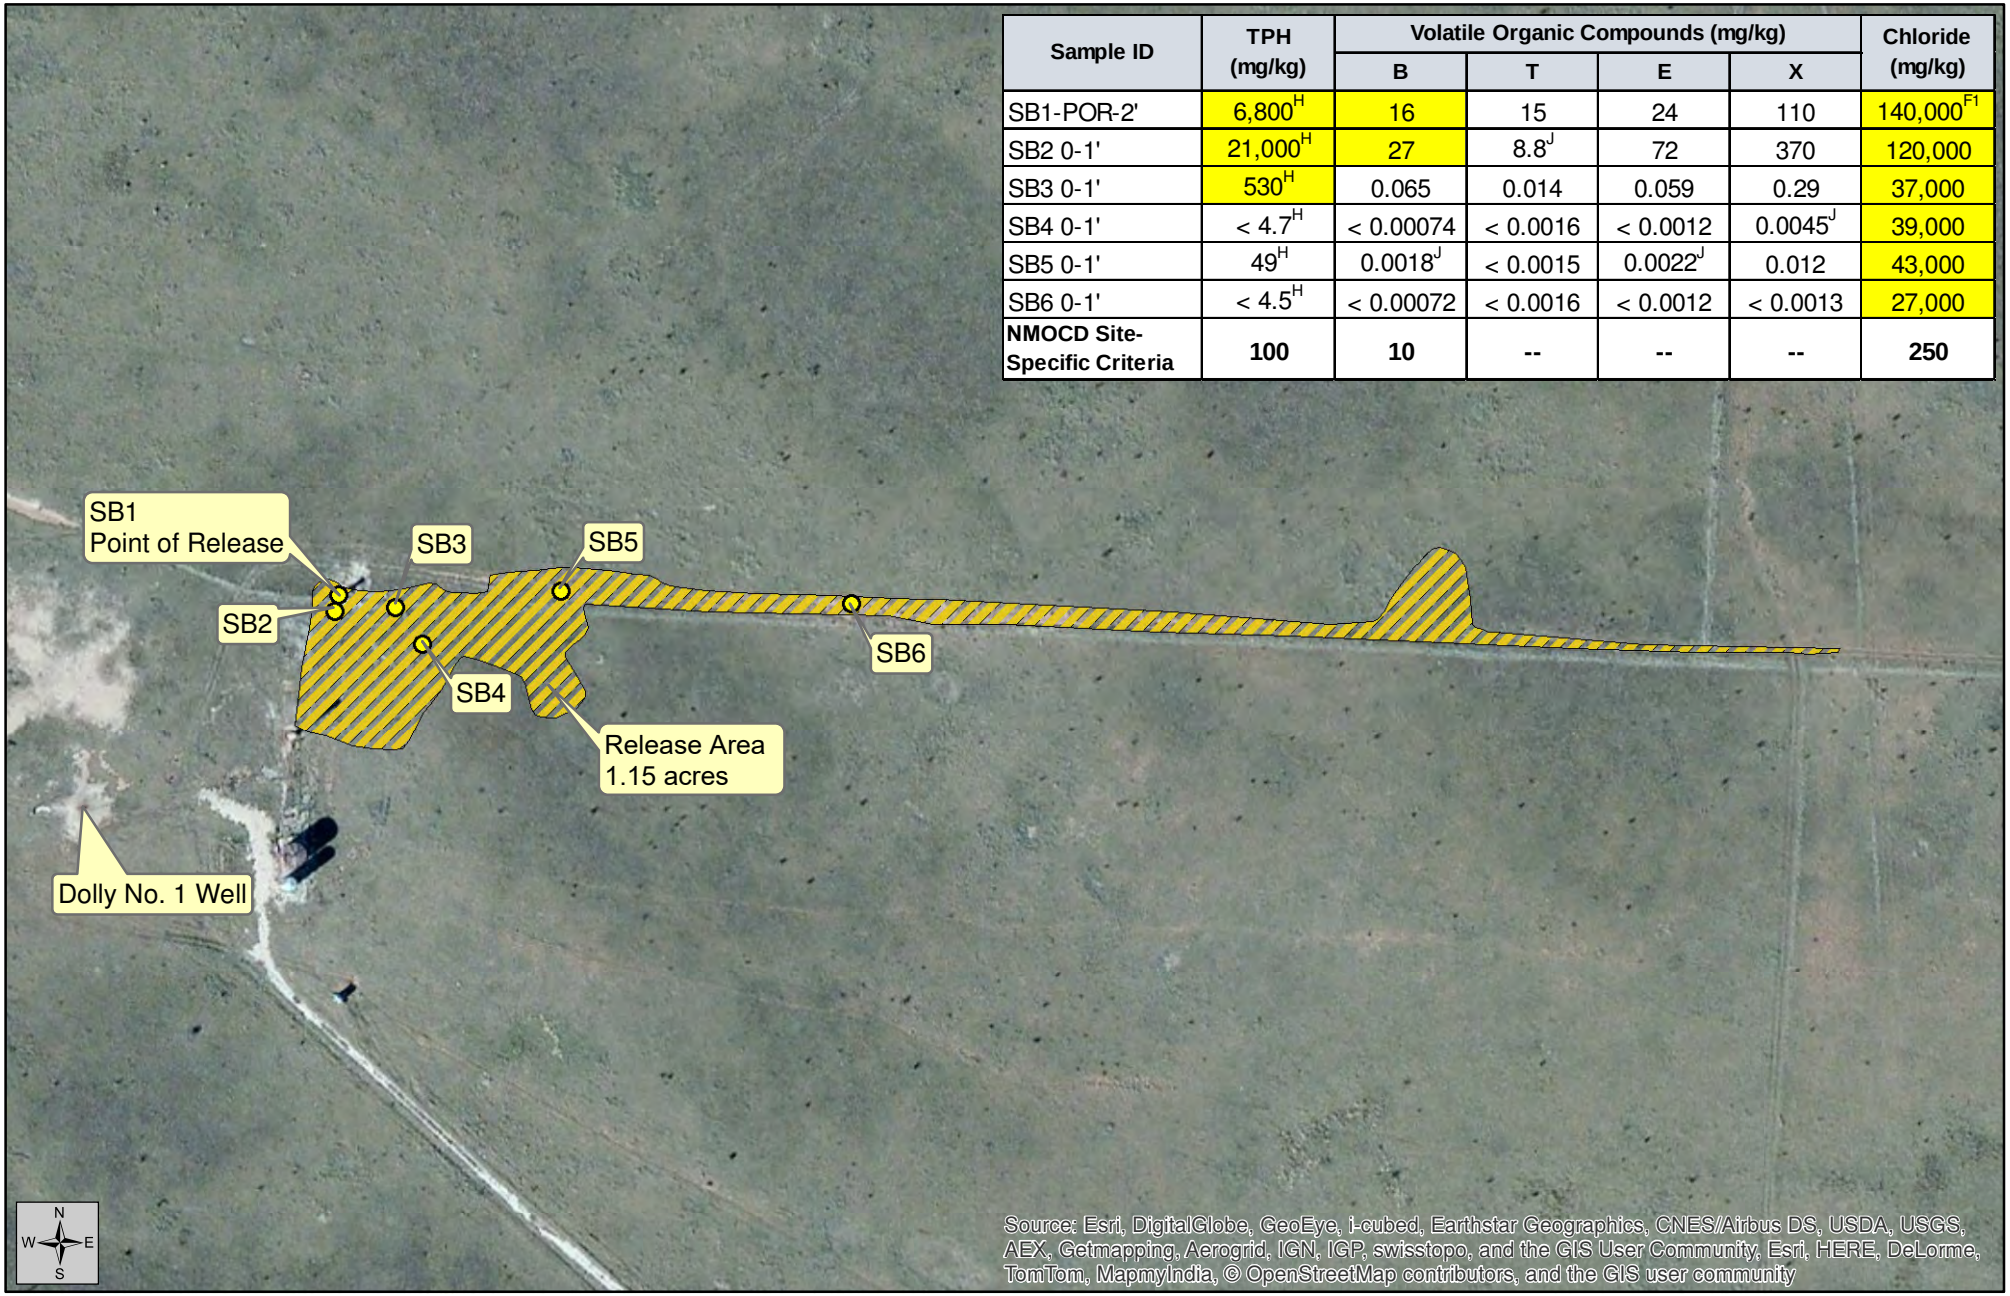
Figure 3
Sample Location and Release Area Map

- The main body of the impacted area encompasses approximately 1.15 acres (Figure 3). The release traveled mostly east following a two track road for approximately 1,655 ft. Initial cleanup included the removal of fluids and scraping the soil surface to consolidate the most heavily impacted soils into a stockpile to the south of the trunkline corridor. Fluids remain within the excavation at the point of release.

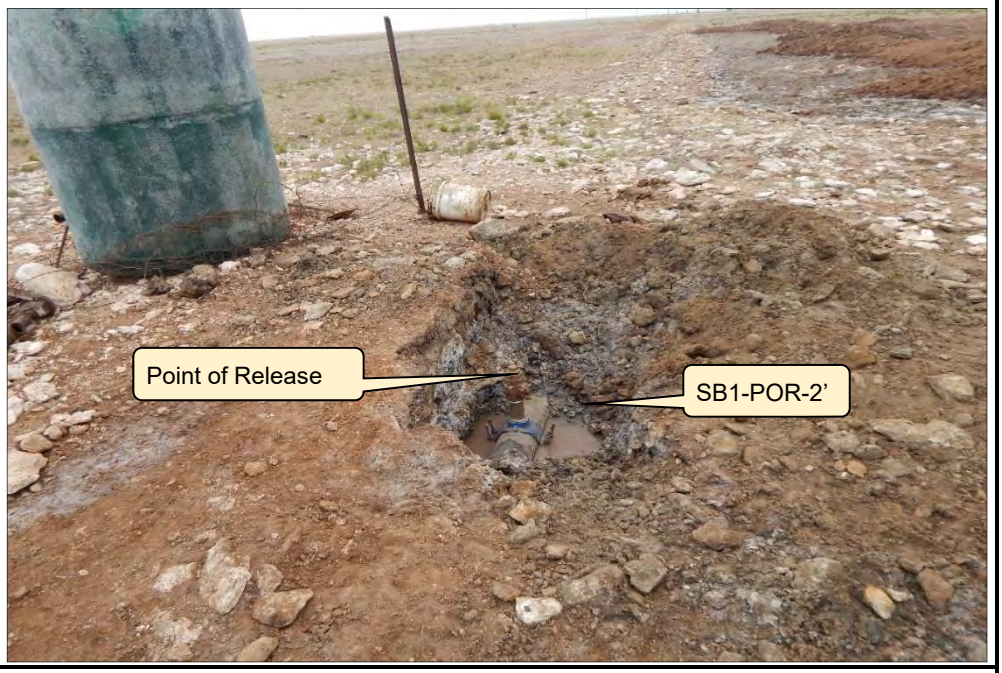
Photo No.: 1

Comments: The excavation, point of release, and the Dolly No. 1 flowline and trunkline junction. Note location of point of release and SB1-POR-2'.

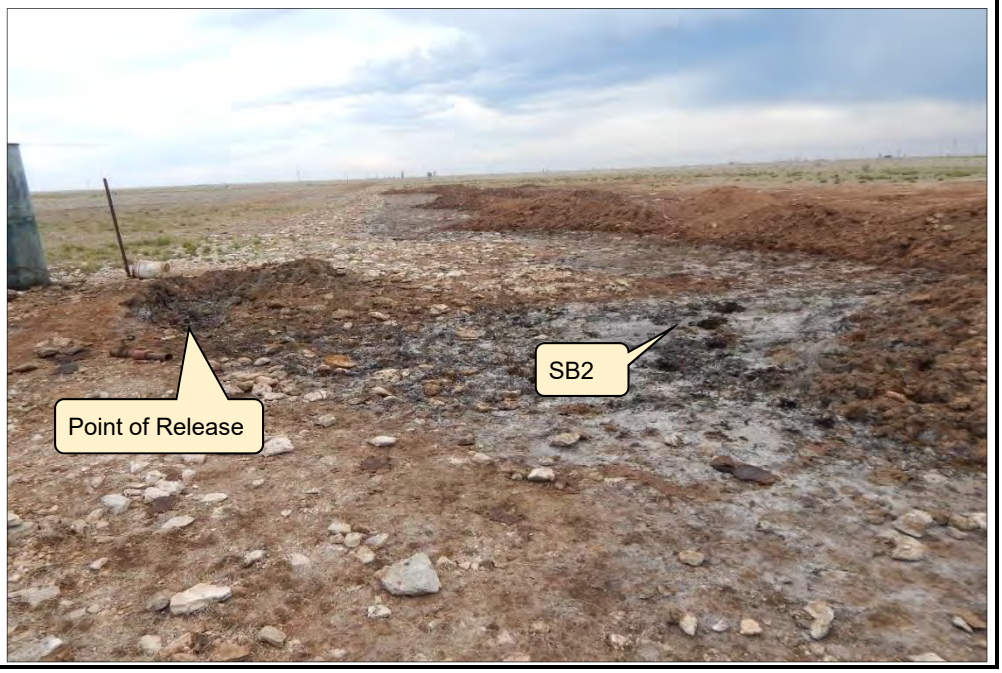
Photo No.: 2

Comments: Impacted soils in the area around the point of release. Note the locations of the point of release and SB2.
