SITE INVESTIGATION REPORT

REMEDIATION PLAN

NEW MEXICO SALT WATER DISPOSAL COMPANY, INC
New Mexico State Lands
SW1/4 SW1/4 Section 15, T10S, R34E

Saltwater Distribution Line Leak
Johnson Lease

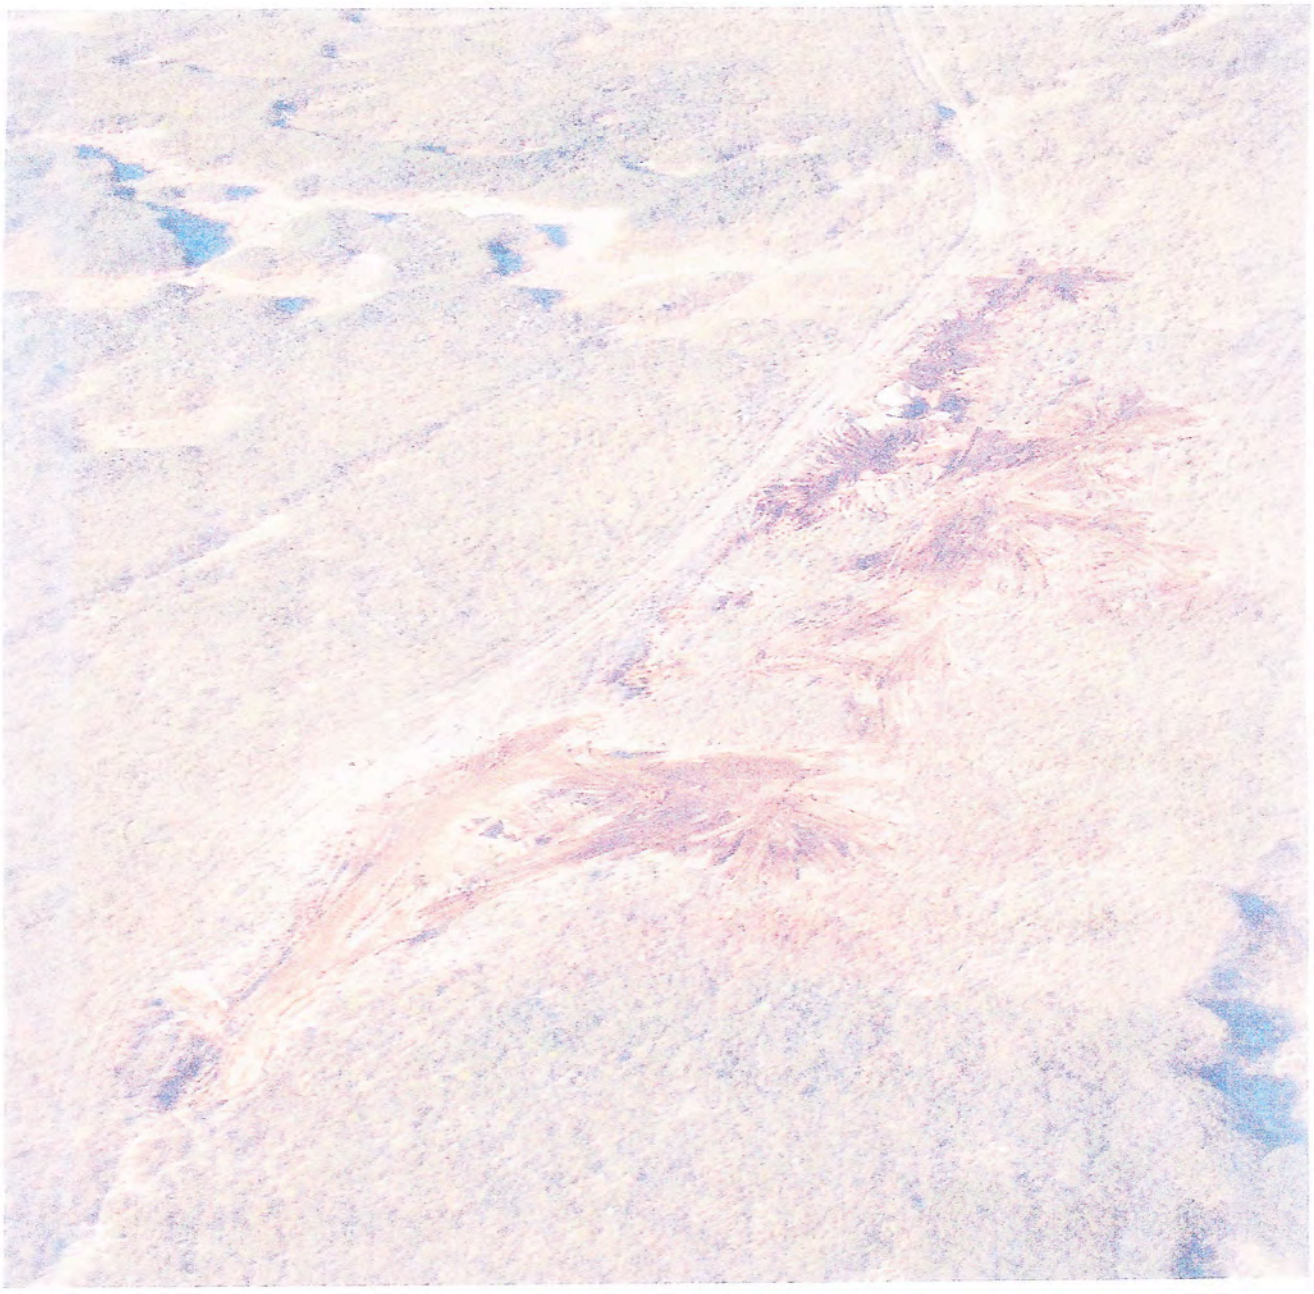
Figure 3. Aerial View of Stained Soil

Stained areas captured in the aerial photograph presented in Figure 3 correspond well to the findings of the EM-38 survey shown in Figure 4. The interpretation is that the stained areas reflect the distribution or pattern of the release to the land surface. Soil samples summarized in Table 1 showed elevated chlorides in the impacted area to the maximum depth sampled before auger refusal. It was concluded that a larger drilling rig capable of advancing a hollow stem auger to 100 plus feet and collecting undisturbed soil for analysis was necessary to delineate the vertical extent of the produced water leak.

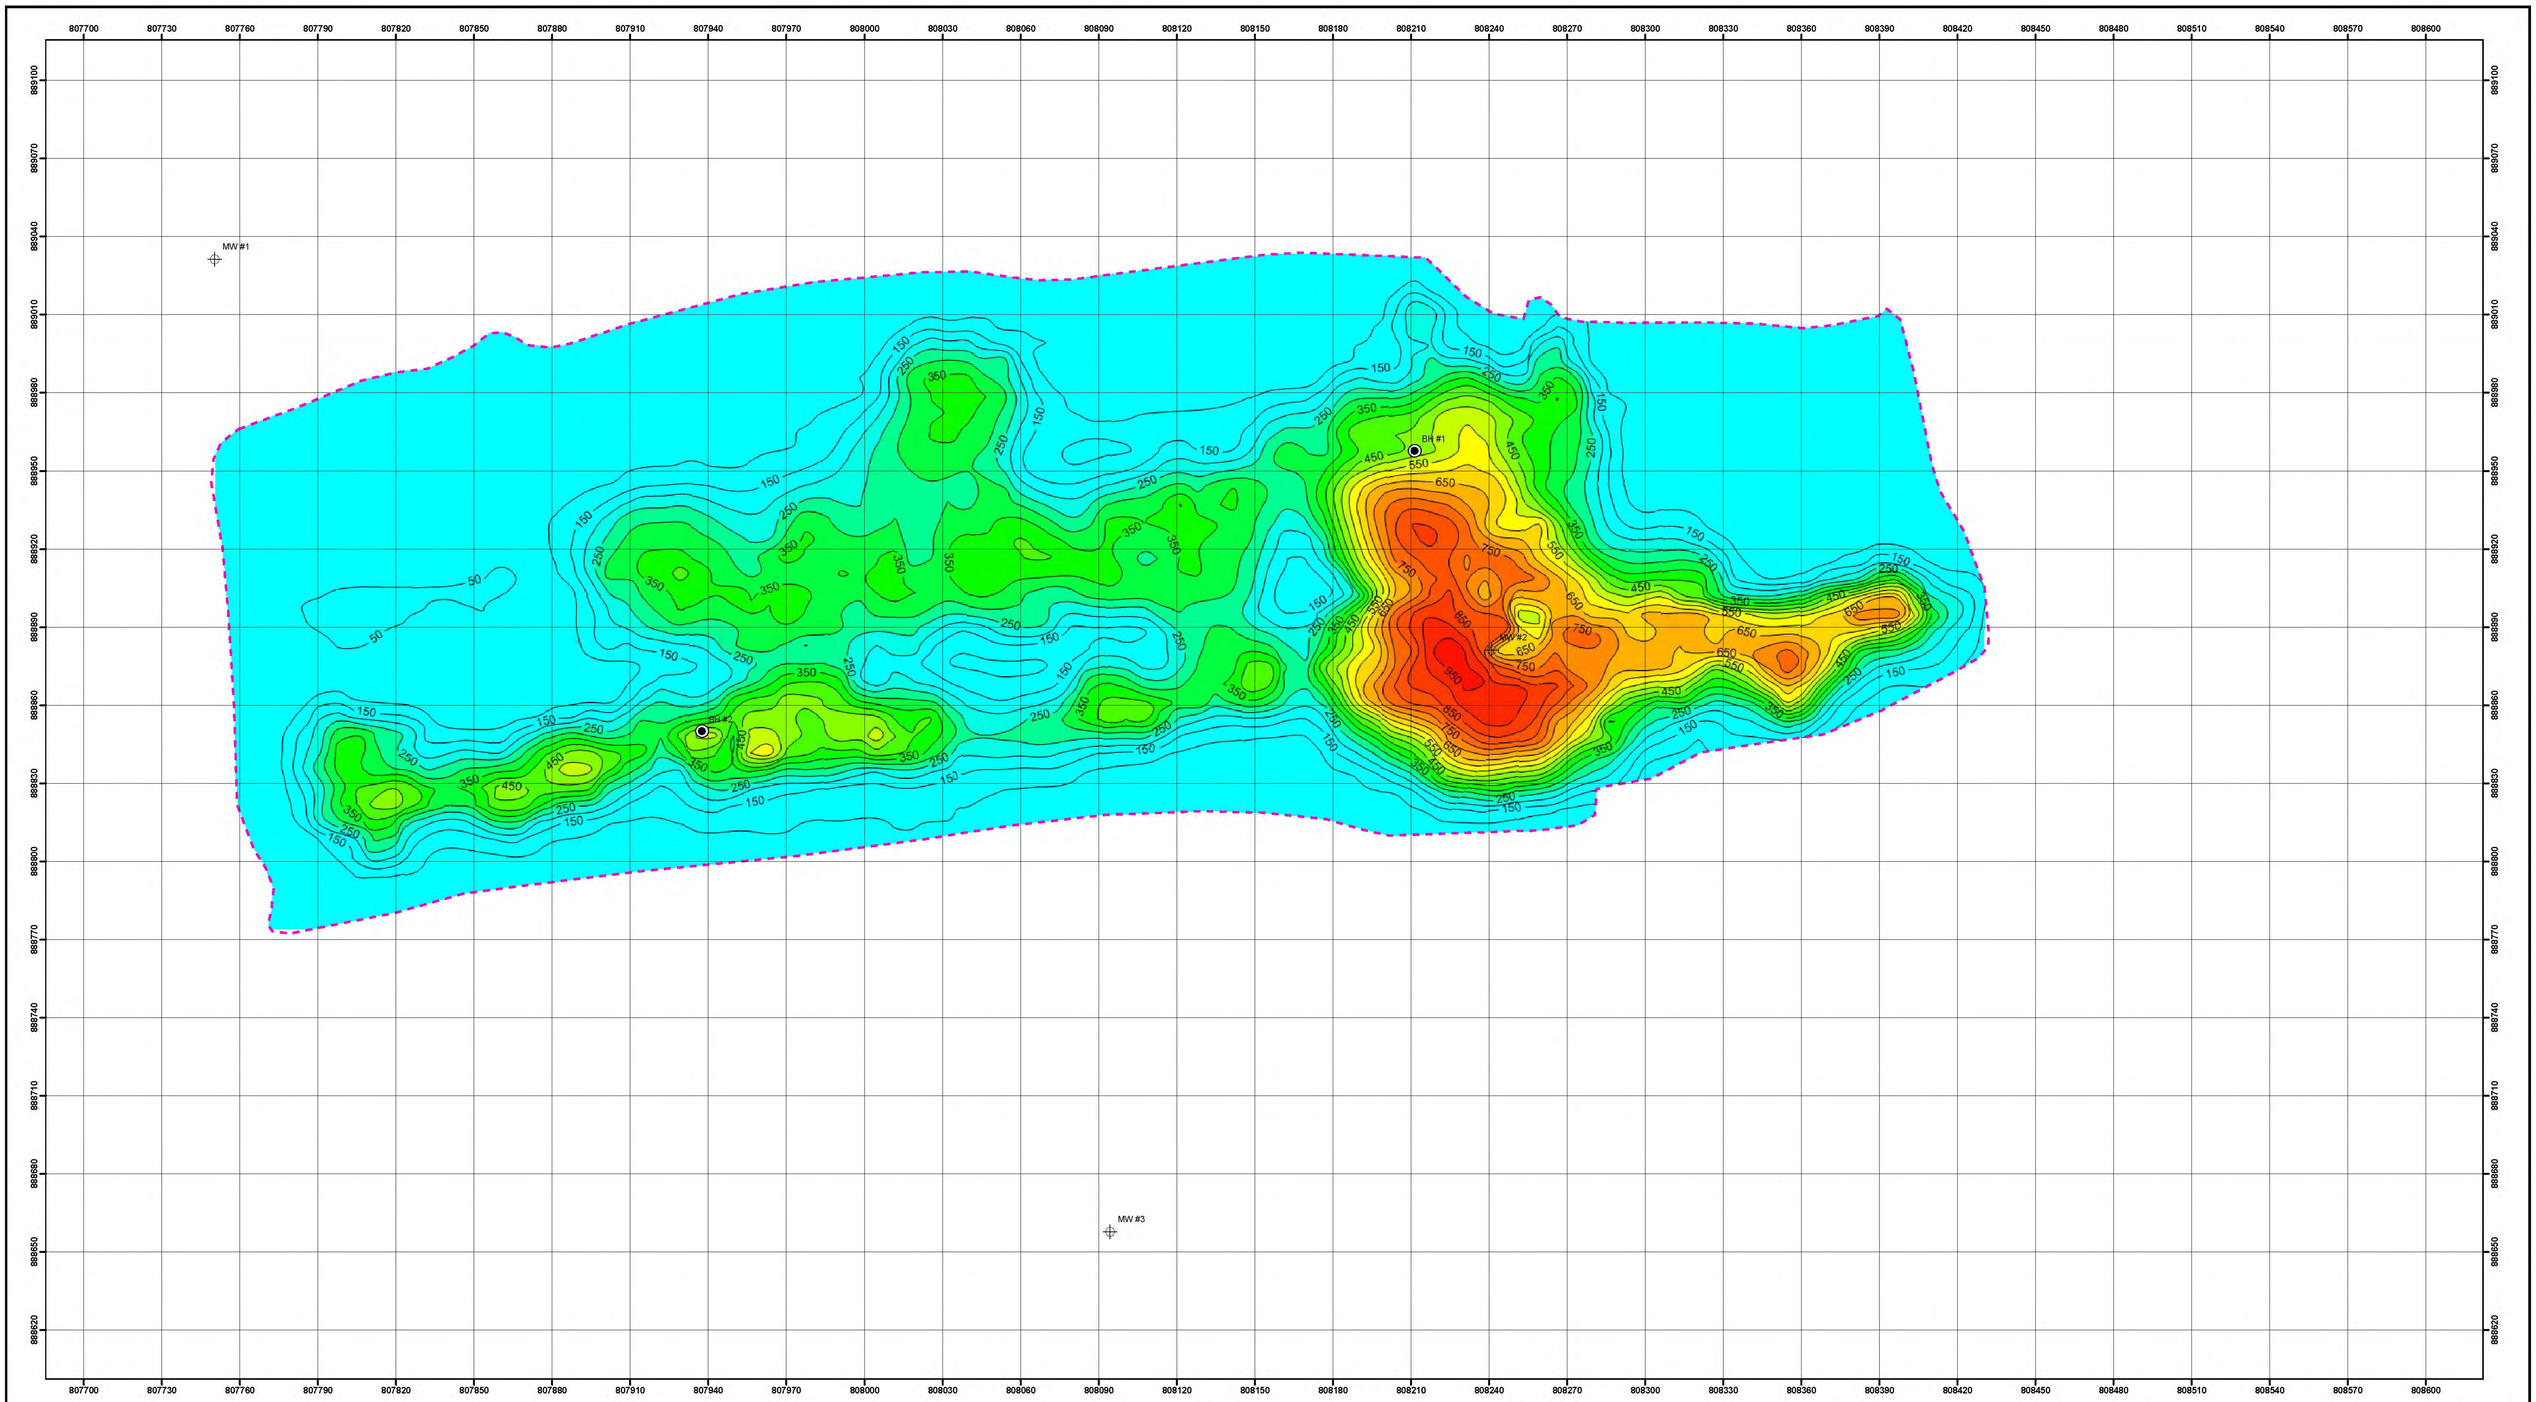
Figure 5. EM-31 Salinity Contour Map

Contour maps of the EM-38 and EM-31 soil electrical conductivity, measured in the vertical dipole configuration, are presented in Figures 4 and 5, respectively. These plots show very similar distribution patterns in that the anomalous high areas, which correspond to the two, produced water leaks found. The east leak source was obviously the largest in terms of volume. Both plots reflect the distribution pattern of the stained soil mentioned previously.

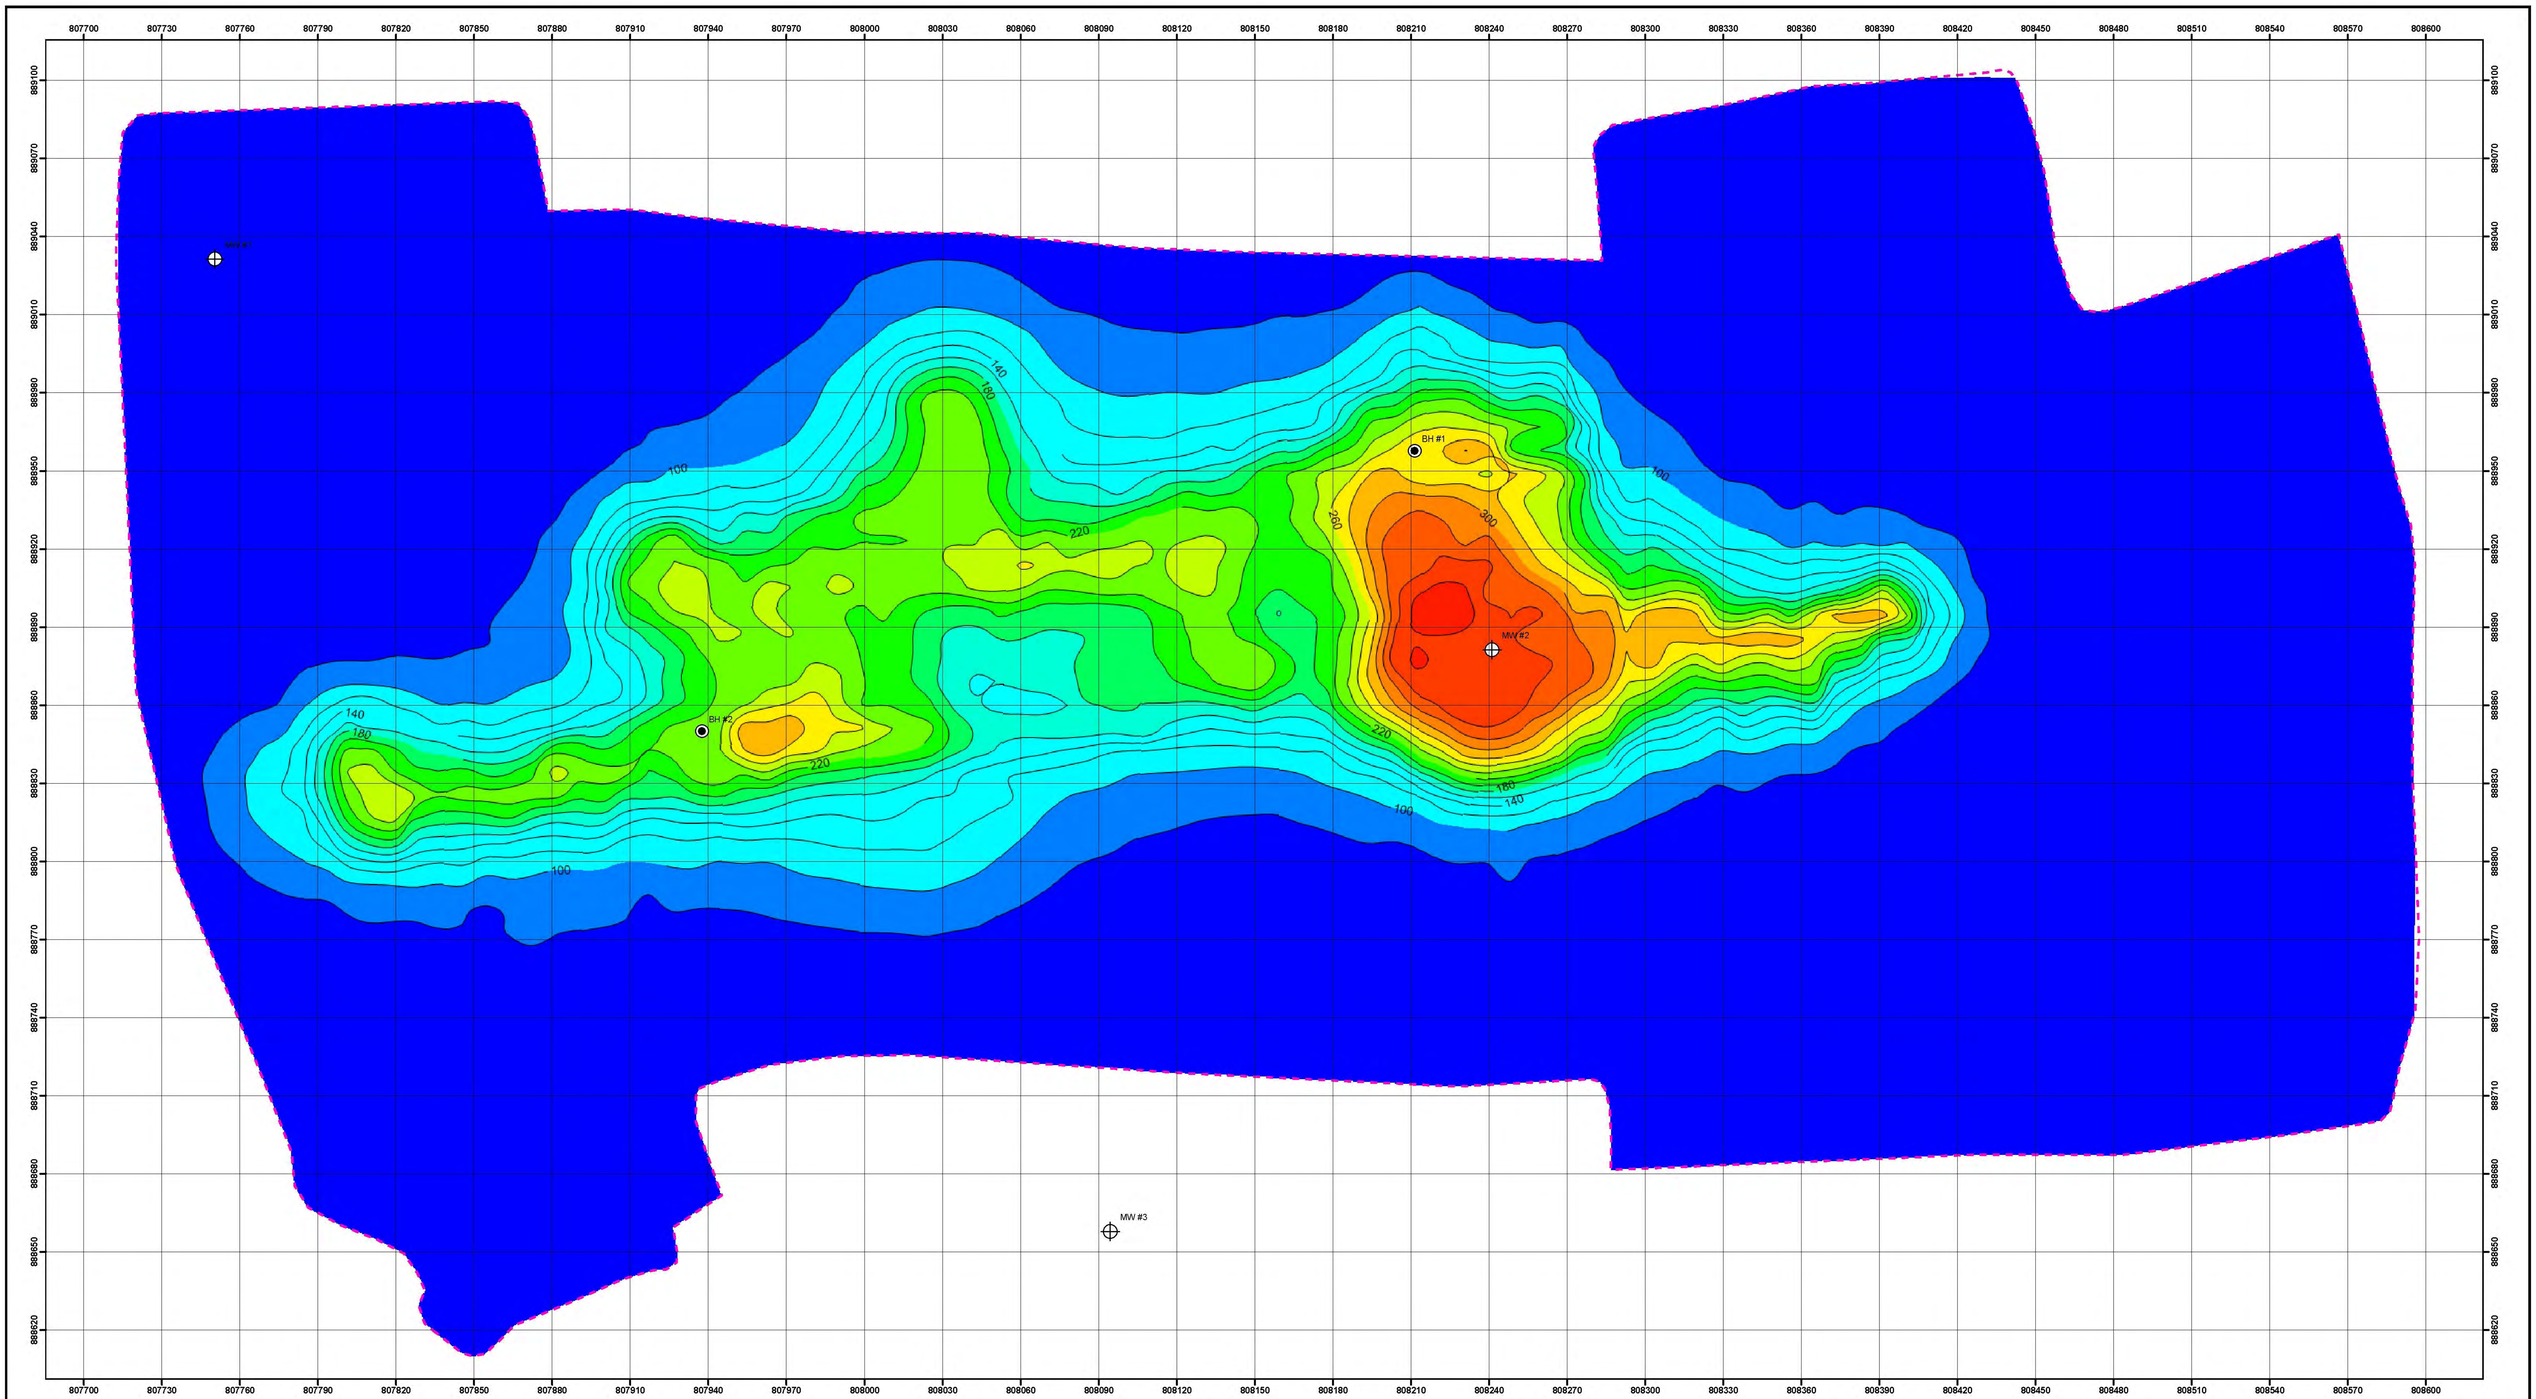
Figure 6. Soil Boring Locations Map

The EM-31 response was used to locate the deep borings and chart the distribution of salt associated with the two leak sites.

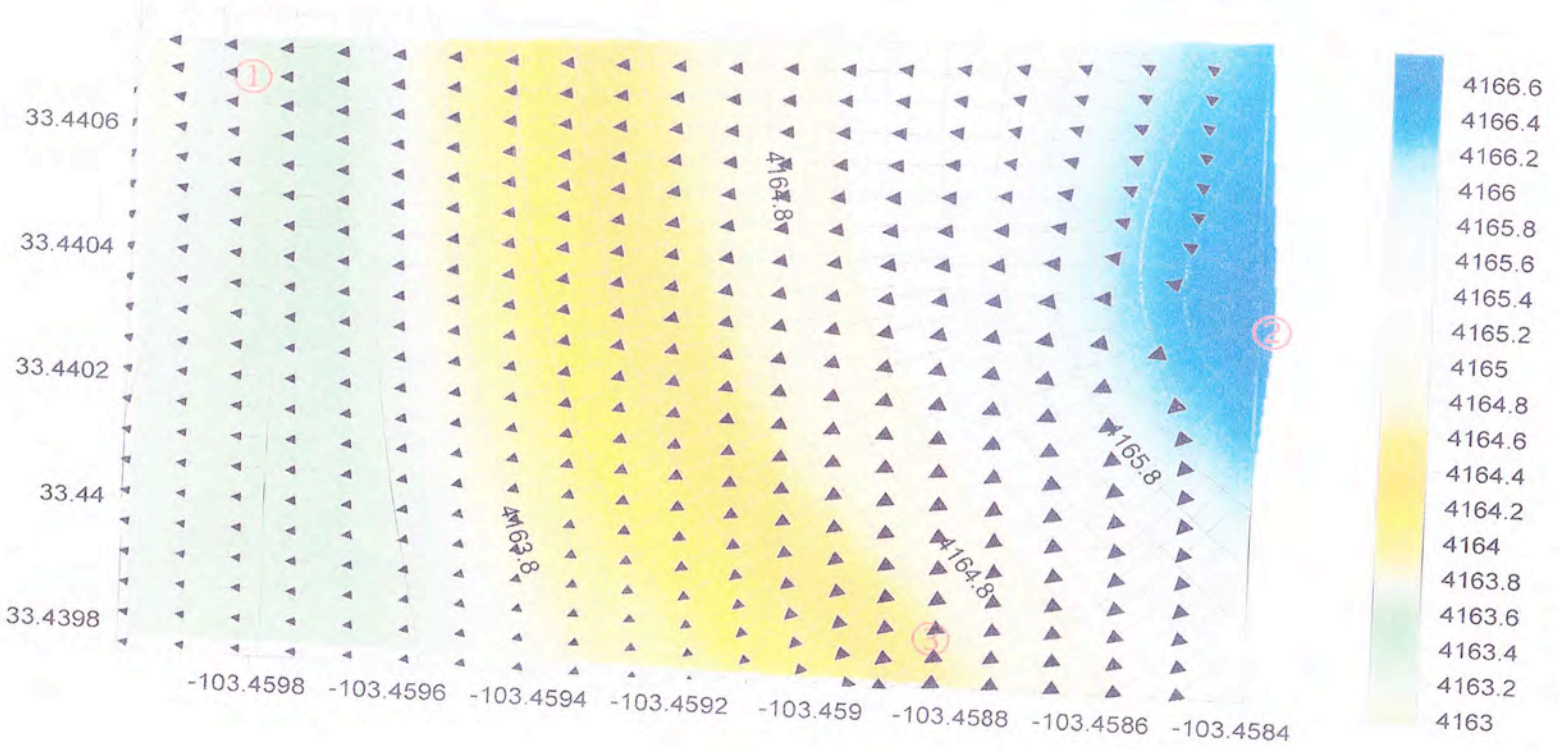
Figure 8. Potentiometric Surface Map

New Mexico SWD Release Area
Groundwater Flow (MSL)
Sec. 15 & 22, T10S R34E

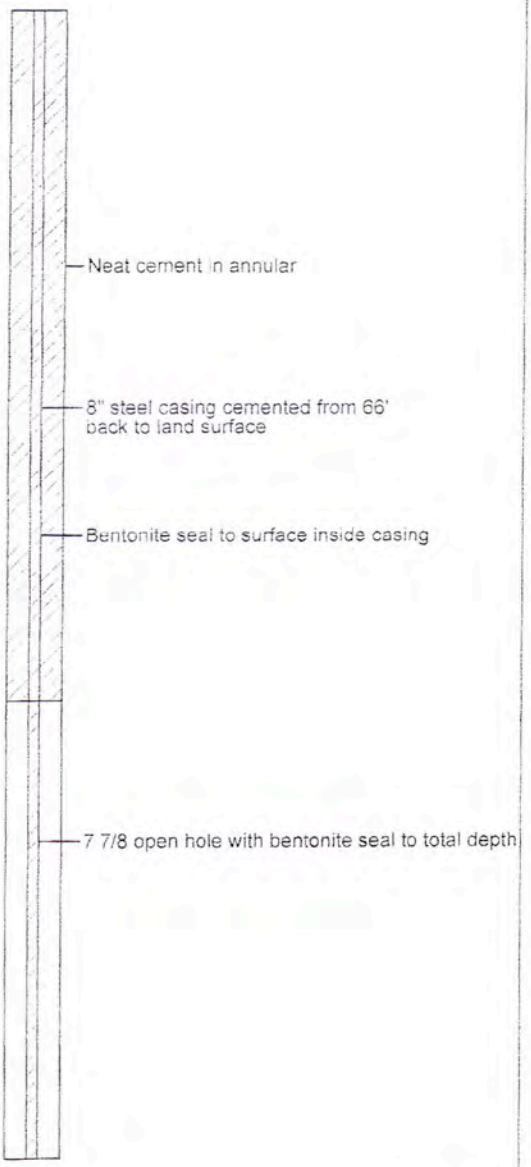
West Side Leak Test Hole

Depth in Feet	GRAPHIC	USCS	Sample	DESCRIPTION
0		SP		Poorly graded sand, loose, tan and black, damp
5				Caliche, firm, tan, dry
30		SP		Poorly graded sand, loose, tan, damp
45		SS		Sandstone, firm, tan, damp
50		SS		Sandstone, firm, yellowish tan, wet
55		GW		Sand and gravel, loose, yellow, wet
60		CL		Sandy clay, soft, yellowish tan, wet
65		CL		Clay, stiff, yellow, moist
70		CL		Clay, stiff, yellowish brown, dry
80		LS		Limestone with clay, firm, gray, dry
85		LS		Limestone, hard, gray, dry
90		CL		Clay, firm, gray, dry
110				Total Depth 110'

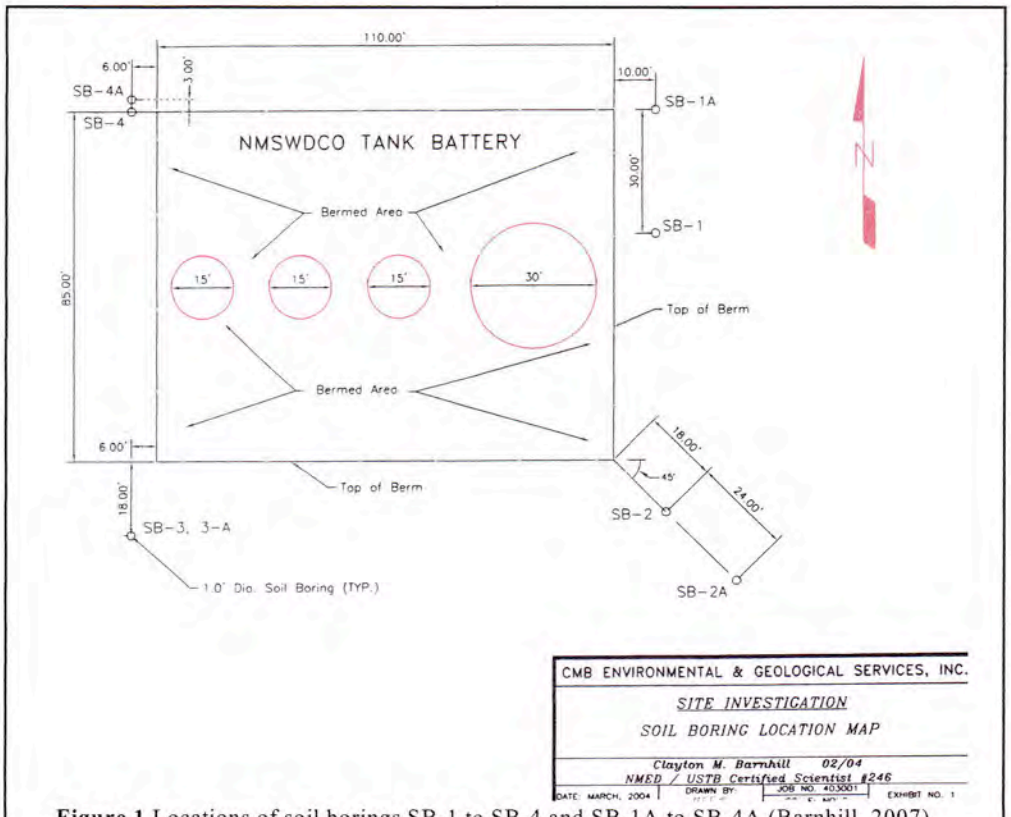
Figure 1 Locations of soil borings SB-1 to SB-4 and SB-1A to SB-4A (Barnhill, 2007)

Initially, four shallow borings were scheduled with locations approximately at the corners of the E-W orientated Station 11 tank battery, Figure 1, p. 1. SB-1, SB-2, and SB-3 were 11 ft deep. SB-4 was drilled to 16 ft. No BTEX or TPH was detected. No water was detected. Soil chlorides were laboratory measured and found to be above 250 ppm (mg/l).

The SLO required addition soil borings (Figure 1, p. 1) be made because the *soil* chlorides were greater than 250 ppm (mg/kg) (the EPA ppm maximum recommendation for drinking *water*).

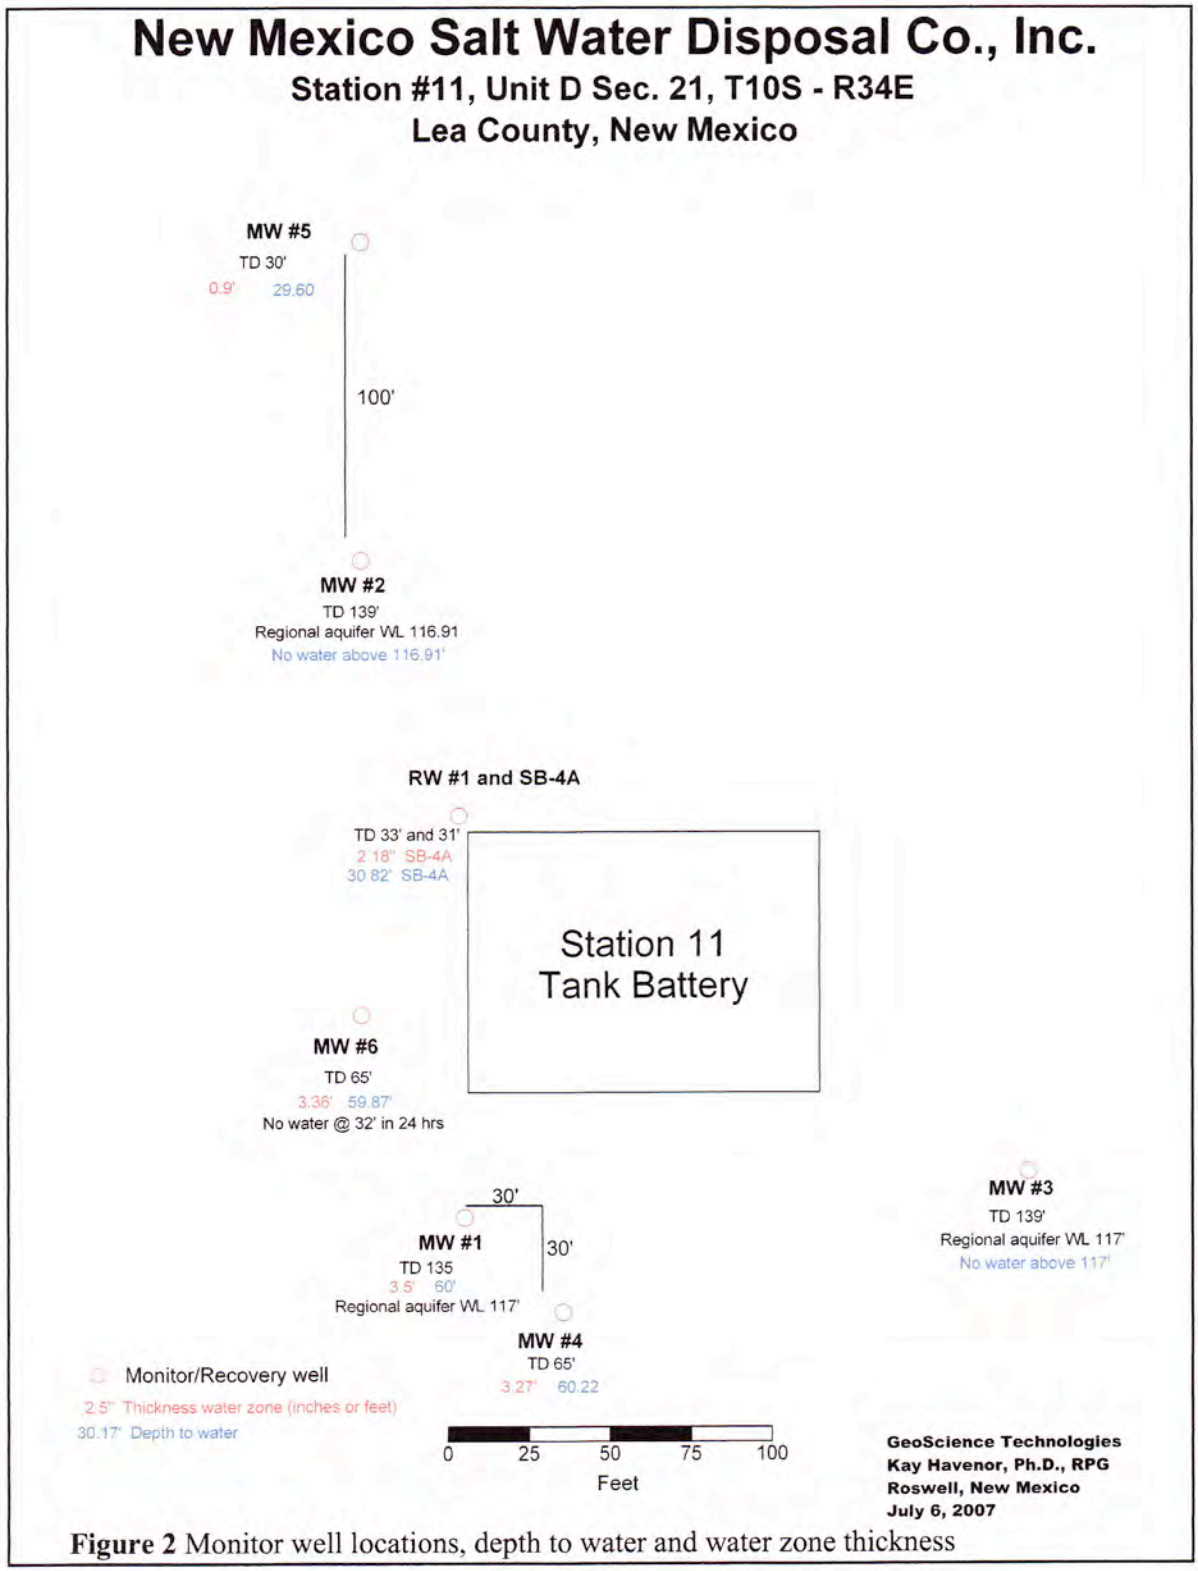
Figure 2 Monitor well locations, depth to water and water zone thickness

MW-2 is located north of the northwest corner of Station 11. The hole was dry in drilling to below 120 ft. A log notation indicated that no water came into the hole. Drilling was temporarily suspended at 124 ft due to lightning. After resumption of drilling shale (fat clay) was penetrated from 133 to 135 ft. The well was completed at 139 ft (rathole) because of heaving sand from 129 - 133 ft. The well was set to 135 ft. Top of water was called at 117 ft, with water level at 116.91 ft, upon completion in the Cretaceous local aquifer.

MW-3 is located southeast of Station 11. After drilling the sand from 49 ft to 64 ft (through the interval with water in MW-1 and MW-4) with no show of water, drilling was shut-down for night. The next morning the hole was dry. Drilling was advanced to 119 ft where the hole was dry. Additional drilling with meager to no sample returns went to 139 ft. The water level on completion was at 119 ft in the Cretaceous local aquifer. Based upon meager samples, the TD of the well appears to have been at the top of the Triassic Dockum Formation.

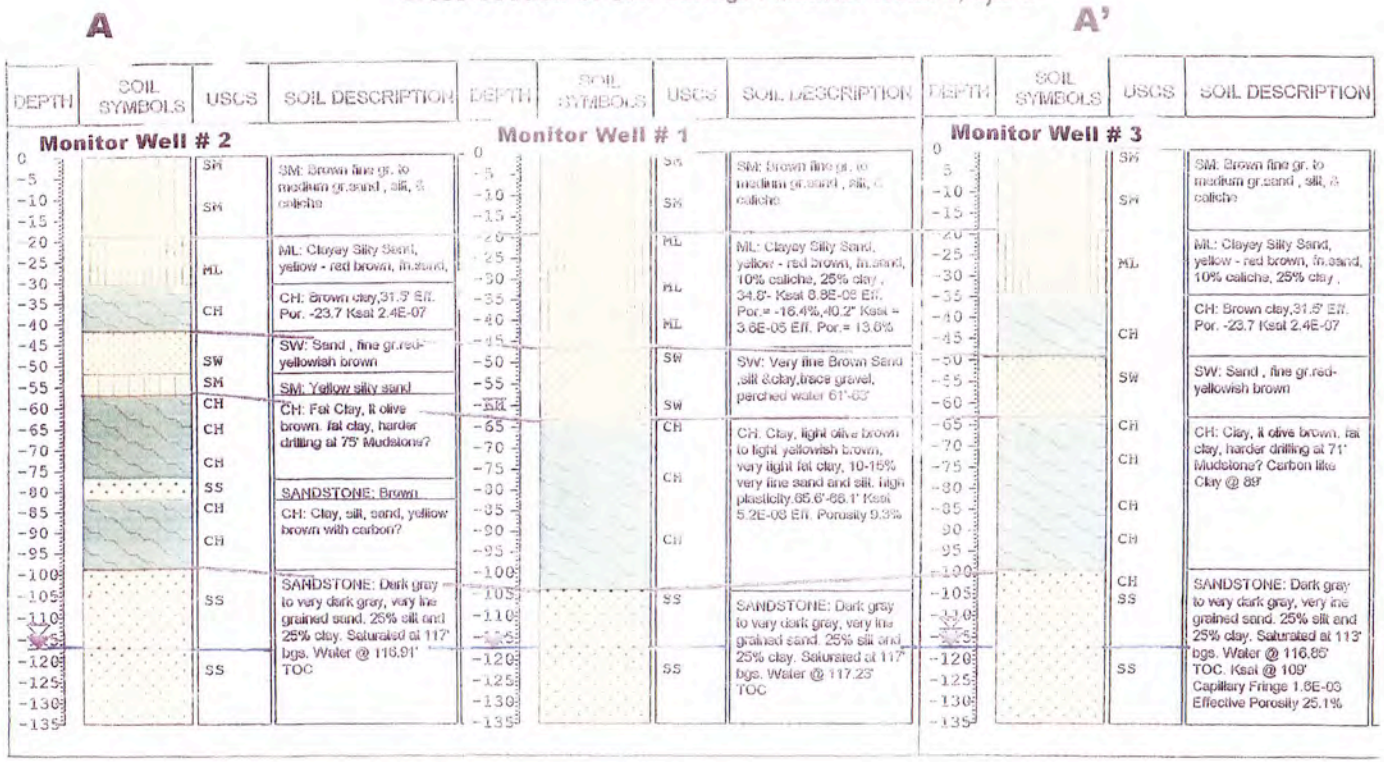
Figure 3 Cross-Section MW-2, MW-1, MW-3 (Barnhill, 2007)

The 40 ft thick shale beneath the Ogallala and the Cenozoic-Paleozoic disconformity is on top, the aquiclude, of the water bearing sandstone in MW-1, MW-2, and MW-3, as shown above in Figure 3, p. 7. MW-4 and MW-6 were only drilled to 65 ft, but both have the same shale underlying their trapped water zone in the 60 ft range. It is a reasonable geological projection that the shale zone is present with consistent thicknesses in MW-4, MW-6, and beneath Station 11 as evidenced by its presence in MW-2 and MW-3.

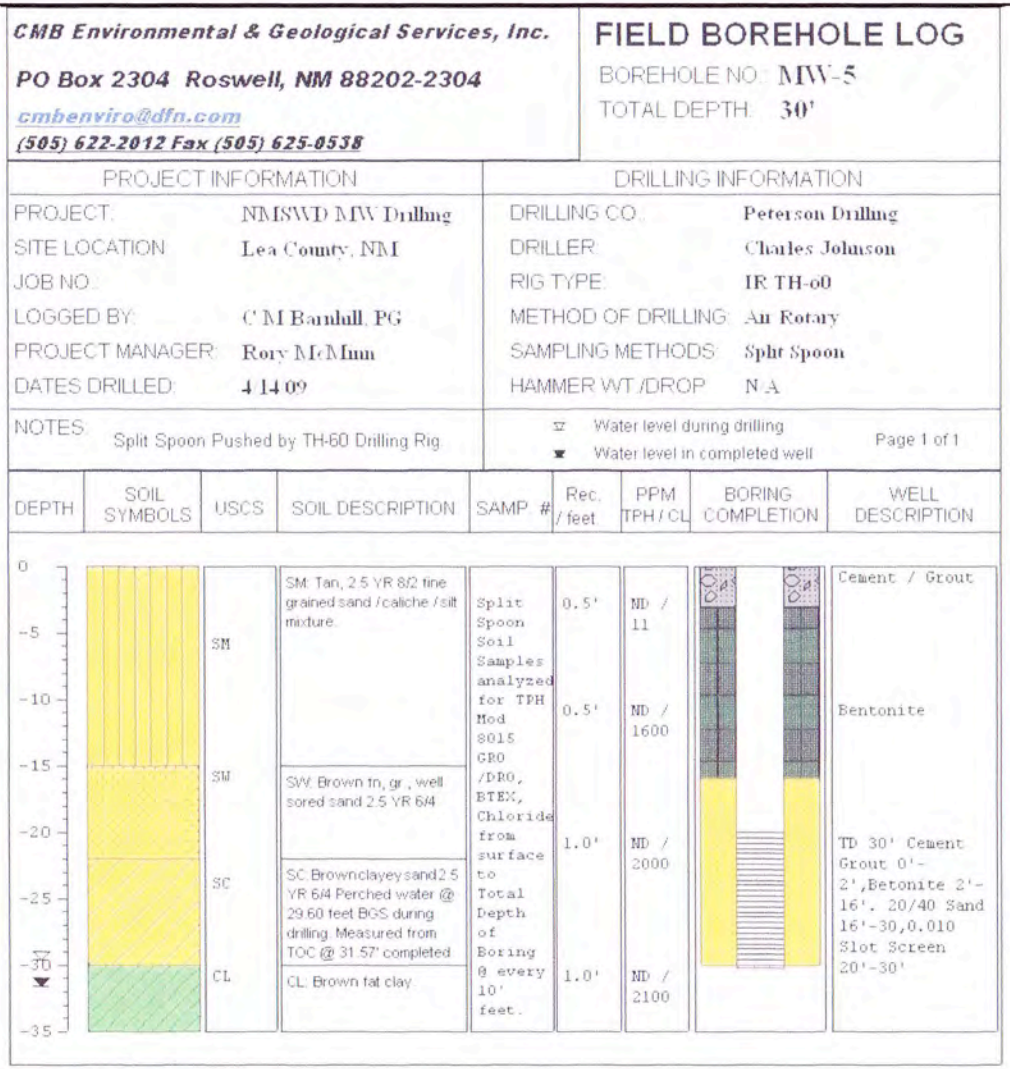
Figure 5 Borehole log MW-5 (Barnhill, 2009)

MW-5 was drilled 100 ft north of MW-2 as shown in Figure 2, p. 4. The well encountered 0.9 ft of water interval from 29.6 ft to 30.5 ft. Drilling was not taken deeper to prevent potential communication with deeper zones. Lab chlorides on the water sample were 28,000 mg/l. The borehole log for MW-5 is shown in Figure 5, p. 9.

The sand at 42 ft in MW-2 was not penetrated in MW-5, located 100 ft north, because it stopped at TD 30 ft. The top of the MW-2's clay at 30 ft overlays sand (42 ft to 57 ft). The clay is also present in MW-5 at 30 ft and is the bed that traps and holds the very thin occurrence of produced water shown at 29.60 ft on the borehole log, Figure 5, p. 9. The water zone in MW-5 extends into the clay layer to 30.5 ft, a water column thickness of 0.9 ft. Lab chlorides on the water measured 28,000 mg/l.

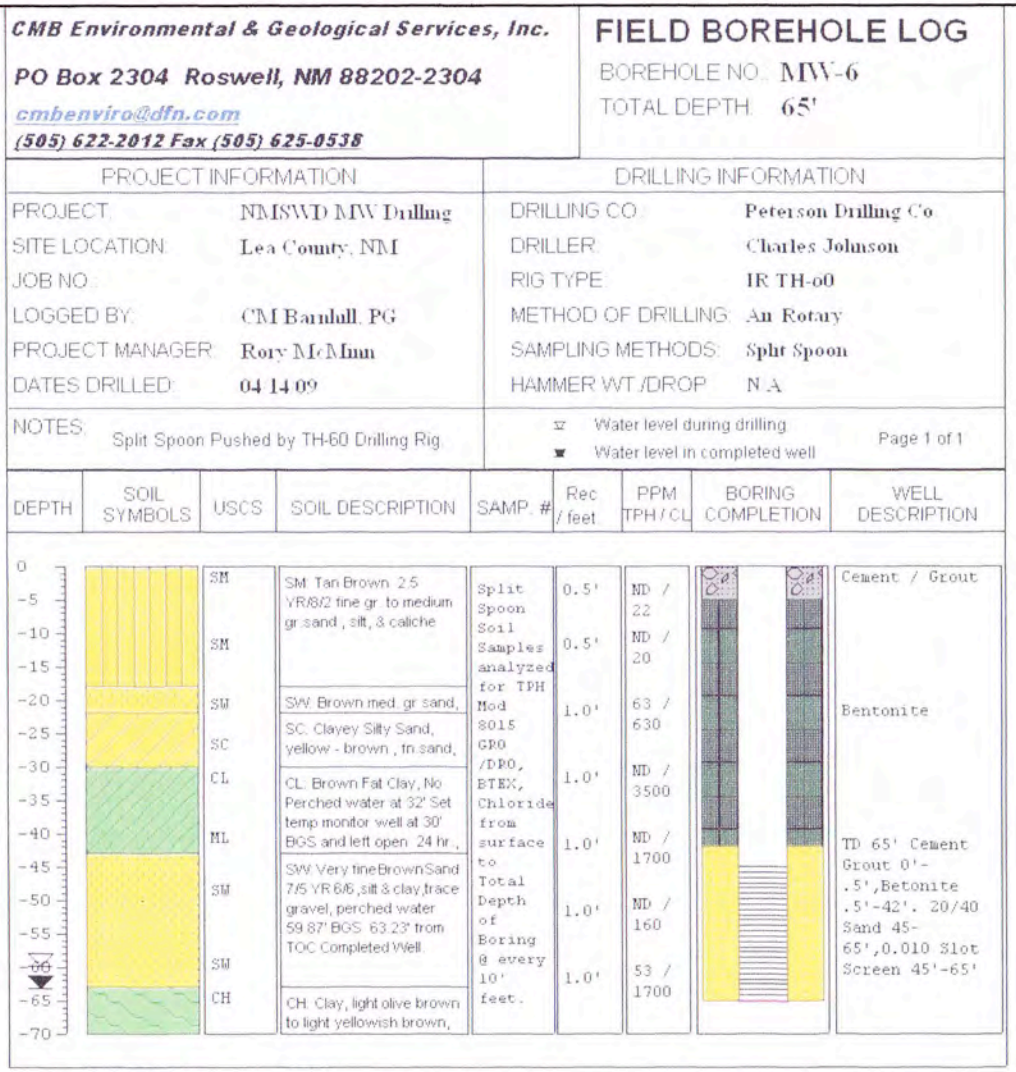
Figure 6 Monitor well MW-6 (Barnhill, 2009)

MW-6 was drilled west of Station 11 (see Figure 2, p. 4) to a depth of 67 ft. Drilling was halted for 24 hours to test for water from 30 ft to 32 ftr. Water observed at this depth in MW-5 was not found in this well. Water was encountered at 59.87 ft in sand overlying Cretaceous shale and its disconformity at 63 ft.. TD was at 65 ft in Cretaceous shale. The top of the water was reported at 59.87 ft. Lab chlorides on the water sample were 20,000 mg/l. The borehole log for MW-6 is shown in Figure 6, p. 10.
