August 18, 2017

Re: Release Characterization Work Plan
Chalupa #4 SWD Wellhead Release Site
Lea County, New Mexico
NMOCD Case No. 1R-4632

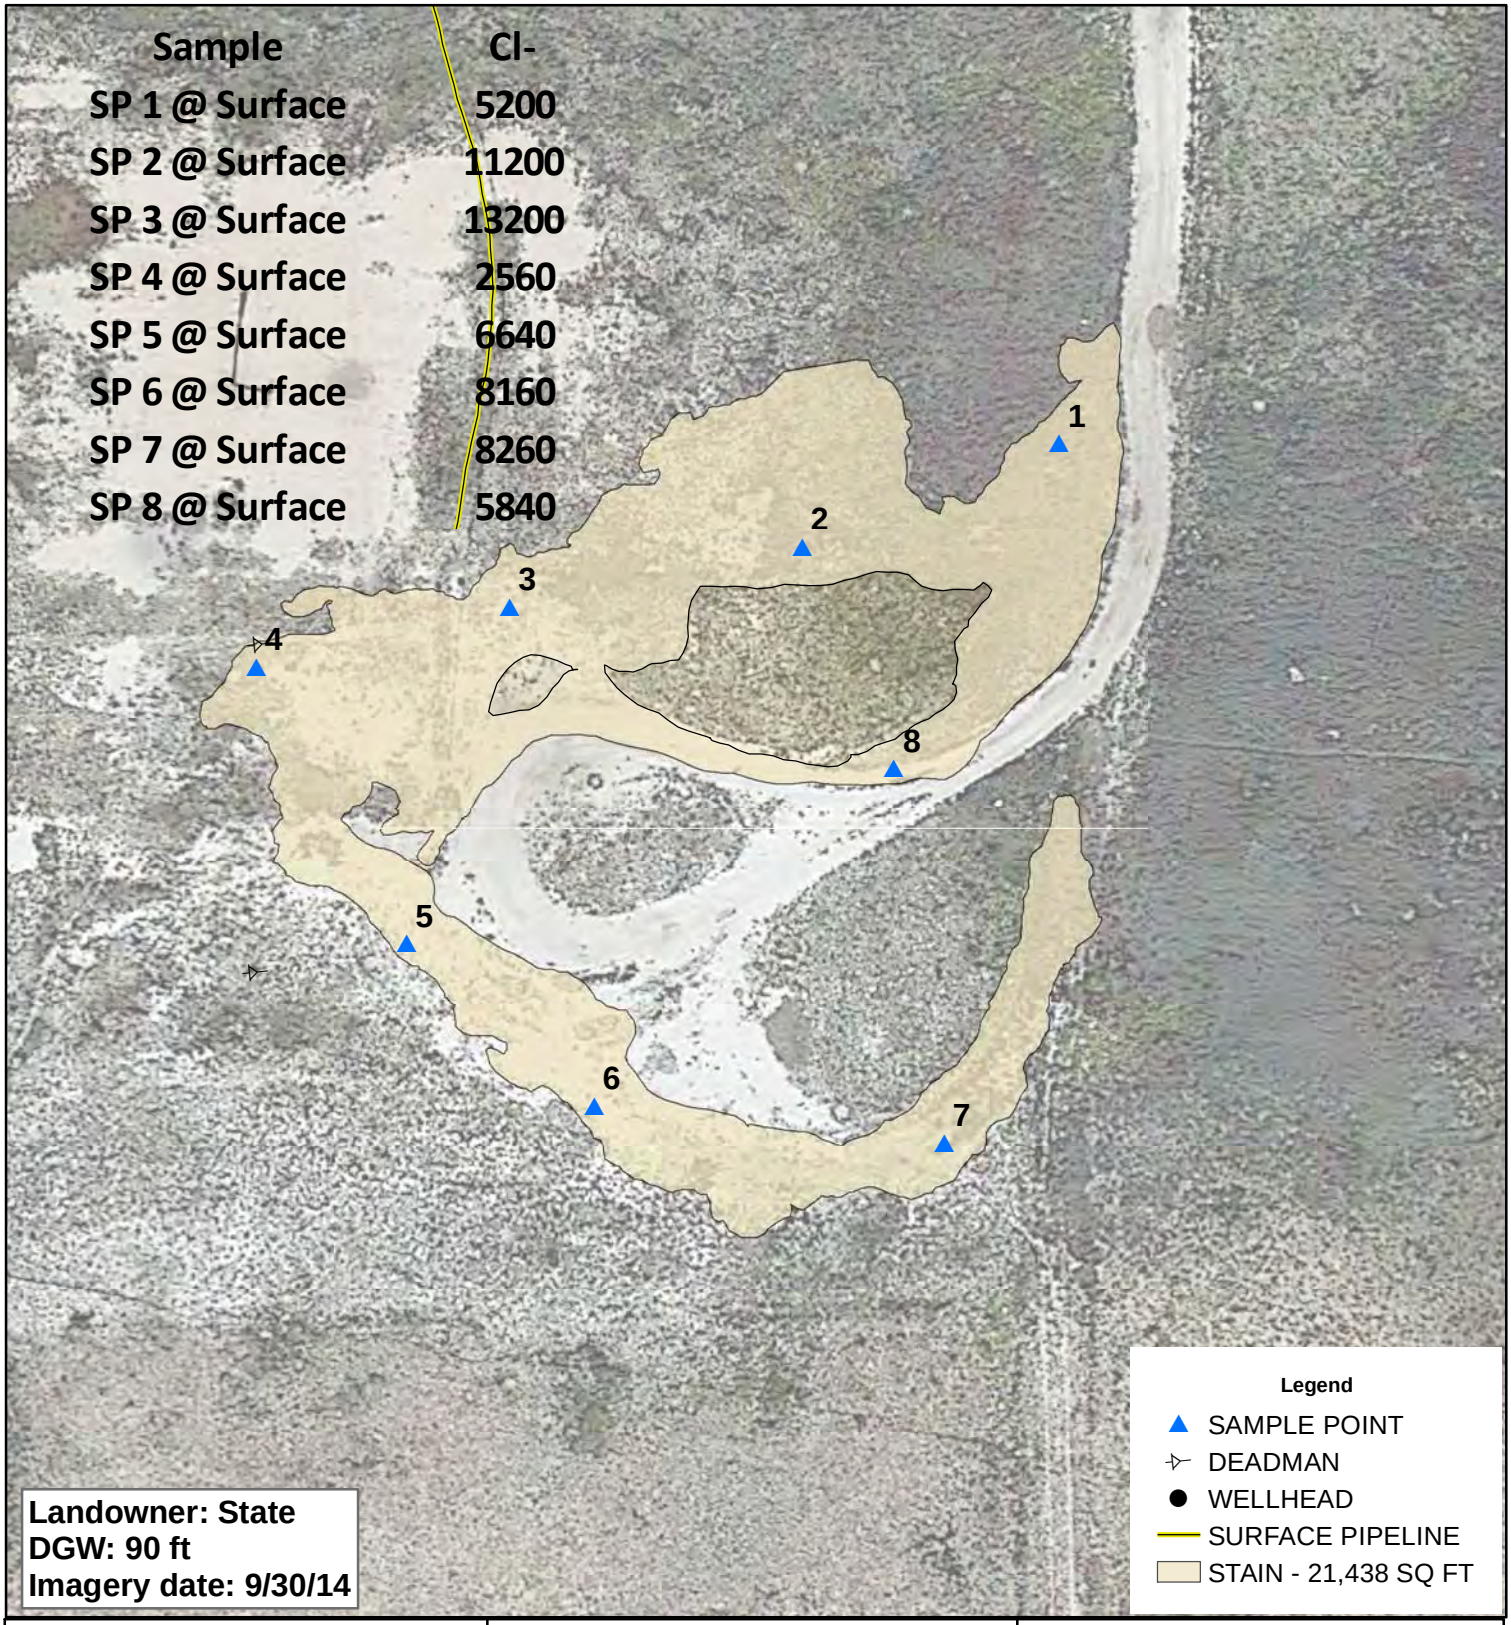
FIGURE 2

FEM retained Basin Environmental Service Technologies, LLC (Basin) to conduct an initial release characterization at the Site. Basin's field work was performed on May 16, 2017. During this investigation, Basin collected surface soil samples at locations SP 1 through SP 8 as shown on Basin's **Figure 2** which is attached. Subsurface soil samples were reportedly not collected because a resistant layer was present. These soil samples were submitted to Cardinal Laboratories in Midland, Texas for chloride analyses (Method SM4500-CI B). Basin delineated the lateral limits of impact by mapping the visually apparent surface soil staining. The results of Basin's characterization work are presented graphically on **Figure 2**. As can be seen from these results, all soil samples collected contained chloride levels that exceed the NMOCD's cleanup level of for this Site of 600 mg/kg. The horizontal and vertical limits of impact have not been fully defined through these initial assessment activities.
