Release Notification and Corrective Action

Name of Company DCP Operating Company, LP (DCP)	Contact Robert Gough
Address 10 Desta Drive, Midland, TX 79705	Telephone No. 432-620-4166
Facility Name Eunice Gas Plant	Facility Type Gas Plant

1RP-4889

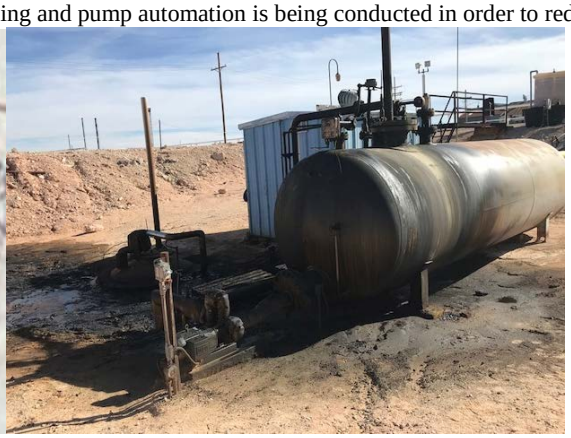
Stock Aerial Photo

Describe Cause of Problem and Remedial Action Taken.*
Skid pads and containment from within the plant drain via gravity to the skimmer on the north side of the plant. The skimmer is located in a recessed earthen area (aerial photo below) to allow liquids to flow into the vessel. The skimmer separates slop oil from water and pumps the oil to tanks for shipment offsite. The tank overfilled and the pipeline backed up. Approximately 15 bbl released at the skimmer (photo after liquids collected below). It is suspected that liquids accumulated in the pipeline and a small volume (<2 bbl) leaked from a new portion of the line. The level is controlled by automatic pumps. In addition there is a high level alarm. Plant maintenance inspected the alarm and found that linkage to the float may have been loose. An additional inspection of the tank, piping and pump automation is being conducted in order to reduce the likelihood of recurrence of these types of event.

After free liquids vacuumed

Describe Area Affected and Cleanup Action Taken.*
Free liquids were vacuumed up. An inspection of the area showed that oil had not absorbed into the soils more than a few inches deep. Impacted soils will be excavated and properly disposed. An investigation is being conducted into the cause and details will be included on the Final C-141 Report.
