Report Type: Work Plan 1RP-4812

March 2, 2018

Re: Work Plan for the COG Operating LLC., Gunner 16 State SWD #1, Unit D, Section 16, Township 26 South, Range 34 East, Lea County, New Mexico.
1RP-4812.

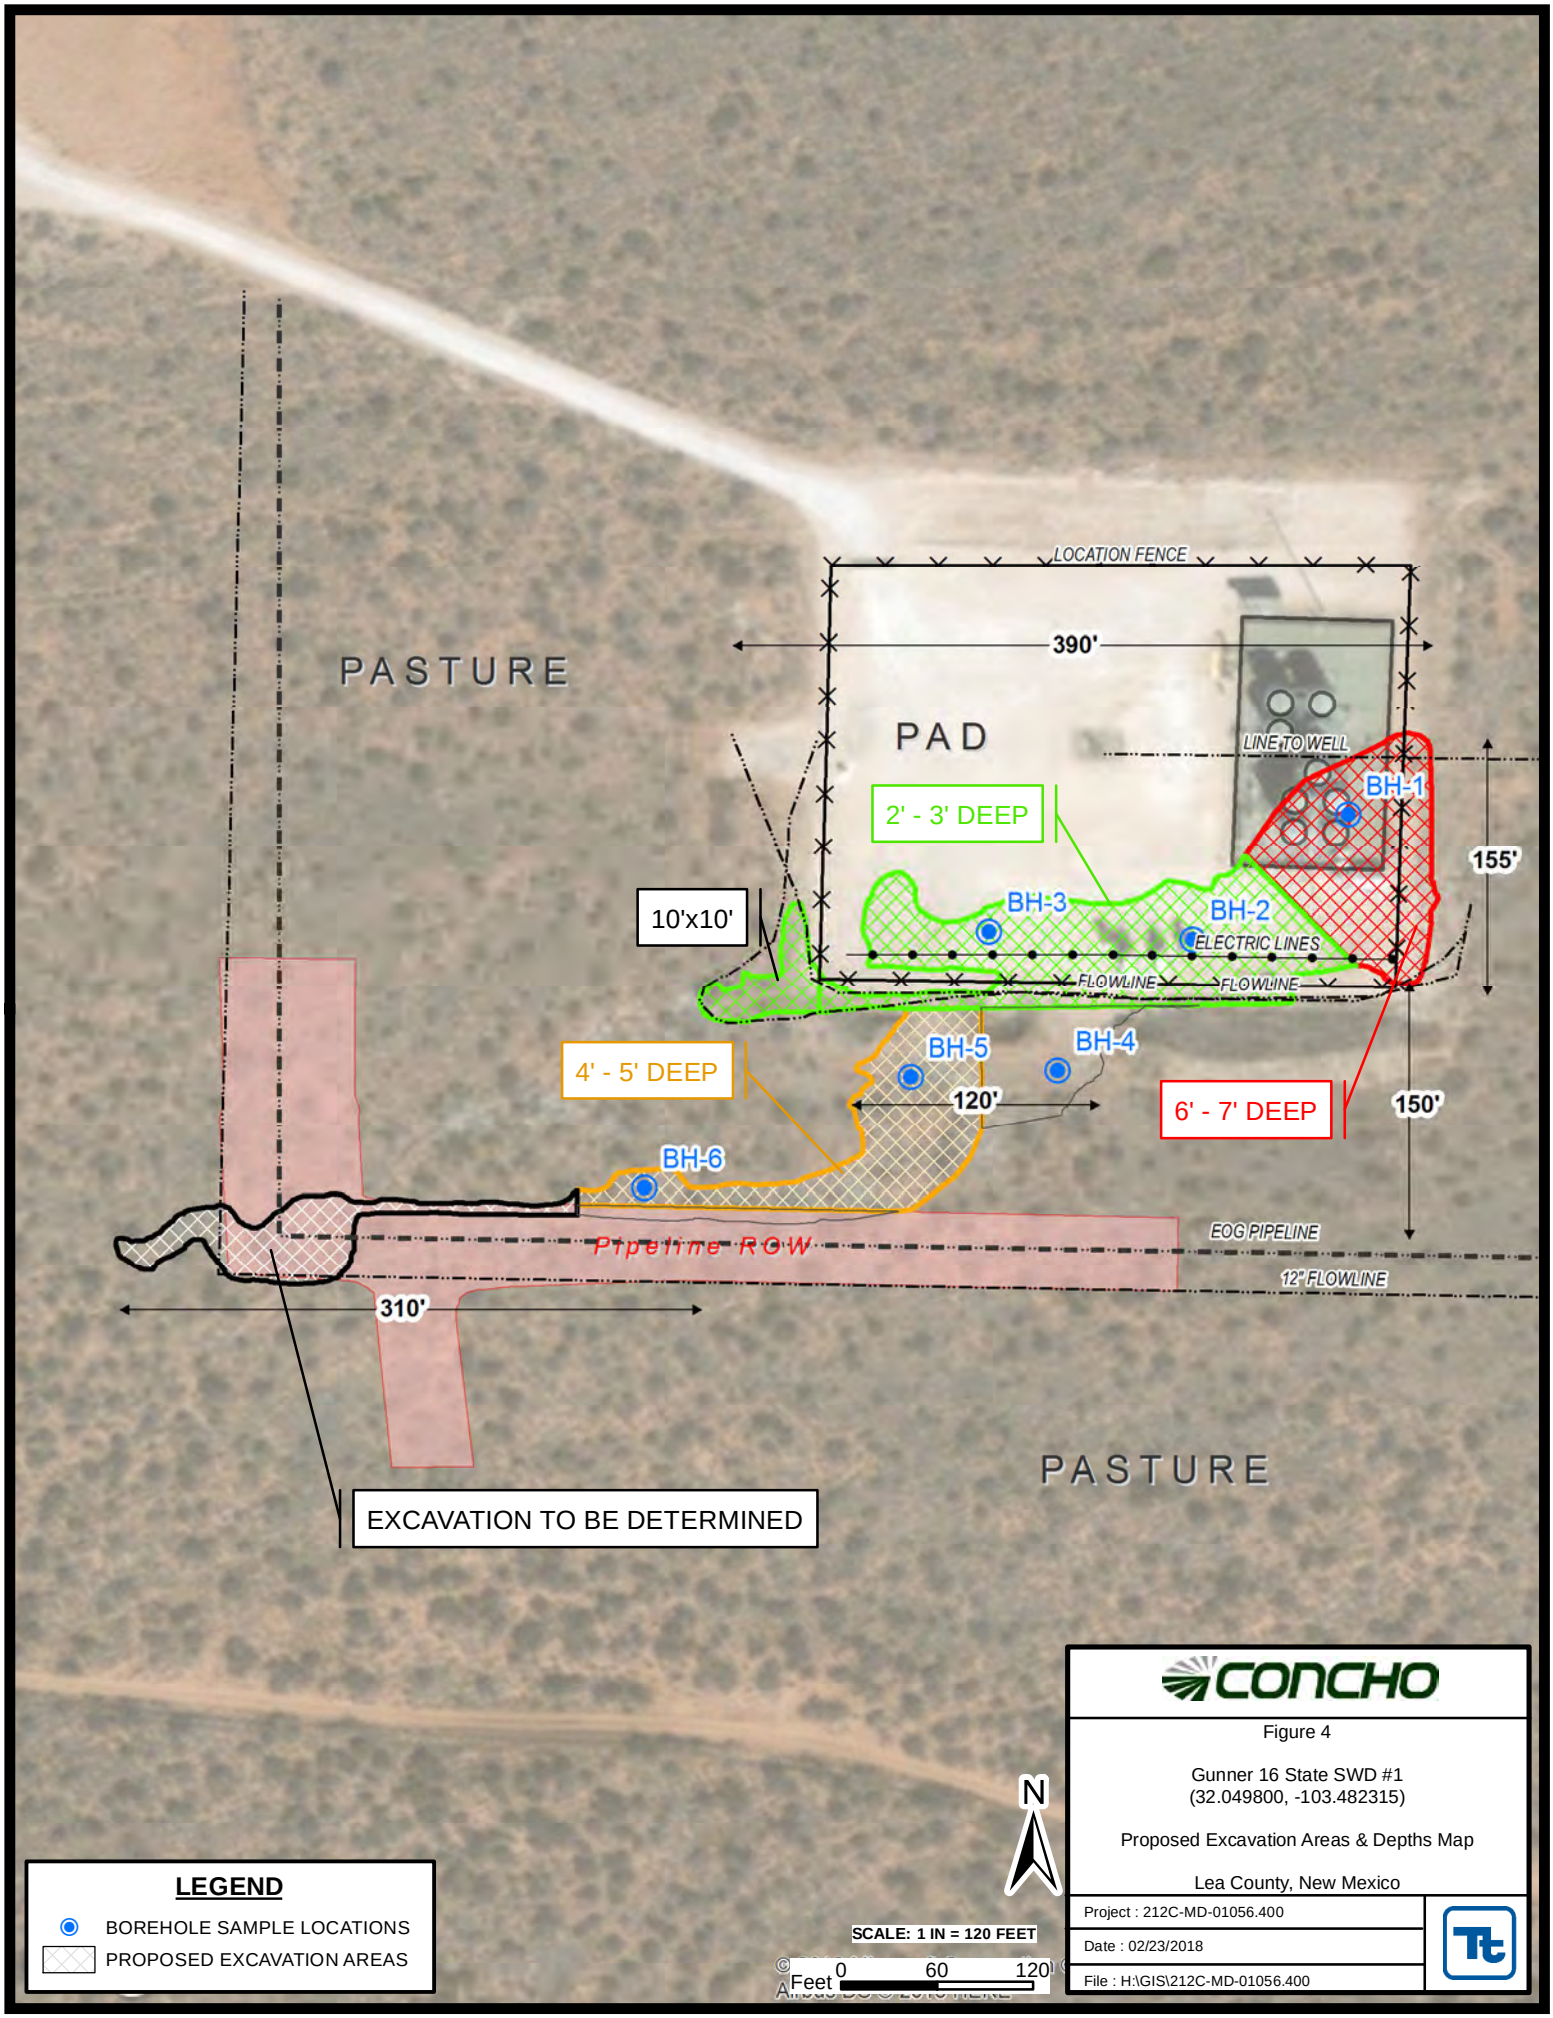
Referring to Table 1, the areas of boreholes (BH-2 and BH-3) did not show any benzene, total BTEX, or TPH concentrations above the laboratory reporting limits. However, the area of borehole (BH-1) showed total BTEX concentrations below the RRALs, with concentrations of 0.179 mg/kg (0-1') and 0.740 mg/kg (2-3'). Additionally, elevated TPH concentrations were detected at borehole (BH-1) with a TPH high of 11,400 mg/kg at 2-3', which declined with depth to below the laboratory reporting limits at 4-5' below surface.

The areas of boreholes (BH-1, BH-2, and BH-3) showed chloride concentrations above the 600 mg/kg threshold in the shallow soils. The area of borehole (BH-1) showed chlorides that increased with depth to 7,120 mg/kg at 4-5', before declining with depth to 1,610 mg/kg at 6-7.0' and 29.0 mg/kg at 9-10' below surface. The areas of boreholes (BH-2 and BH-3) showed chloride highs of 891 mg/kg and 5,060 mg/kg at 2-3', before declining with depth to 466 mg/kg and 113 mg/kg at 4-5.0' below surface, respectively.

Referring to Table 1, none of the samples analyzed from boreholes (BH-4, BH-5, and BH-6) showed benzene, total BTEX, or TPH concentrations above the RRALs or the laboratory reporting limits. However, the areas of boreholes (BH-5 and BH-6) showed elevated chloride concentrations in the shallow soils. The chloride concentrations increased with depth to 6,380 mg/kg at 2-3' (BH-5) and 3,890 mg/kg at 4-5' (BH-6). The chloride concentrations then declined to <4.99 mg/kg (BH-5) and 5.52 mg/kg (BH-6) at 6-7' below surface. The area of

borehole (BH-4) showed insignificant chloride concentrations at 0-1' and 2-3', however a chloride spike of 813 mg/kg at 4-5' below surface was detected. The deeper samples in the area of borehole (BH-4) showed chloride concentrations of 5.60 mg/kg at 6-7', 43.4 mg/kg at 9.0-10' and 69.3 mg/kg at 14-15' below surface.

LOCATION FENCE
390'
PASTURE
PAD
LINE TO WELL
BH-1
2' - 3' DEEP
155'
10'x10'
BH-3
BH-2
ELECTRIC LINES
FLOWLINE
FLOWLINE
BH-5
BH-4
4' - 5' DEEP
120'
6' - 7' DEEP
150'
BH-6
Pipeline ROW
EOG PIPELINE
12" FLOWLINE
310'
PASTURE
EXCAVATION TO BE DETERMINED
N
SCALE: 1 IN = 120 FEET
Feet 0 60 120
LEGEND
BOREHOLE SAMPLE LOCATIONS
PROPOSED EXCAVATION AREAS
CONCHO
Figure 4
Gunner 16 State SWD #1
(32.049800, -103.482315)
Proposed Excavation Areas & Depths Map
Lea County, New Mexico
Project : 212C-MD-01056.400
Date : 02/23/2018
File : H:\GIS\212C-MD-01056.400
Mapped By: Isabel Marmolejo

Based on the laboratory results, COG proposes to remove the impacted soils as shown on Figure 4 and highlighted (green) on Table 1. The area of borehole (BH-1) will be excavated to 6-7', the areas of boreholes (BH-5 and BH-6) will be excavated to 4-5', and the areas of boreholes (BH-2 and BH-3) will be excavated to 2-3' below surface. For the impacted area west of BH-6 along the pipeline ROW, EOG will be contacted to determine if any of the impacted soils can either be assessed or removed from the ROW. The excavated areas will then be backfilled with clean material to surface grade. All of the excavated material will be transported offsite for proper disposal.

The proposed excavation depths may not be reached due to wall cave ins and safety concerns for onsite personnel. In addition, impacted soil around oil and gas equipment, structures or lines may not be feasible or practicable to be removed due to safely concerns for onsite personnel. As such, COG will excavate the impacted soils to the maximum extent practicable.
