July 11, 2018

Re: Corrective Action Plan Amendment – 1RP-4687
Devon Billiken 7 Federal 1H
Legal: Unit M, Sec 12, T26S R34E, Lea County, NM
Latitude/Longitude: 32.050688/ -103.429337
Etech Proj. Number: 817-8169-000
Depth to Groundwater: 150-175feet - Chevron/Texaco Lea County Depth to Groundwater Map
- USGS National Water Information System: Web Interface
Release Type: Produced Water

Amended Scope of Work

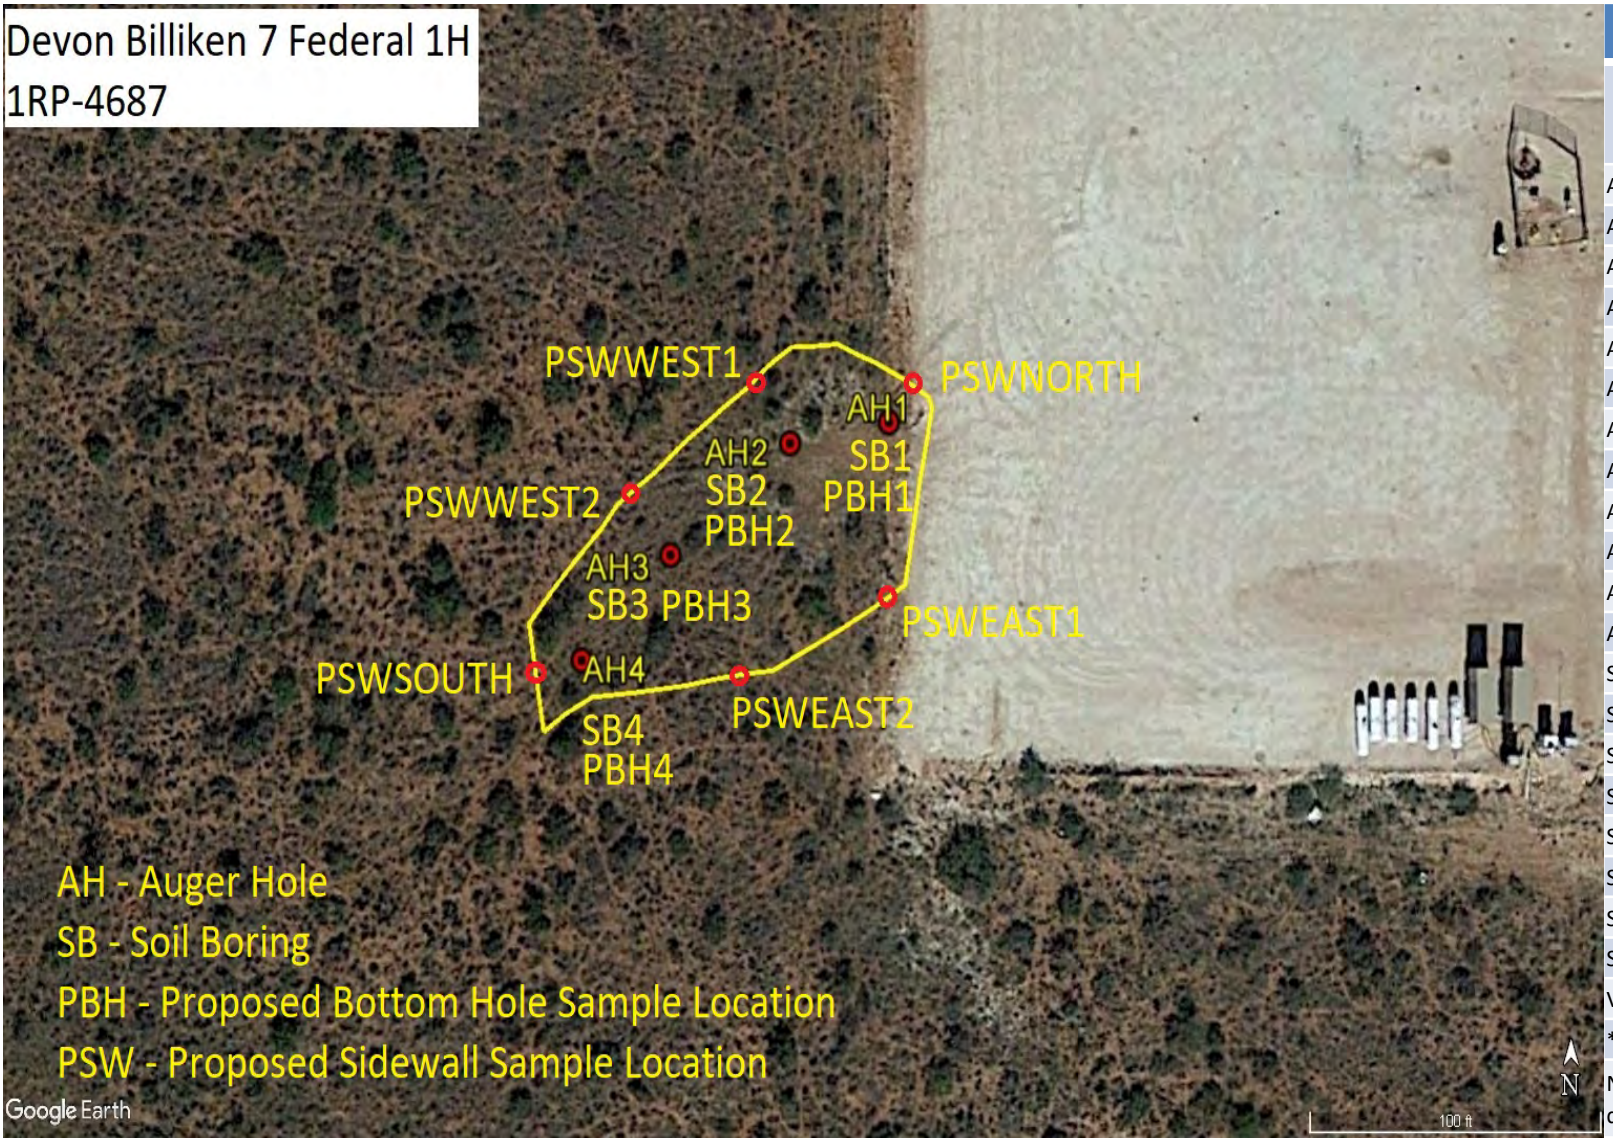
Attachment B
Annotated Aerial Imagery

ETECH Environmental & Safety Solutions, Inc.	Delineation & Assessment Report ©	Lease Name:	Devon Billiken 7 Fed 1H	Case No.:	1RP-4687
		Date Assessed:	April 24, 2017 and March 22, 2018

Sample I.D.	Depth (ft.)	Chloride (mg/kg)
AH 1	1	3,700
AH 1	2	5,930
AH 1	3*	602
AH 2	1	5,050
AH 2	2	2,400
AH 2	2.5*	1,690
AH 3	1	10,000
AH 3	2	8,710
AH 3	3*	3,770
AH 4	1	8,380
AH 4	2	6,380
AH 4	2.5*	5,000
SB 1	7	ND
SB 1	12	16
SB 2	8	16
SB 2	13	16
SB 3	8	48
SB 3	13	16
SB 4	7.5	16
SB 4	12.5	16

Values are laboratory results

* Depth of hand auger refusal

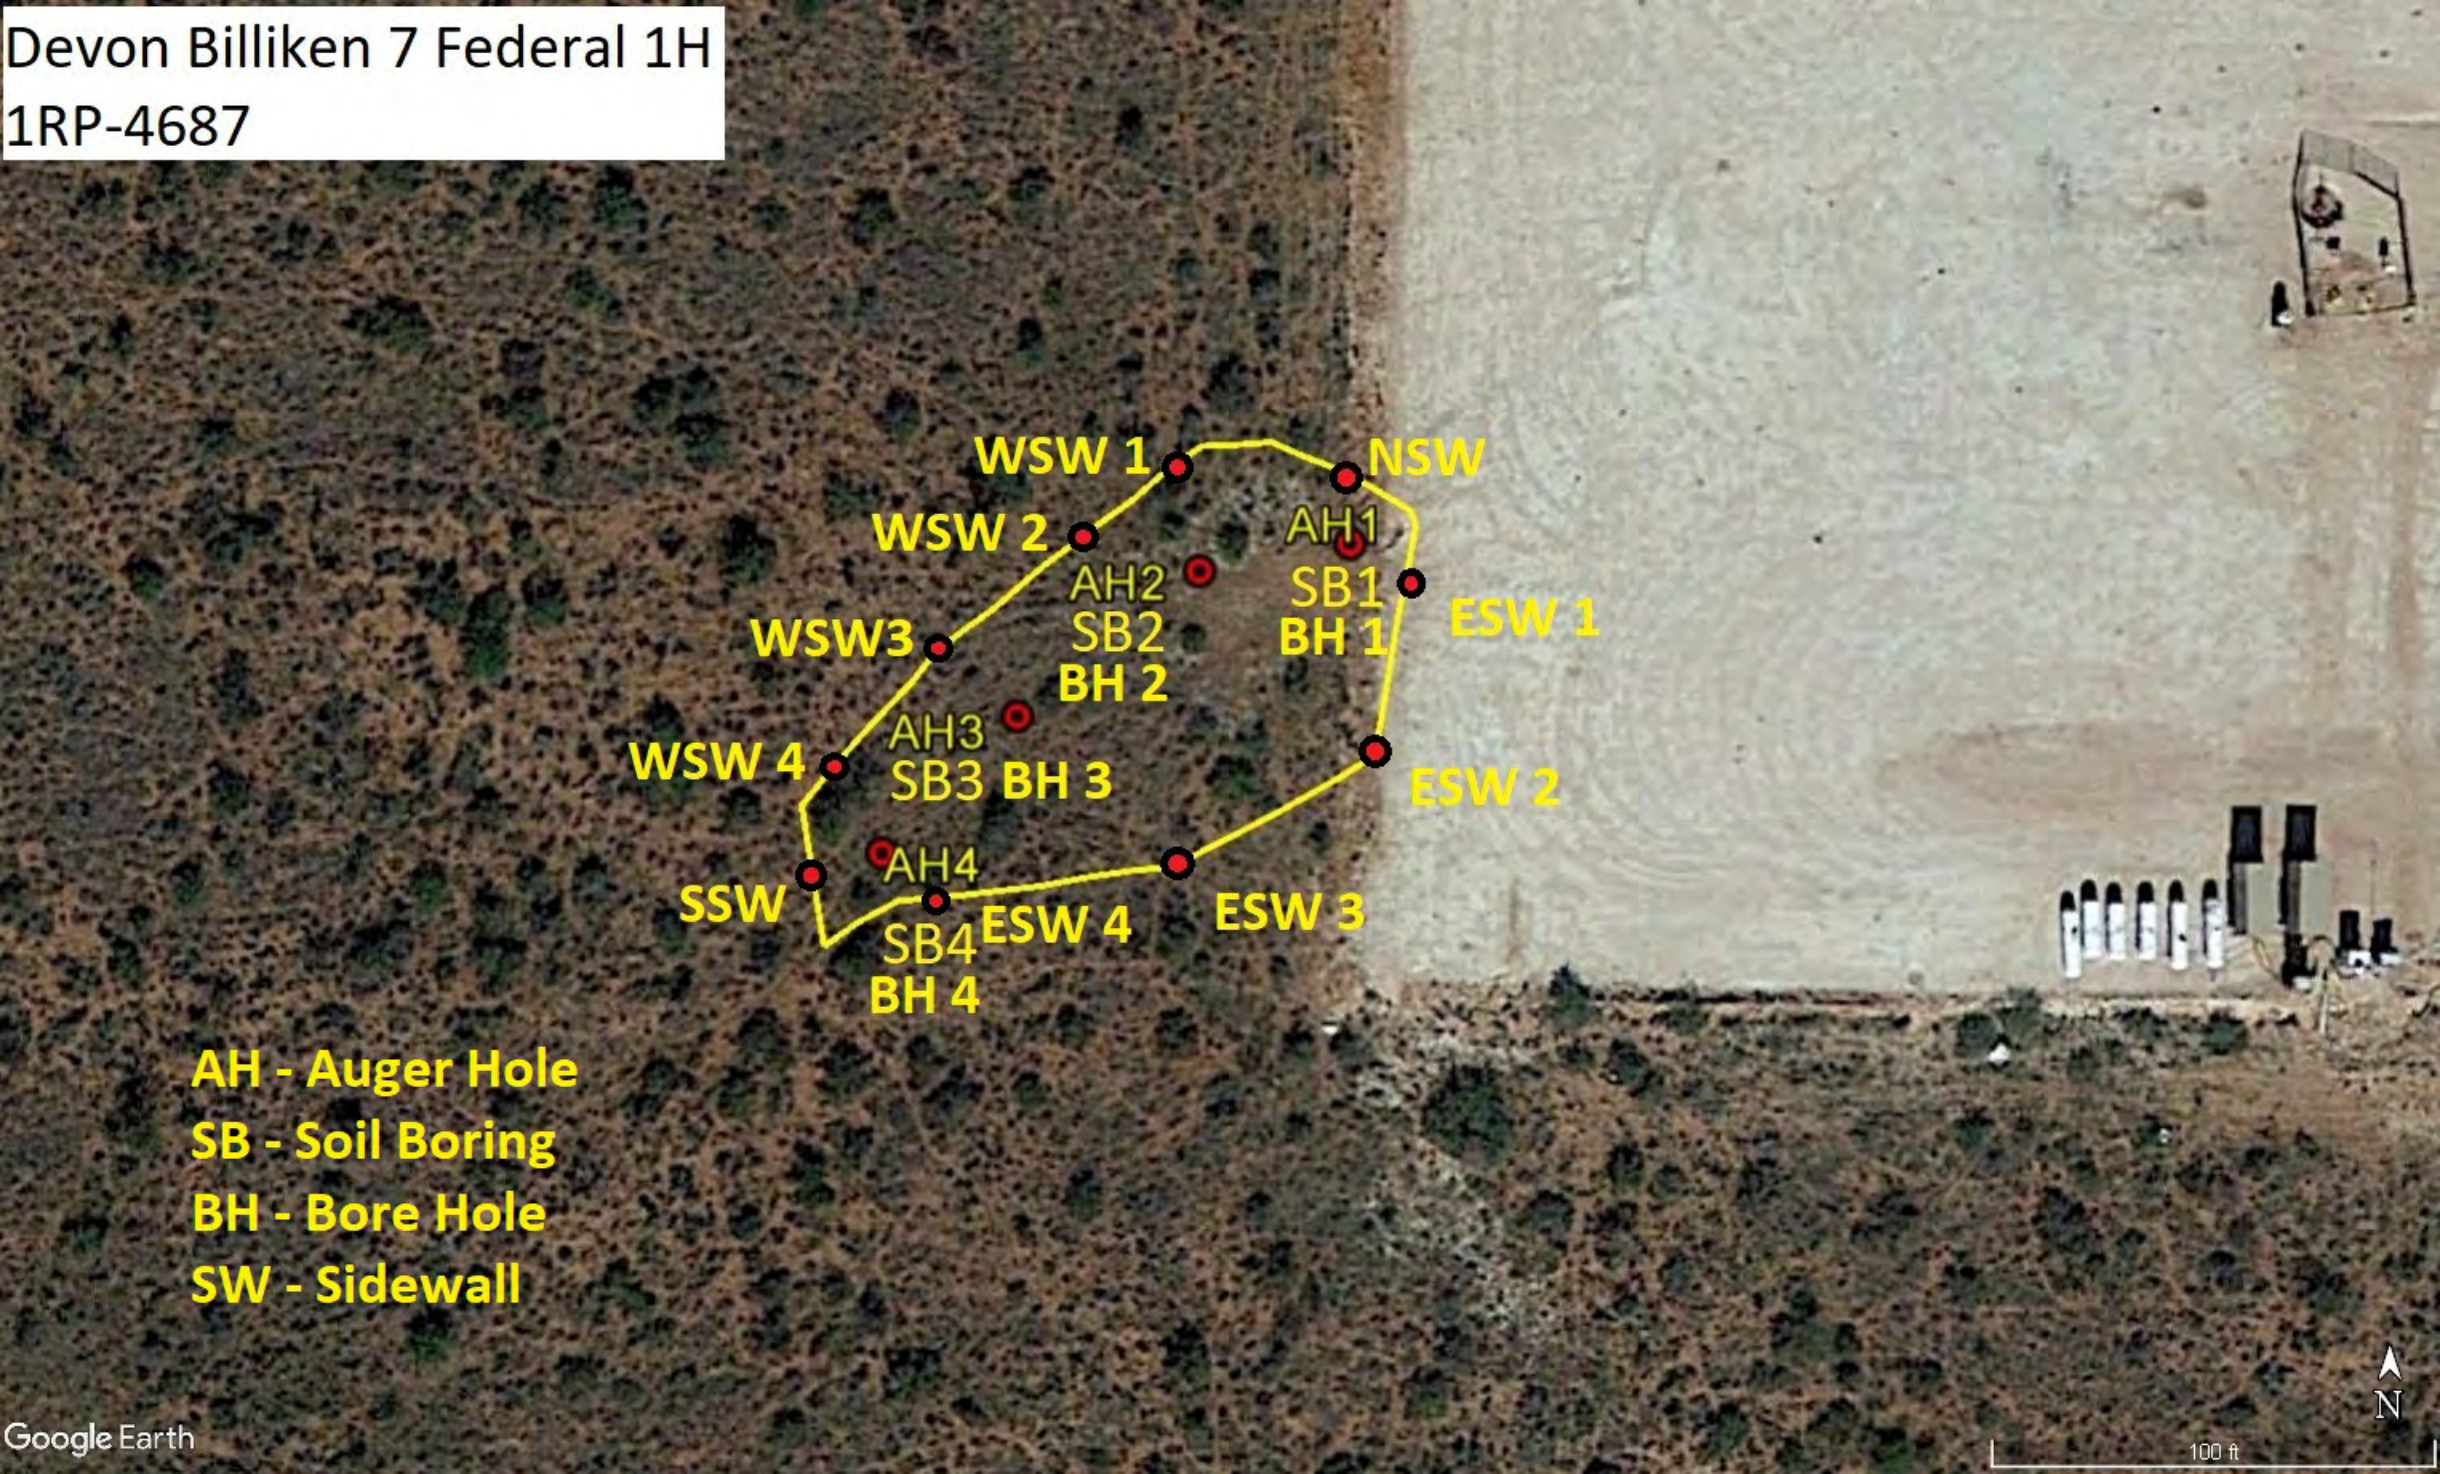
Devon Billiken 7 Federal 1H
1RP-4687
WSW 1
NSW
WSW 2
AH1
AH2
SB1
SB2
BH 1
ESW 1
WSW3
BH 2
AH3
WSW 4
SB3 BH 3
ESW 2
AH4
SSW
ESW 4
ESW 3
SB4
BH 4
AH - Auger Hole
SB - Soil Boring
BH - Bore Hole
SW - Sidewall
Google Earth
N
100 ft

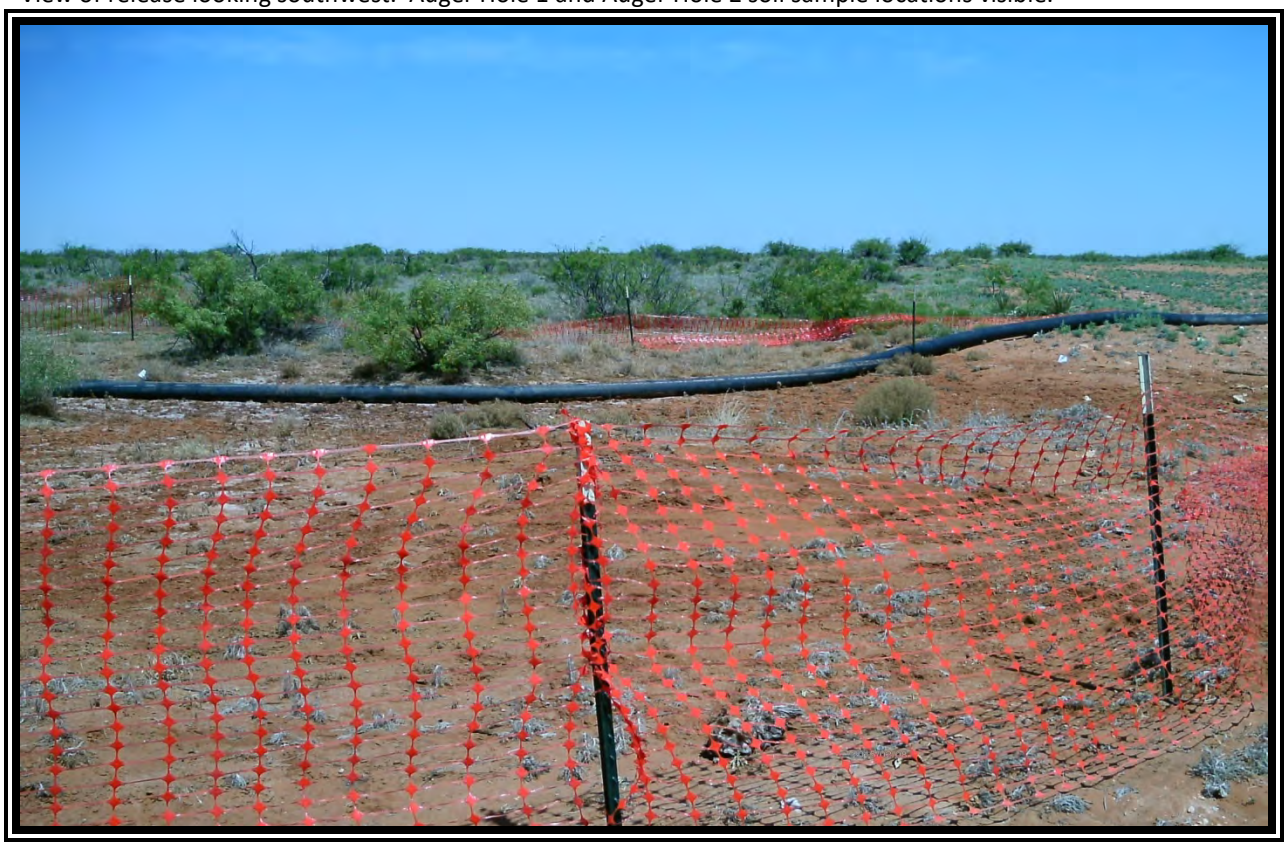
View of release looking southwest. Auger Hole 1 and Auger Hole 2 soil sample locations visible.
