Report Type: Work Plan 1RP-5018

May 22, 2018

Re: Work Plan for the Marathon Oil Company, McKay West Federal #1 Tank Battery, Unit F, Section 34, Township 18 South, Range 32 East, Lea County, New Mexico. 1RP-5018.

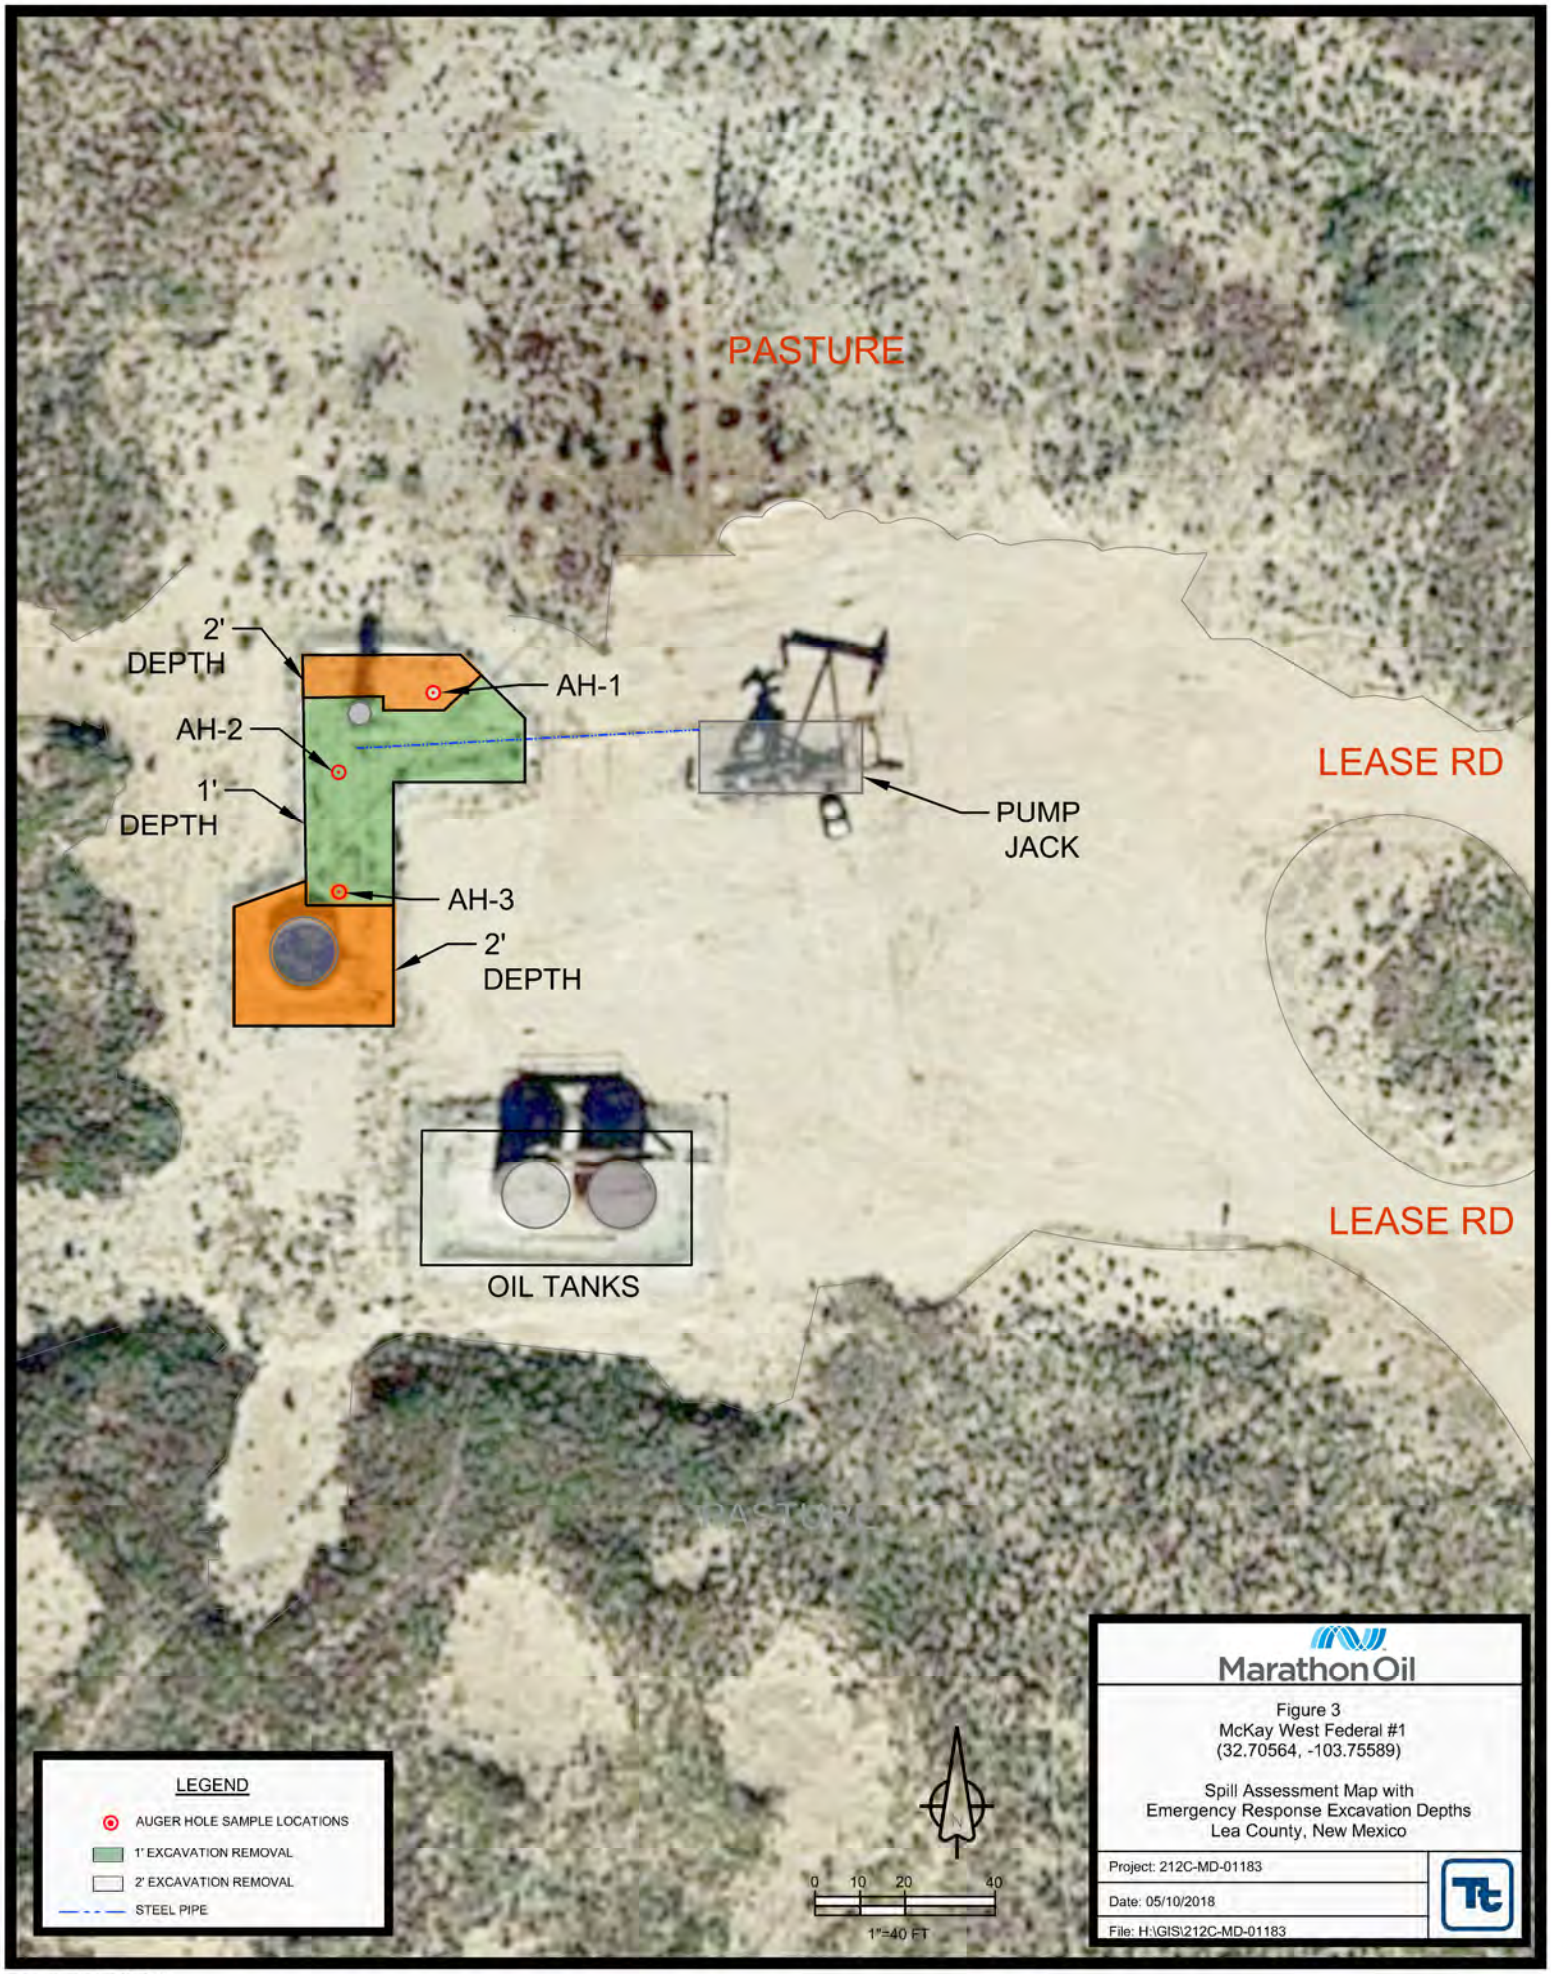
A total of three (3) auger holes (AH-1 through AH-3) were installed in the release area to total depths of 3.0' below the excavation bottom to assess and vertically define extents. Selected samples were analyzed for TPH analysis by EPA method 8015 modified, BTEX by EPA Method 8021B and chloride by EPA method 300.0. Copies of laboratory analysis and chain-of-custody documentation are included in Appendix C. The sampling results are summarized in Table 1. The sample locations and excavation depths are depicted on Figure 3.

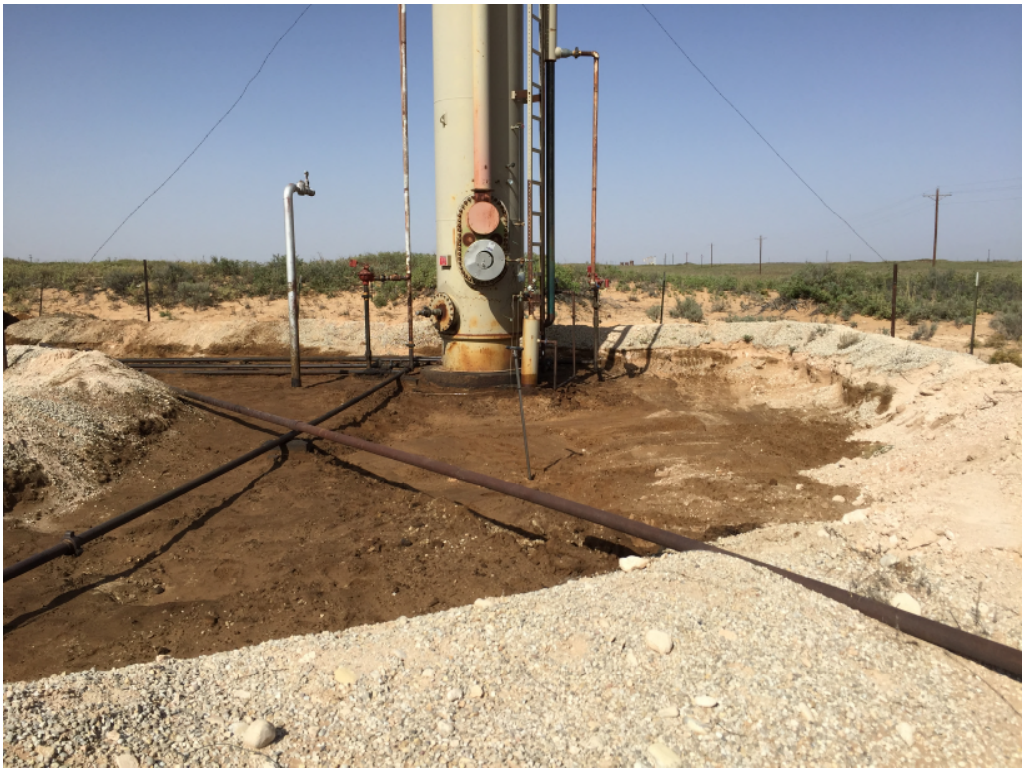
View West– Area of AH-1

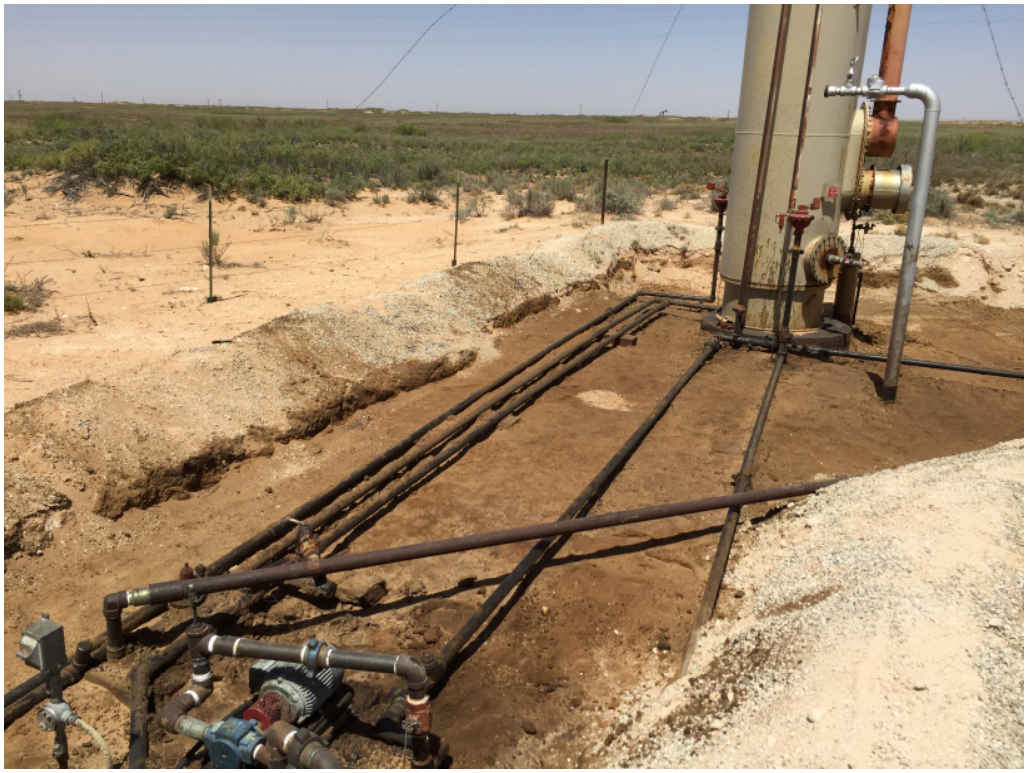
View Northwest – Area of AH-2
