August 13, 2018

Re: **Remediation Summary and Closure Report**
Pan Head Fee #023H
API No. 30-025-42756
GPS: 32.855150, -103.739437
UL "C", Sec. 11, T17S, R32E
Lea Co, NM
NMOCD Ref. No. 1RP-4948

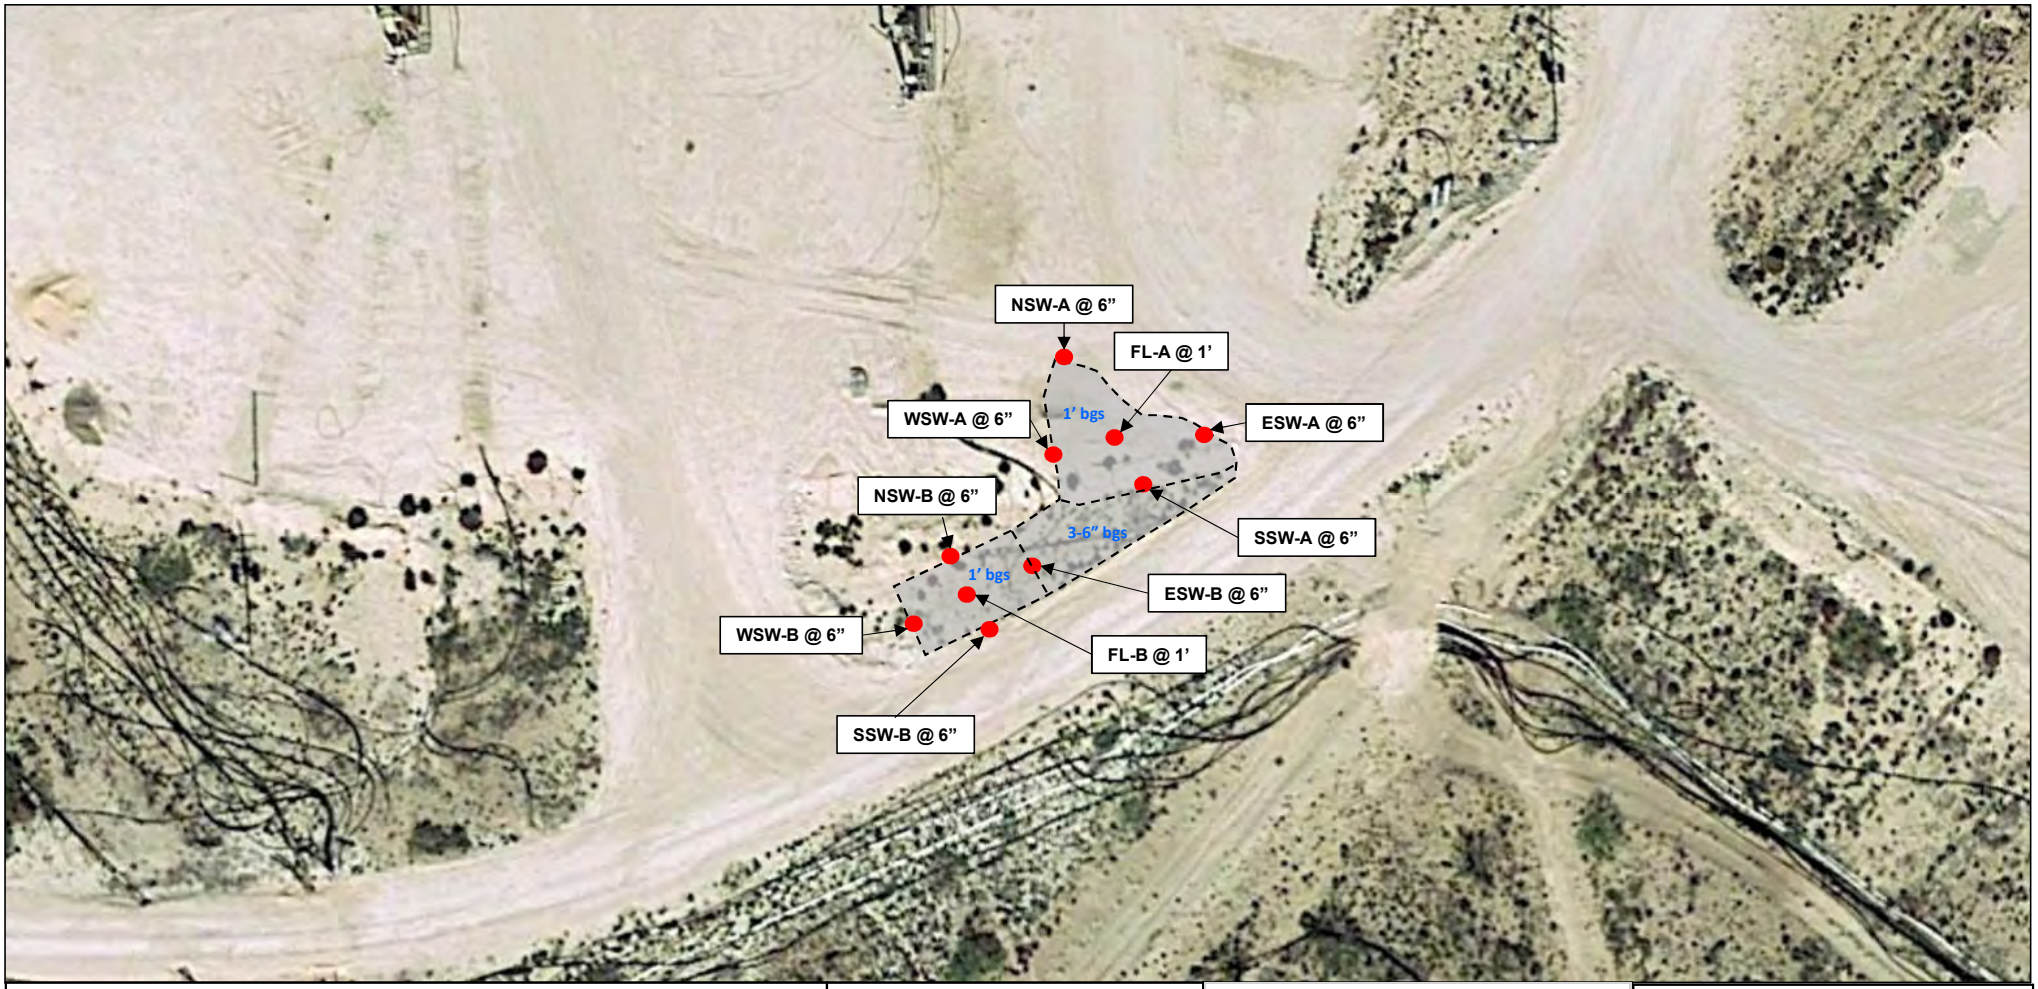
Impacted soil within the release margins, represented by soil samples SP-1 and SP-3 were excavated to a depth of one (1) foot bgs and temporarily stockpiled on-site, atop an impermeable liner, pending final disposition at a NMOCD-approved disposal facility. The impacted area represented by SP-2 was aesthetically addressed and contoured to meet the needs of the well pad. Ten (10) confirmation floor and sidewall samples were taken from the excavated area represented by SP-1 and SP-3 and were submitted to the laboratory for analysis of benzene, BTEX, TPH and/or chloride concentrations. Upon receiving laboratory analytical data showing that the submitted samples were below the NMOCD RRAL, impacted soil was transported to a NMOCD disposal facility and the excavated area was backfilled with locally sourced, non-impacted "like" material. A table summarizing laboratory analytical results from confirmation soil samples is provided below:

EXCAVATION/REMEDIATION DETAIL SUMMARY			
Type of Remediation:	Dig and Haul		
Date Remediation Activities Began:	June 27, 2018		
Excavation Dimensions (West):	**Length:** 40 Ft.	**Width:** 25 Ft.	**Depth:** 1 Ft.
Excavation Dimensions (East):	**Length:** 13 to 55 Ft.	**Width:** 12 to 55 Ft.	**Depth:** 1 Ft.
Soil Transportation Start Date:	June 28, 2018	**Backfill Date:**	June 29, 2018
Total Yards Transported to Disposal:	80	**Disposal Facility:**	R360 Halfway Facility

Upon receiving laboratory analytical results from confirmation soil samples, the excavated area was backfilled with locally sourced, non-impacted "like" material. A Photographic Log is provided as Attachment #5.
