August 7, 2018

Re: **Remediation Summary and Closure Report**
Pan Head Fee #011H
API No. 30-025-42817
GPS: 32.85579, -103.74374
UL "D", Sec. 11, T17S, R32E
Lea Co, NM
NMOCD Ref. No. 1RP-4971

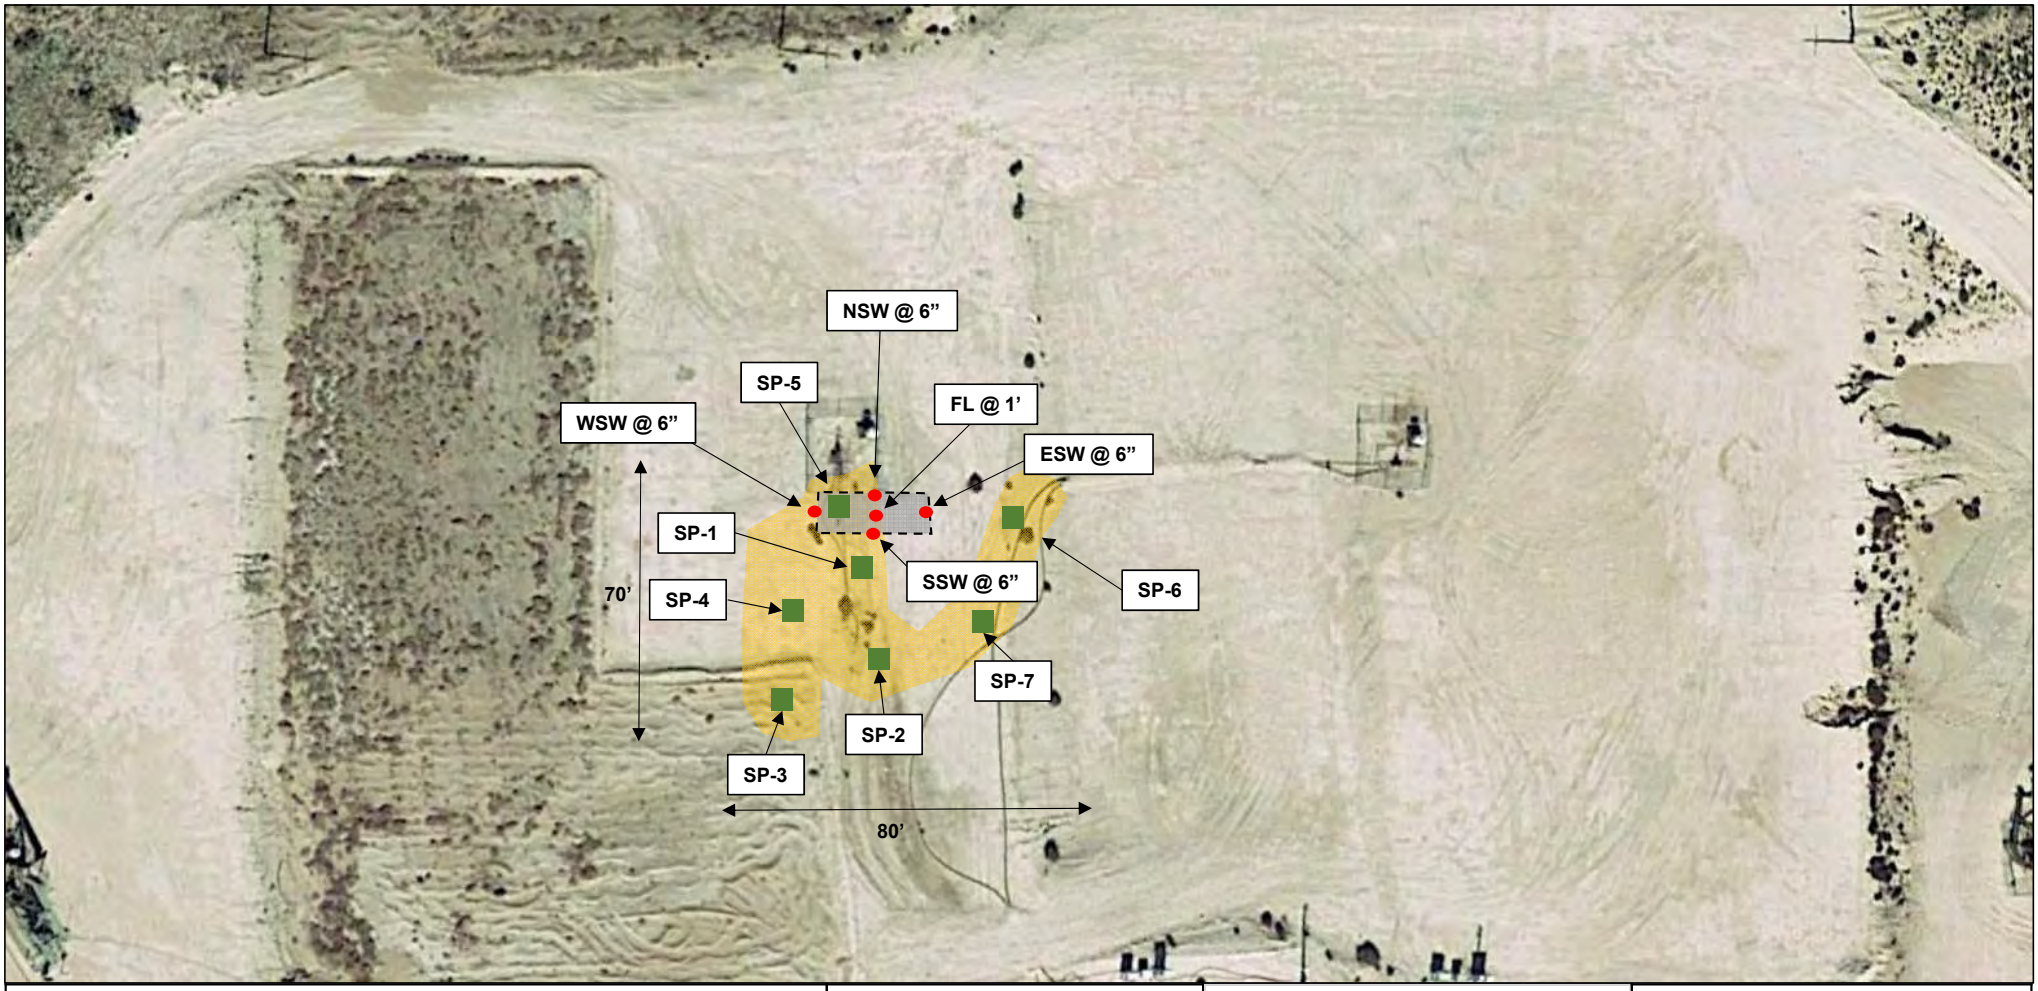
Figure 2

Impacted soil around the area represented by SP-5 was excavated and temporarily stockpiled on-site, atop an impermeable liner, pending final disposition. The floor of the excavation was excavated to a depth of approximately one (1) foot and sidewalls of the excavated area were advanced until the laboratory analytical results from confirmation soil samples indicated Benzene, BTEX, TPH and chloride concentrations were below the NMOCD RRAL. Upon excavating impacted soil from within the release margins, one (1) confirmation soil sample was collected from the floor and four (4) confirmation soil samples were collected from the sidewalls of the excavated area on June 28, 2018. The collected soil samples were submitted to the laboratory for analysis of benzene, BTEX, TPH and chloride. Upon receiving confirmation analytical results indicating that levels for benzene, BTEX, TPH, and chlorides were below NMOCD RRAL, the stockpiled material was transported to a NMOCD-approved disposal facility. A table summarizing laboratory analytical results from confirmation soil samples is provided below:

Upon receiving laboratory analytical results from confirmation soil samples, the excavated area was backfilled with locally sourced, non-impacted "like" material. A Photographic Log is provided as Attachment #5.
