Report Type: Closure Report 1RP-3677

General Site Information:						
Site:	**Lotus SWD #1**					
Company:	**EOG Resources**					
Section, Township and Range	**Unit A**	**Sec. 32**	**T 22S**	**R 32E**		
Lease Number:	**API No. 30-025-36004**					
County:	**Lea County**					
GPS:	**32.353257º N**			**103.68989º W**		
Surface Owner:	State					
Mineral Owner:	State					
Directions:	From the intersection of Red Rd & Mills Ranch Rd in rural Lea County, travel south on Red Rd for 0.35 mi, turn east onto lease road for 3.0 mi to location.

Re: Closure Report for the EOG Resources, Lotus SWD #1, Unit A, Section 32, Township 22 South, Range 32 East, Lea County, New Mexico.
1RP-3677

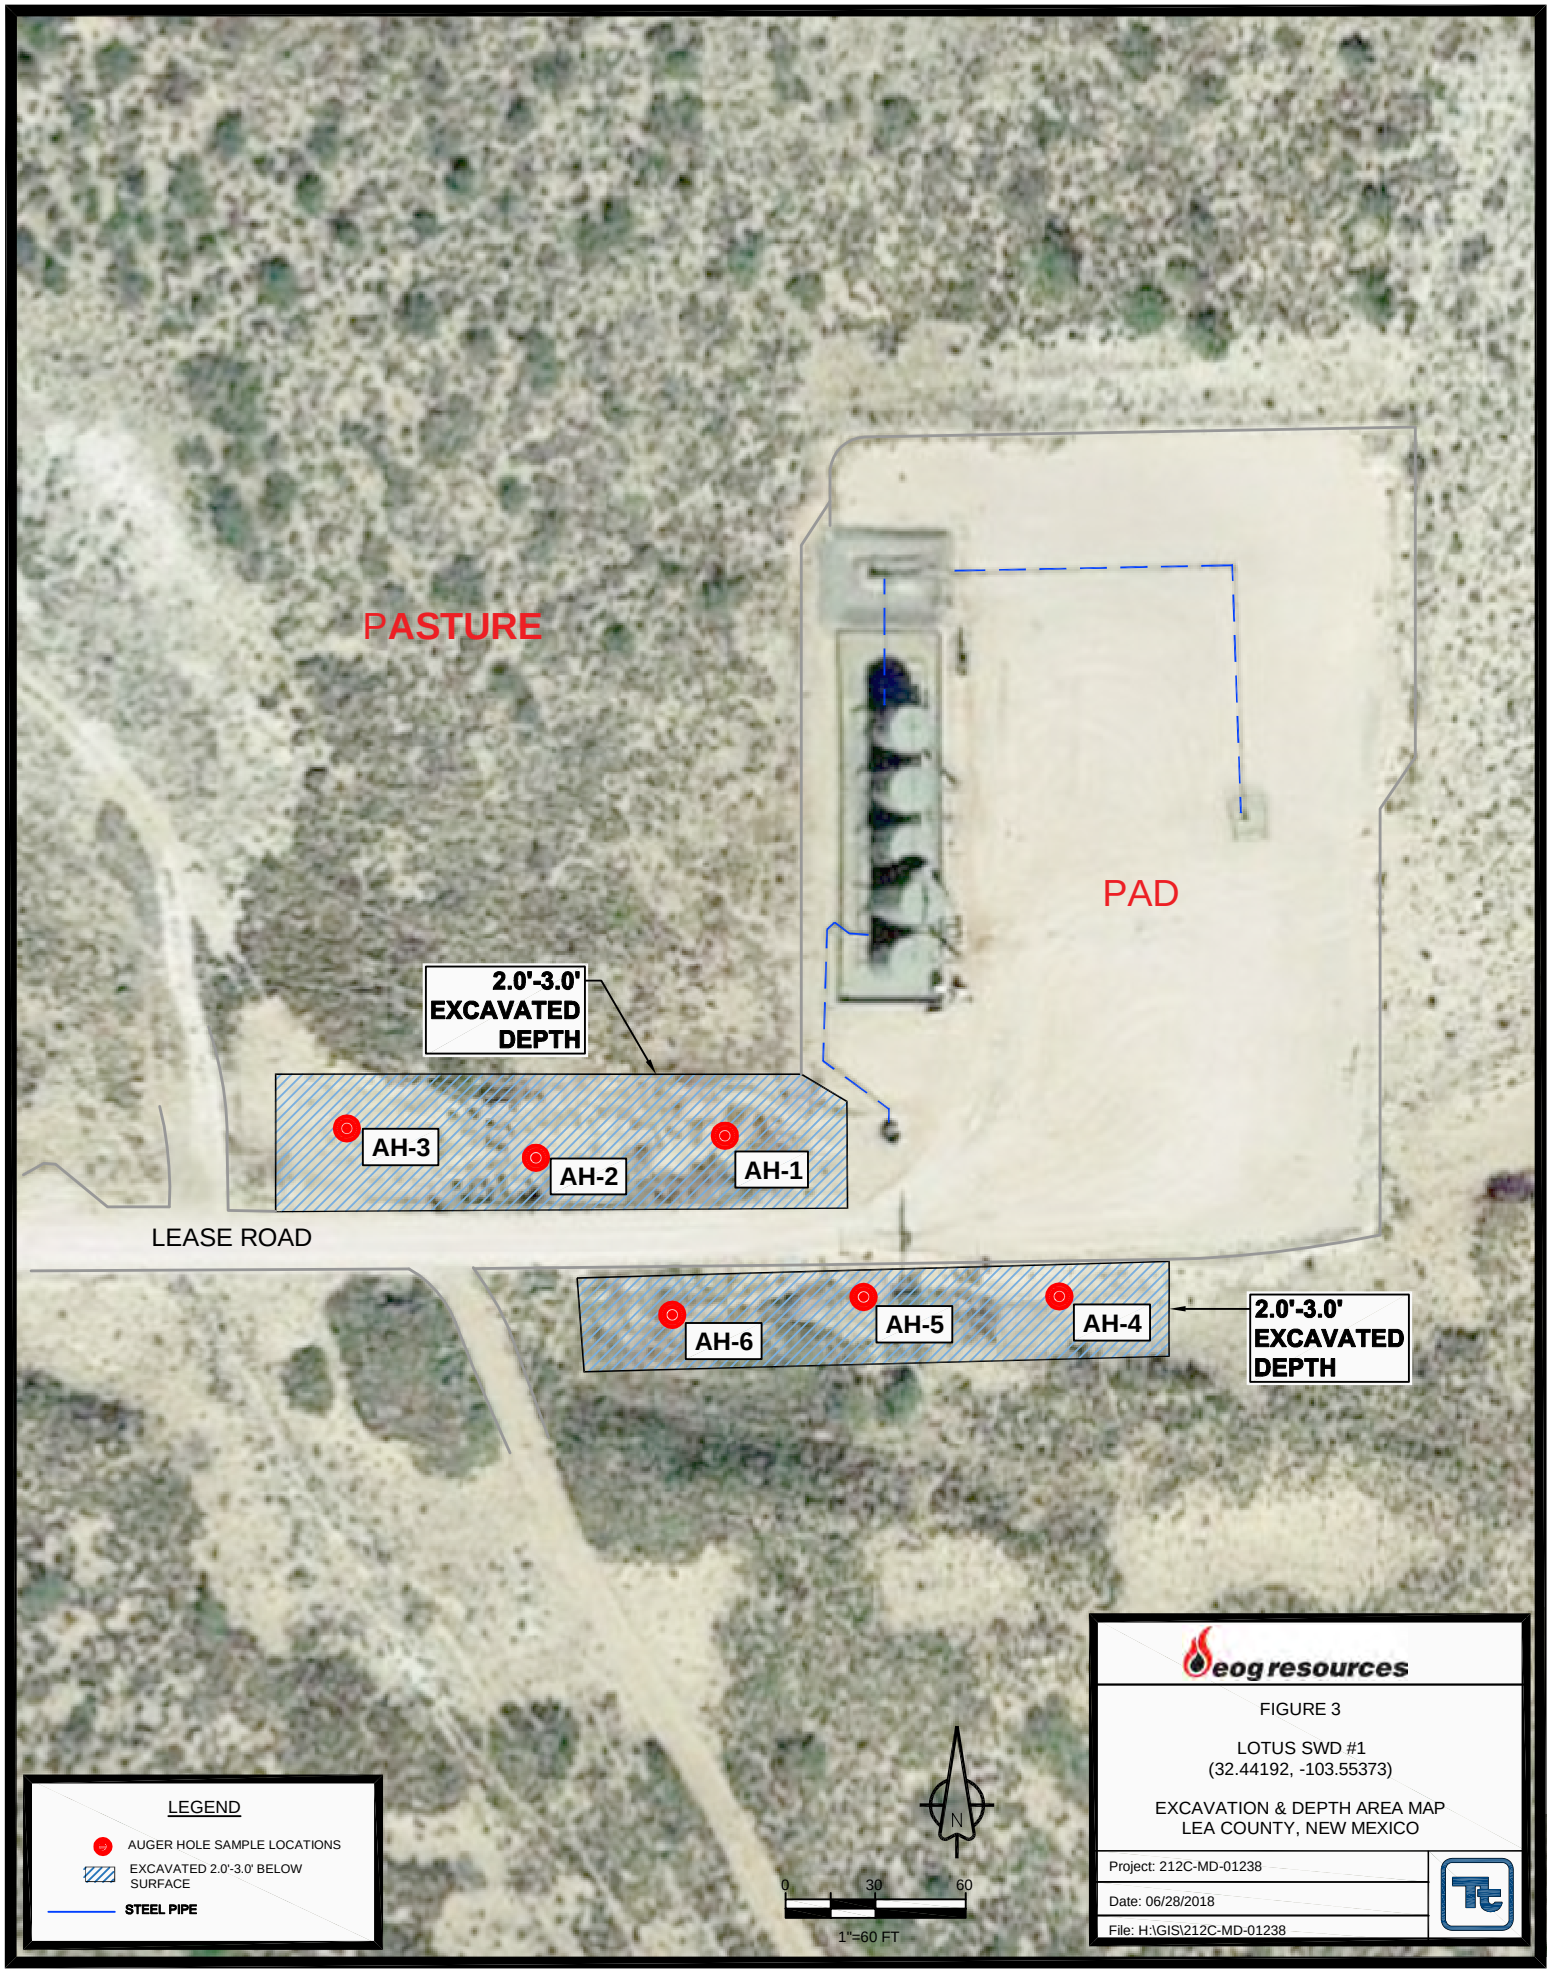
On May 9, 2018, Tetra Tech personnel were onsite to evaluate and sample the release area, which had previously been excavated to 2-3' below surface. A total of six (6) auger holes (AH-1 through AH-6) were installed in the release areas in the pasture to total depths of 0-1' below the 2-3' excavation bottom (BEB). Samples were not collected in the area of the battery as the facility has since been reconstructed with a metal containment. Soil samples were collected and submitted to the laboratory for TPH analysis by EPA method 8015 modified, BTEX by EPA Method 8021B, and chloride by EPA method 300.0. Copies of laboratory analysis and chain-of-custody documentation are included in Appendix C. The results of the sampling are summarized in Table 1. The sample locations are shown on Figure 3.

Referring to Table 1, one of the samples collected showed benzene, total BTEX, or TPH concentrations above the RRALs. Additionally, the areas of auger holes (AH-2, AH-3, AH-4, AH-5, and AH-6) showed chloride concentrations below the laboratory reporting limit. The area of auger hole (AH-1) showed a chloride concentration of 186 mg/kg.
