Report Type: Closure Report 1RP-4478 and 1RP-4479

General Site Information:						
Site:	**Schubert 18-4H**					
Company:	**Forge Energy, LLC.**					
Section, Township and Range	**Unit O**	**Sec. 18**	**T 19S**	**R 39E**		
Lease Number:	**API No. 30-025-43365**					
County:	**Lea County**					
GPS:	**32.65385° N**			**103.08413° W**		
Surface Owner:	**Private**					
Mineral Owner:						
Directions:	From the intersection of NM-18 and E Nadine Rd, travel east on E Nadine Rd for approximately 1.5 mi, turn north onto lease road for 1 mi to fork in the road and go northeast for approximately 0.5 mi, make hairpin turn to the west for 1.6 mi to the location on the north side of the lease road.

Re: Closure Report for the Forge Energy, LLC., Schubert 18-4H, Unit O, Section 18, Township 19 South, Range 39 East, Lea County, New Mexico. 1RP-4478 and 1RP-4479

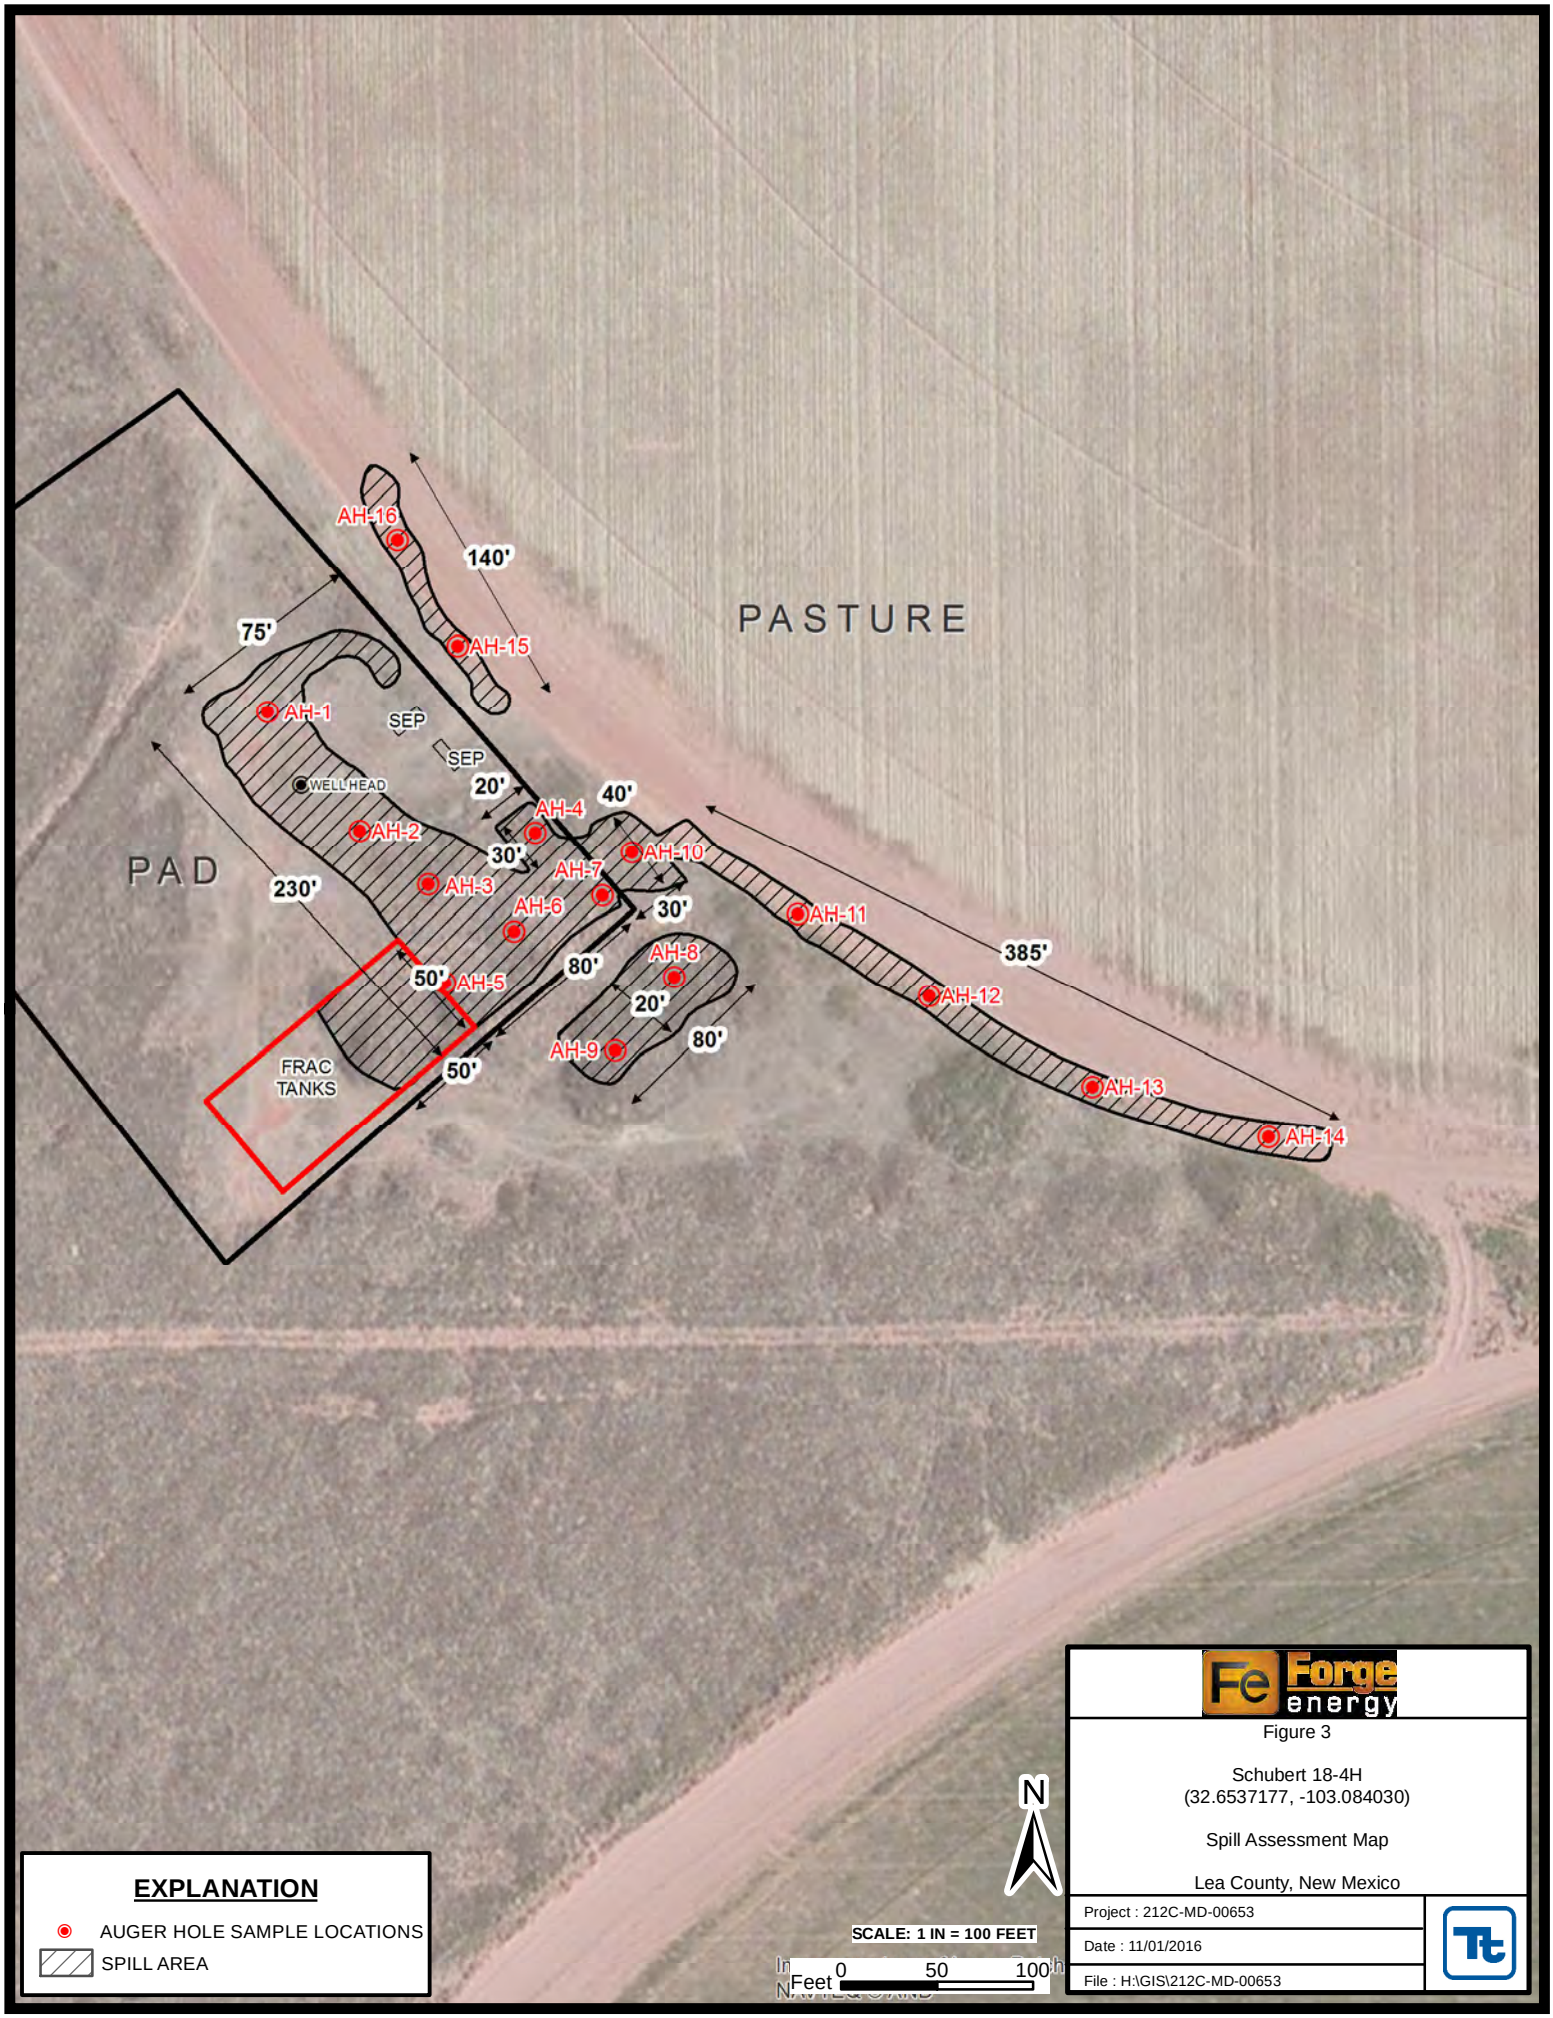
Two produced water releases occurred at the site in October 2016. The initial C-141 forms are included in Appendix A. The release areas are shown on Figure 3.

- 1RP-4478: According to the State of New Mexico C-141 Initial Report, the first release was discovered on October 23, 2016. Approximately seventy (70) bbls of produced water was released during completion operations. Ten (10) bbls of produced water was recovered, leaving approximately sixty (60) bbls unrecovered. The impacted area measured approximately 75' x 230' on the pad. The release also migrated into the adjacent pasture impacting areas measuring approximately 15' x 140' to the northeast of the pad, and 80' x 80' to the southeast of the pad.

- 1RP-4479: According to the State of New Mexico C-141 Initial Report, the second release was discovered on October 25, 2016, and was the result of a frac tank that overflowed. Approximately six hundred and eighty seven (687) bbls of produced water was released. Vacuum trucks were used to recover all standing fluids, and

Copies of laboratory analysis and chain-of-custody documentation are included in Appendix C. The sampling results are summarized in Table 1. The auger hole locations are shown on Figure 3.

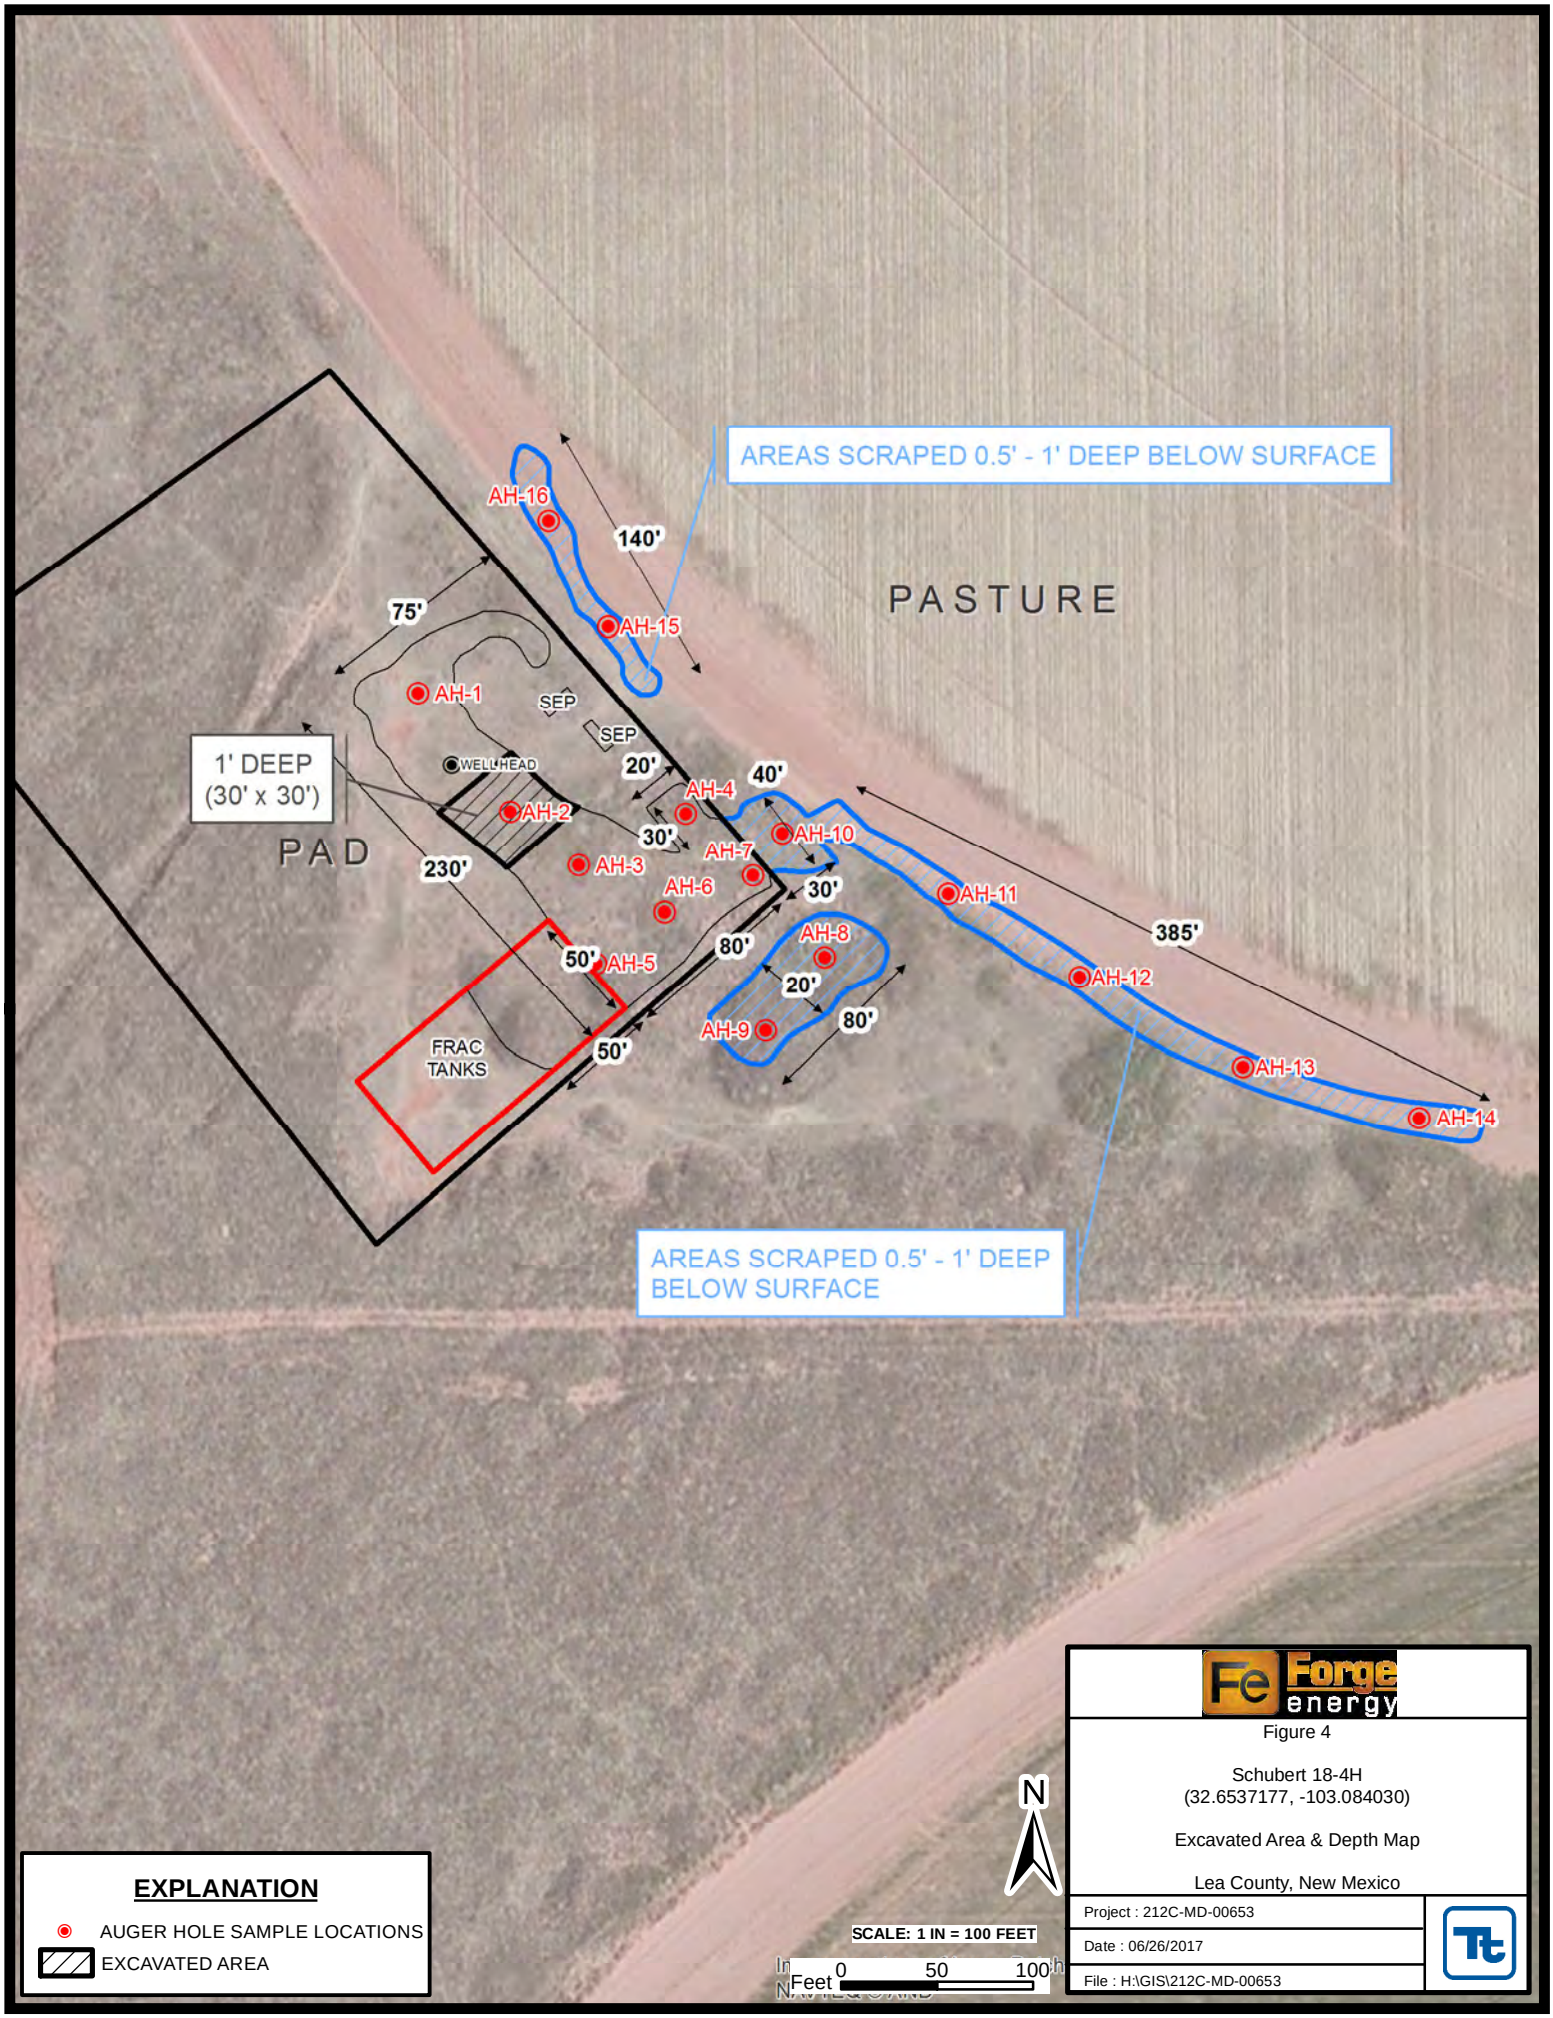
As part of rapid response, Forge proposed to scrape the heavy saturated areas and a surficial scrape on the pad. The areas of auger holes (AH-8, AH-9, AH-10, AH-11, AH-12, AH-13, and AH-14) were scraped 0.5-1.0' below surface prior to sampling.

AREAS SCRAPED 0.5' - 1' DEEP BELOW SURFACE
PASTURE
AH-16
140'
AH-15
75'
AH-1
SEP
SEP
1' DEEP
(30' x 30')
WELLHEAD
20'
40'
AH-4
AH-2
AH-10
30'
AH-7
PAD
230'
AH-3
AH-6
30'
AH-11
385'
AH-8
50'
AH-5
80'
20'
AH-12
80'
AH-9
FRAC
TANKS
50'
AH-13
AH-14
AREAS SCRAPED 0.5' - 1' DEEP
BELOW SURFACE
EXPLANATION
AUGER HOLE SAMPLE LOCATIONS
EXCAVATED AREA
N
SCALE: 1 IN = 100 FEET
Feet 0 50 100
Figure 4
Schubert 18-4H
(32.6537177, -103.084030)
Excavated Area & Depth Map
Lea County, New Mexico
Project : 212C-MD-00653
Date : 06/26/2017
File : H:\GIS\212C-MD-00653
Mapped By: Isabel Marmolejo

On June 14, 2017, Tetra Tech personnel were onsite to supervise the excavation and remediation activities. As proposed in the work plan, the excavation area and depth are highlighted (green) in Table 1 and shown on Figure 4. Based on the laboratory results, the area of auger hole (AH-2) on the pad was excavated to a depth of 1.0' below surface area and measured approximately 30' x 30'. Approximately 40 cubic yards was removed and transported to proper disposal. The excavated area was backfield with clean material to surface grade.
