Release Notification and Corrective Action

Name of Company: CHEVRON U.S.A. Inc.	Contact: Edem Sededji
Address: 56 Texas Camp Road, Lovington, NM 88260	Telephone No.: Office: (575) 396-4414 Mobile: (432) 234-4437
Facility Name: West Vacuum Unit #68	Facility Type: Produced Water Transfer Line

Subject:
Site Assessment Report
West Vacuum Unit #68
Lea County, New Mexico

Date:
July 29, 2014

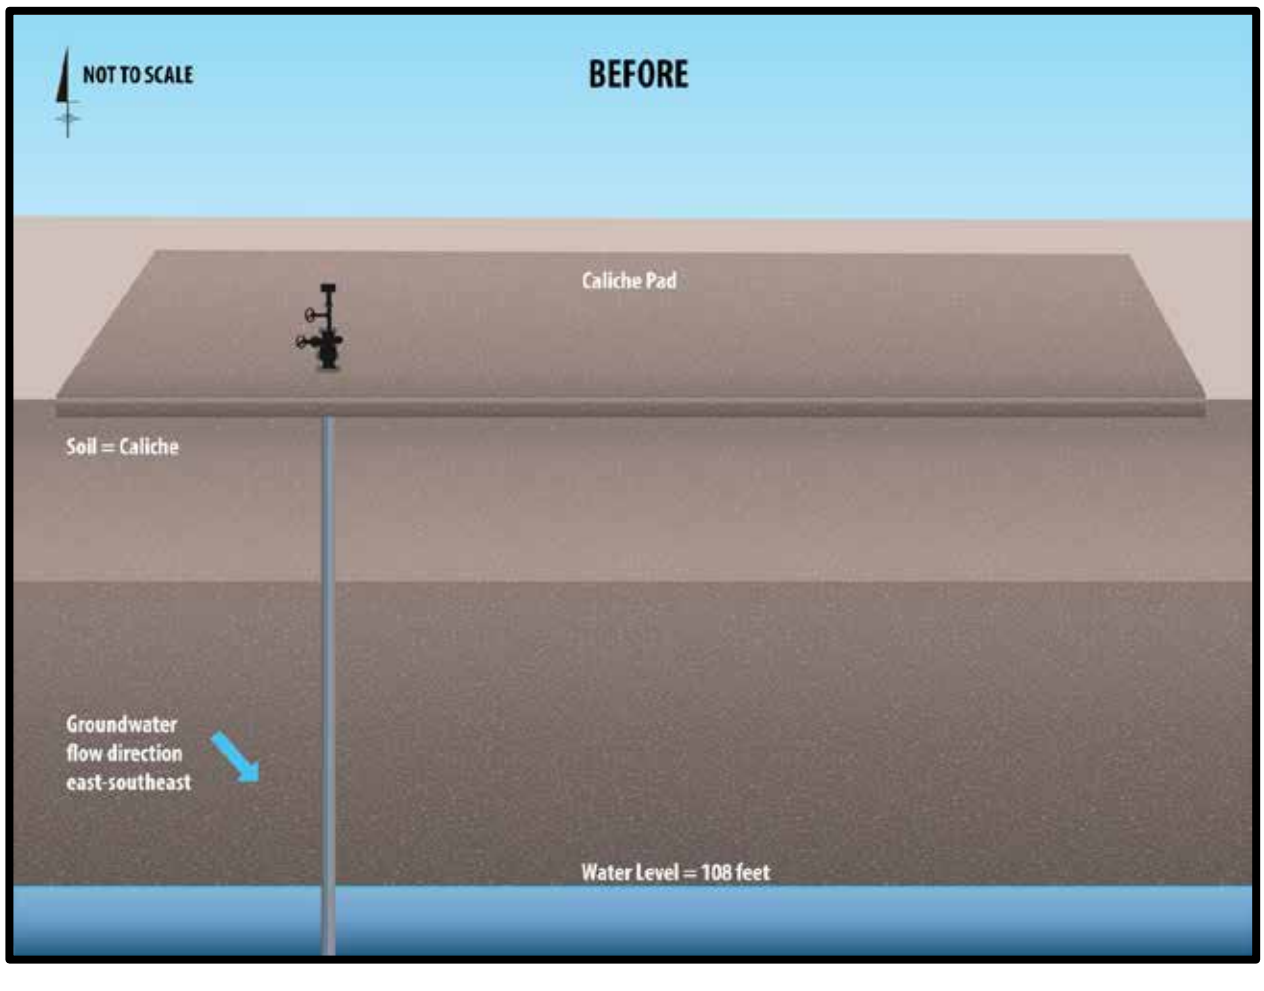
The site is located in the western edge of the Permian Basin with Lovington (the closest town) located approximately 15 miles southwest of the site. Due to the arid climate, the site experiences low precipitation and high evapotranspiration rates. According to information obtained from the NMOSE online database, groundwater near the site is encountered at a depth of approximately 108 feet bgs.
