Characterization Plan

Moped BQP State #1

30-005-20645

April 3, 2018

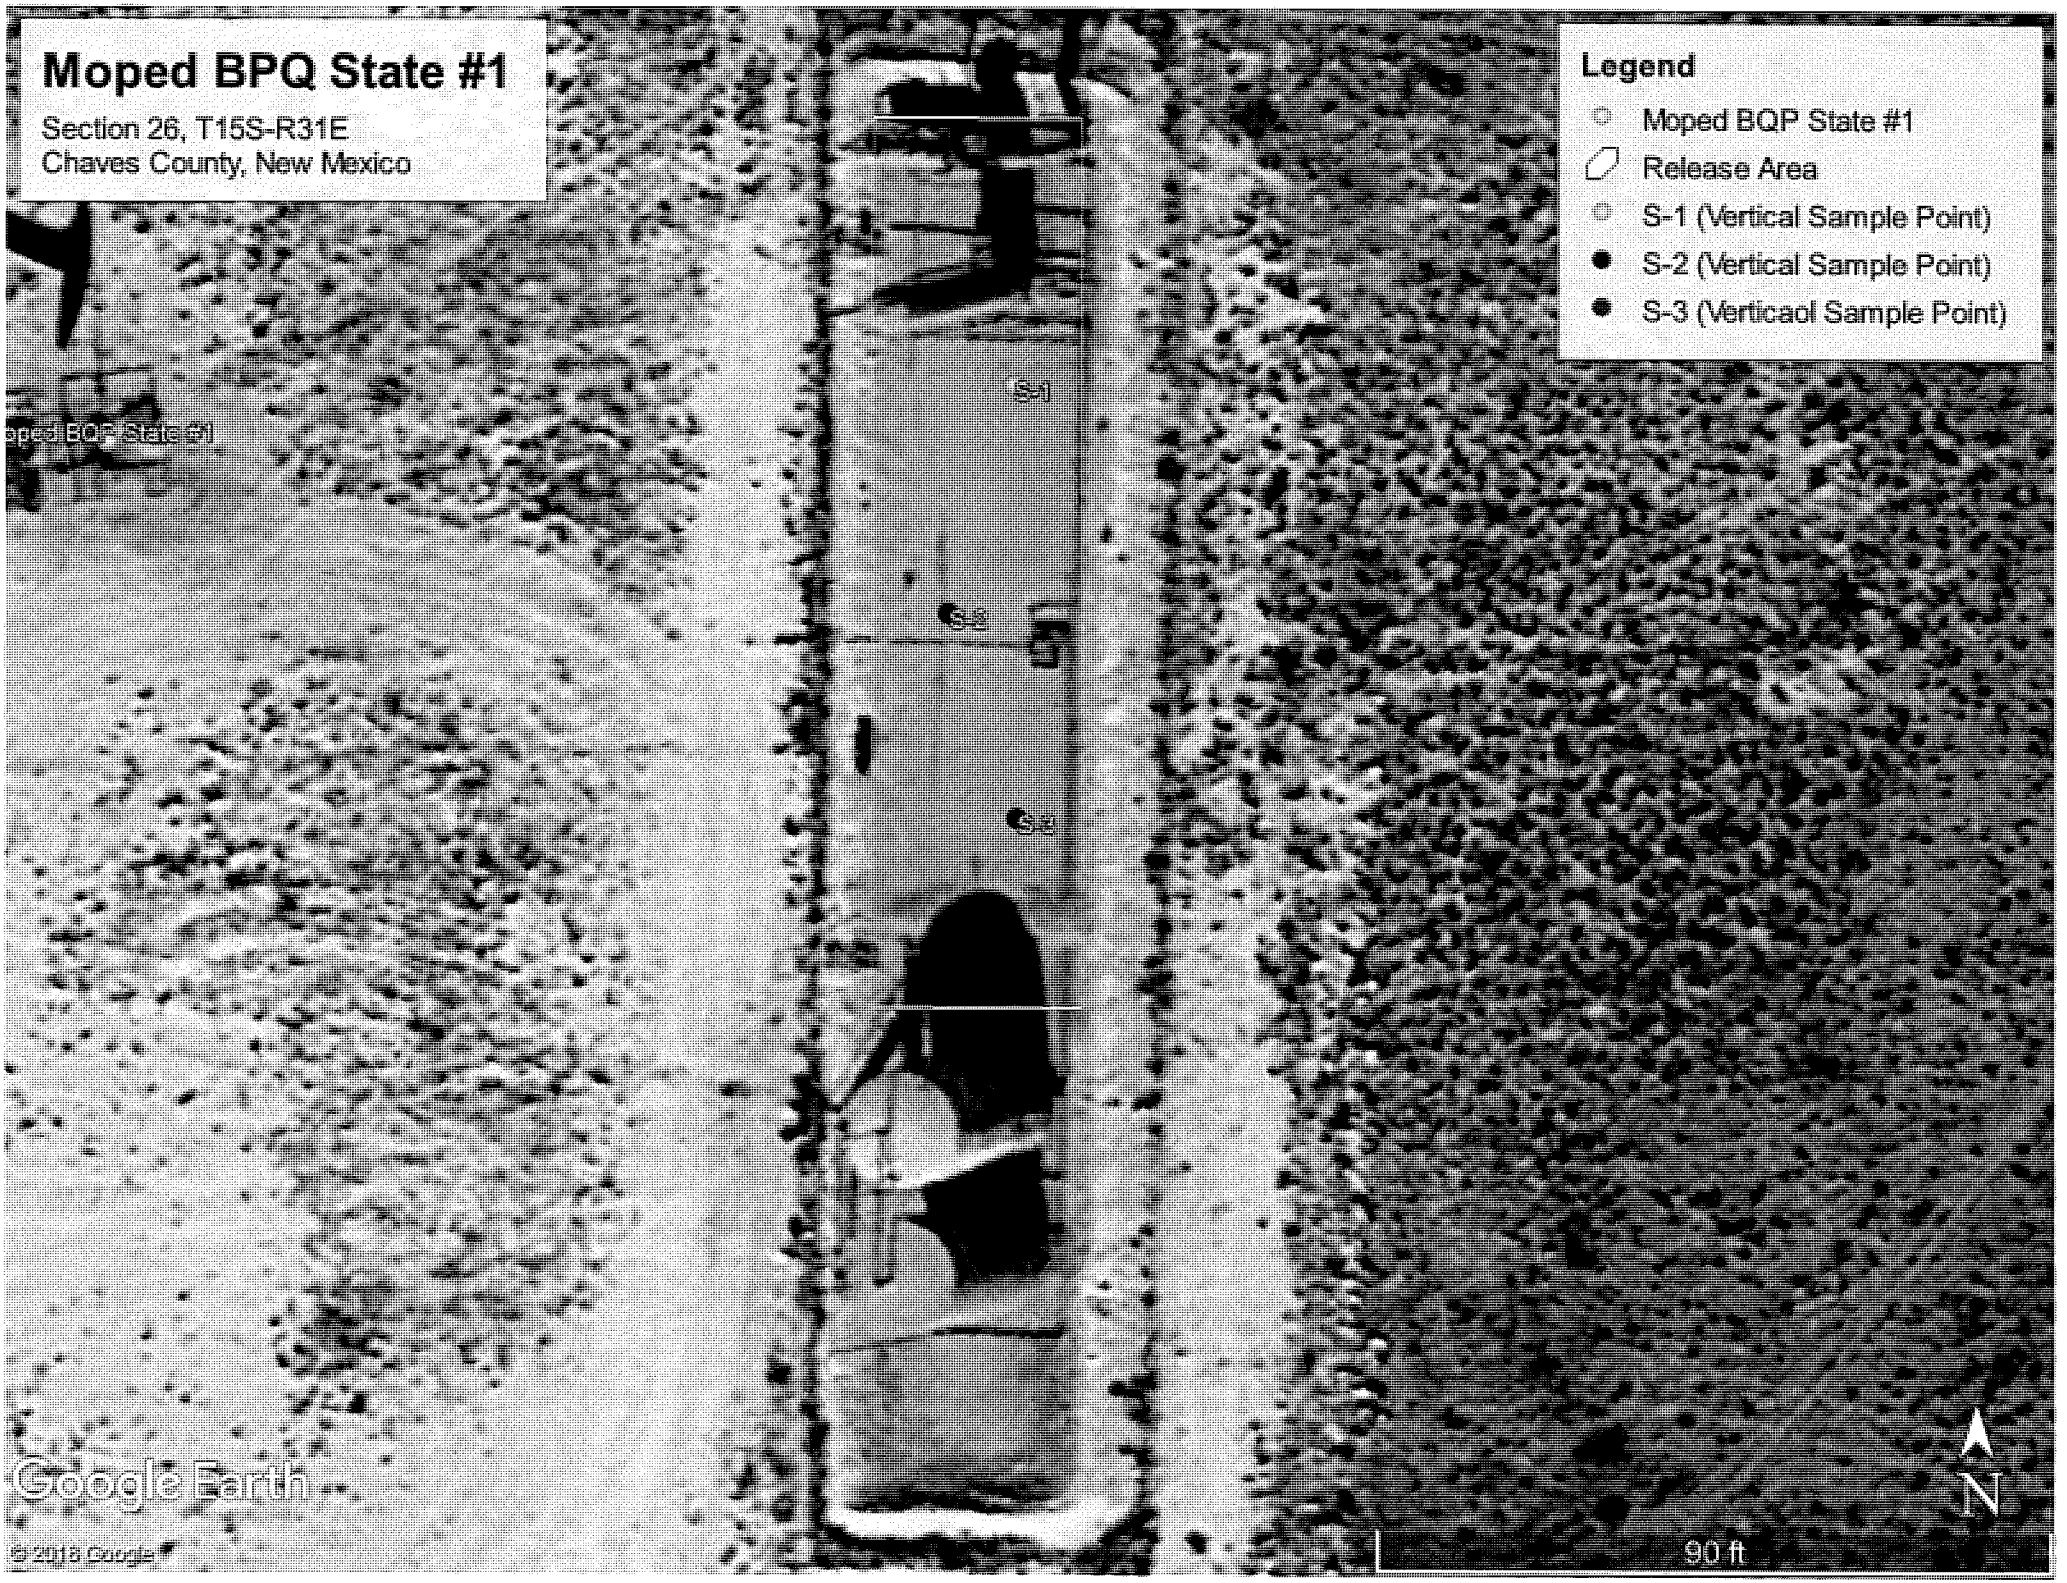
Figure 2

Vertical delineation samples (SP-1, SP-2 &SP-3) will be collected within the release area. Samples will be collected at 1', 2', 3', and 4' below grade surface (bgs) or when auger and or backhoe refusal is encountered. Due to the nature of the release (produced water), the vertical delineation soil samples will be analyzed for Benzene, BTEX, TPH extended (Chlorides for documentation, with no established RRAL's for chlorides). All samples will be sent to a NMOCD approved laboratory for analysis.

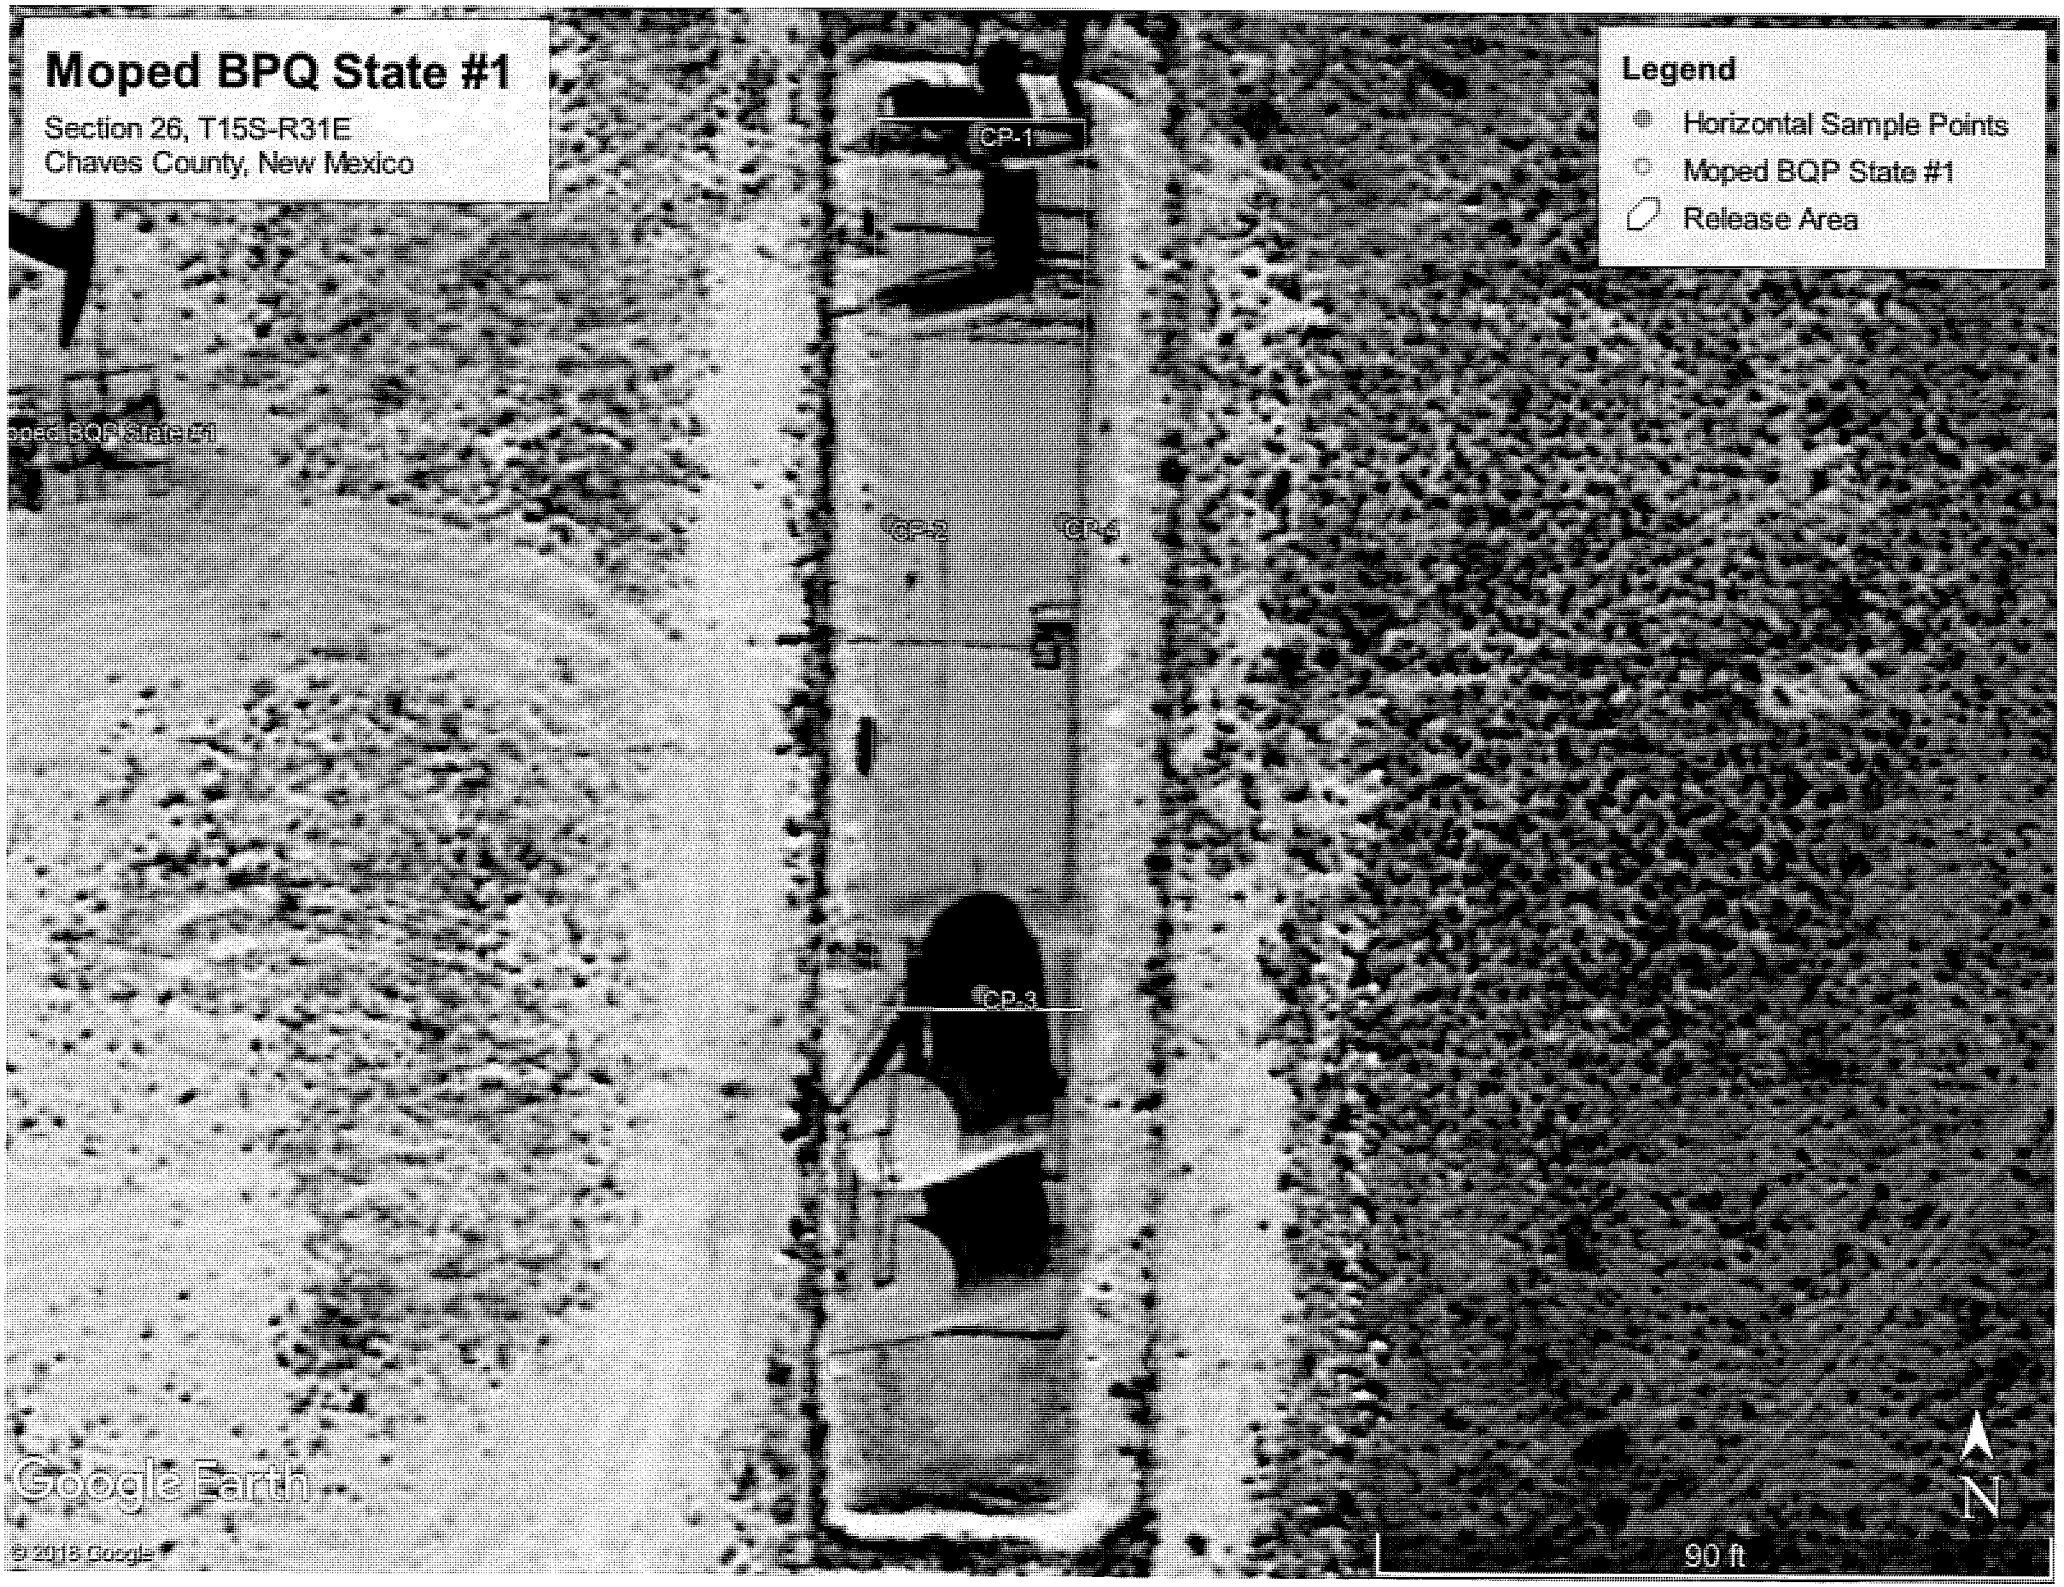
Figure 3

Horizontal delineation samples will be collected at the 4 cardinal point (CP1-CP4) at what is believed to be the outer edge of the release area. Samples will be collected at 1' below grade surface (bgs) or when auger and or backhoe refusal is encountered. If a sample point is determined to be impacted by the release, a new sample will be collected moving out further until an area without impaction is located. Once located, samples will be taken to collaborate the impaction path to the next sample point in the sequence. Due to the nature of the release (produced water), the vertical delineation soil samples will be analyzed for Benzene, BTEX, TPH extended (Chlorides for documentation). All samples will be sent to a NMOCD approved laboratory for analysis.

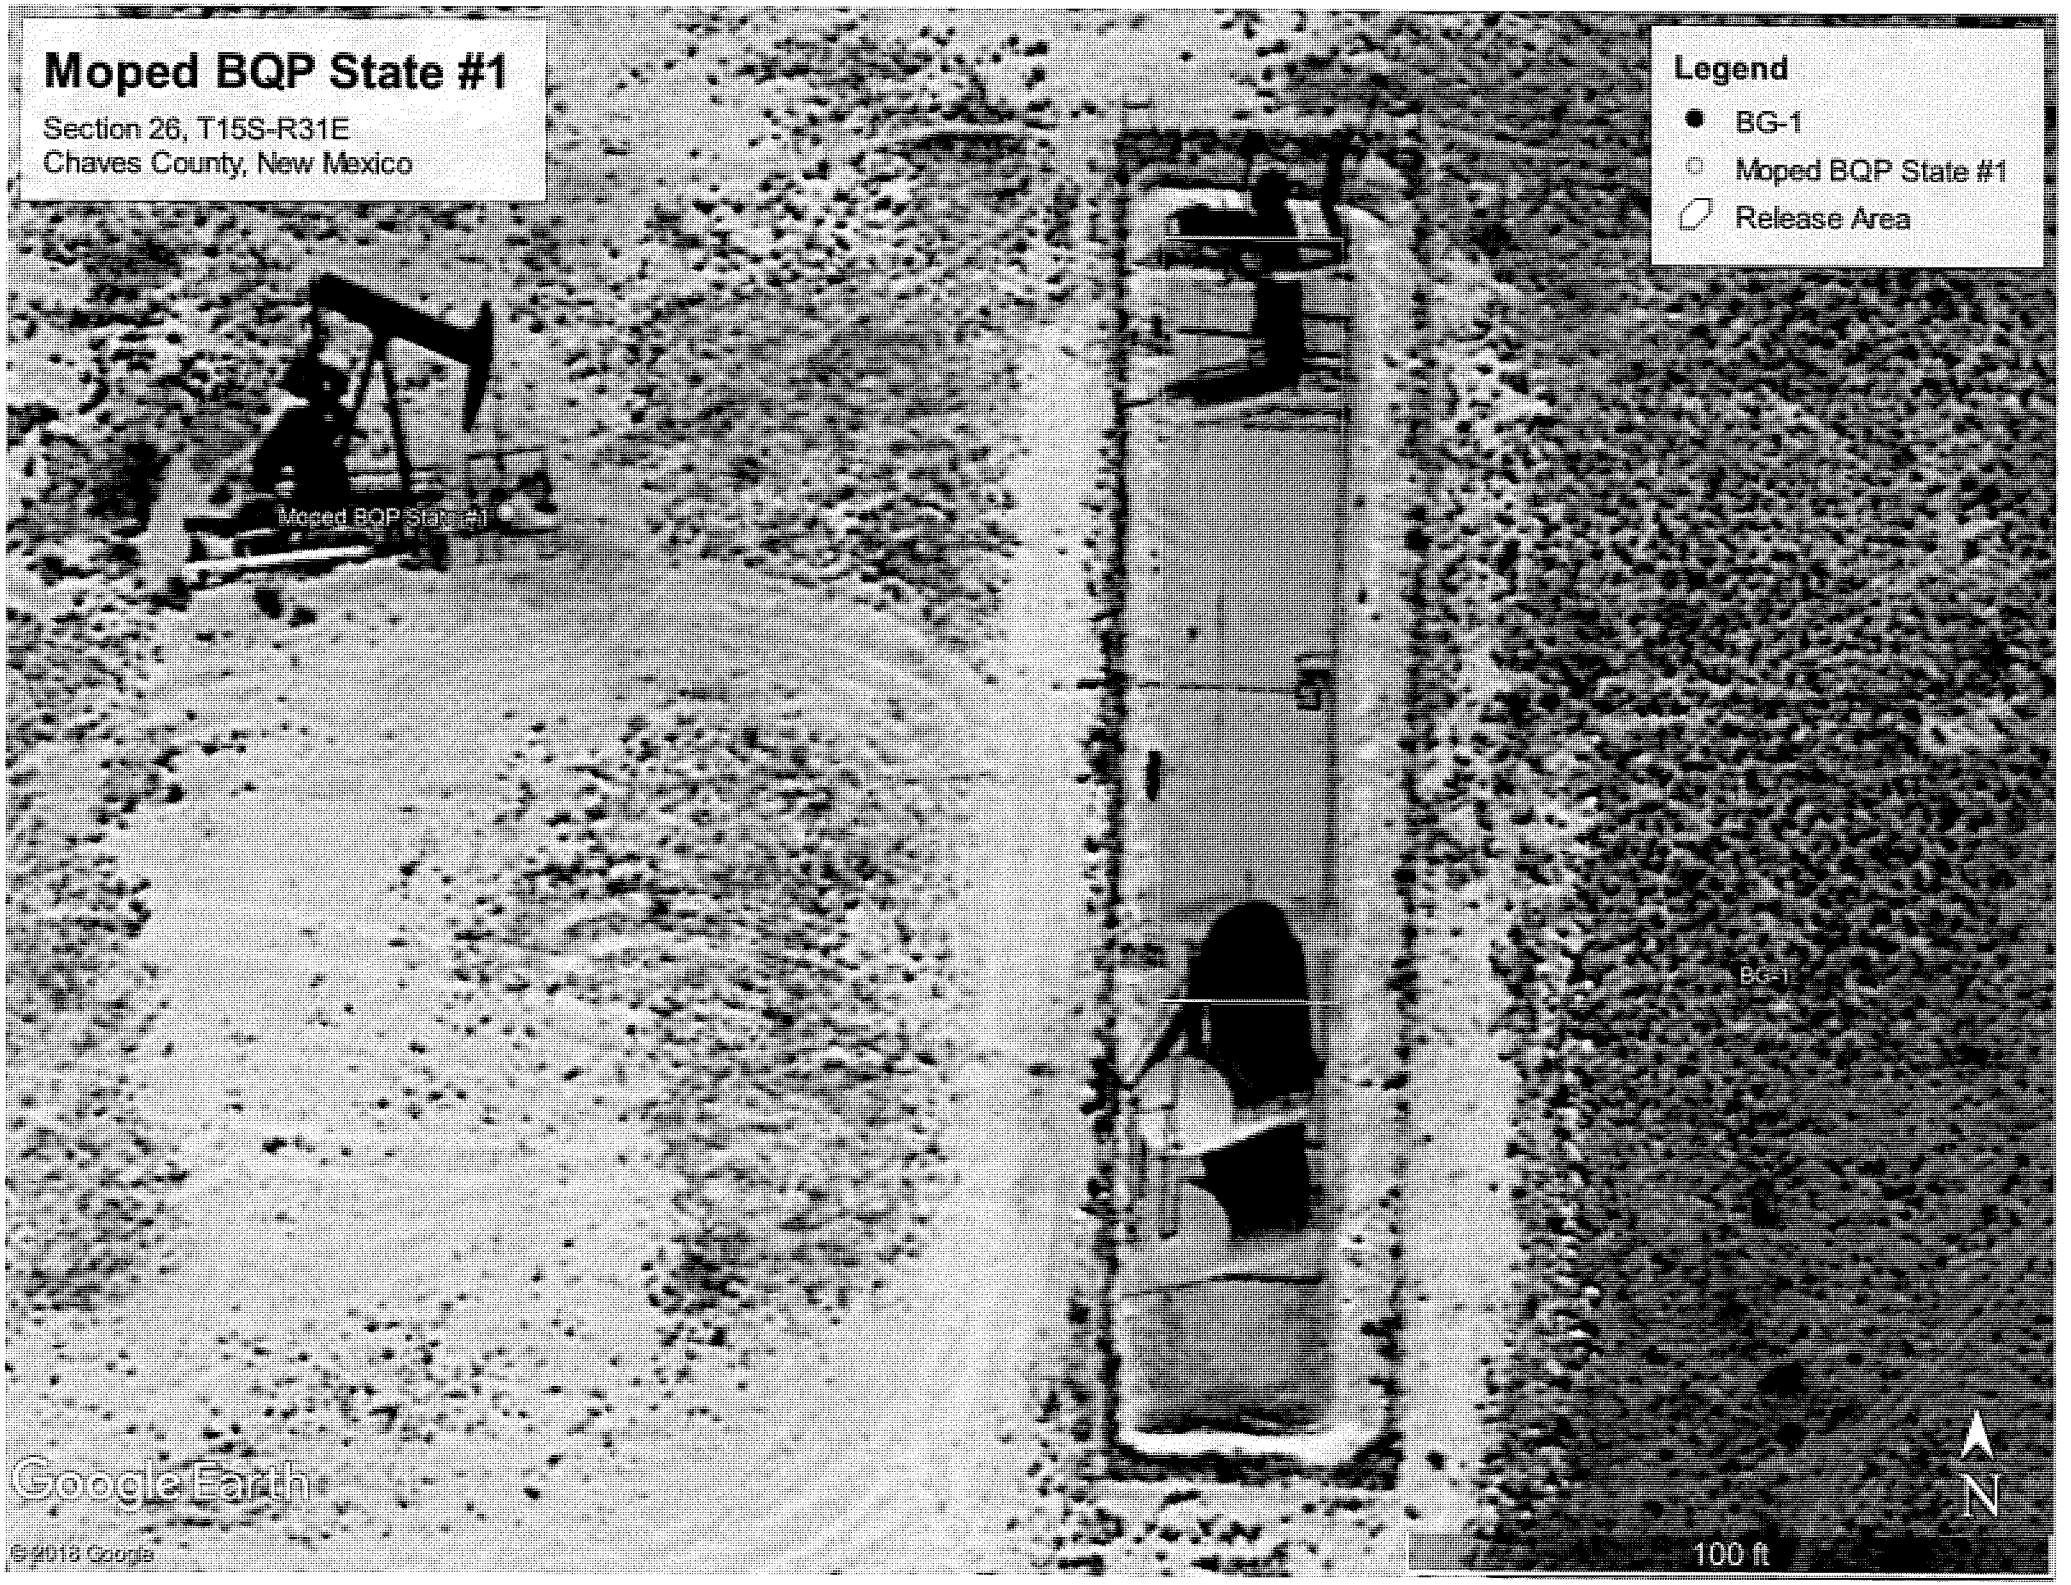
Figure 4

As a baseline for all sampling analytical data, a background sample (BG-1) will be collected east of the battery.

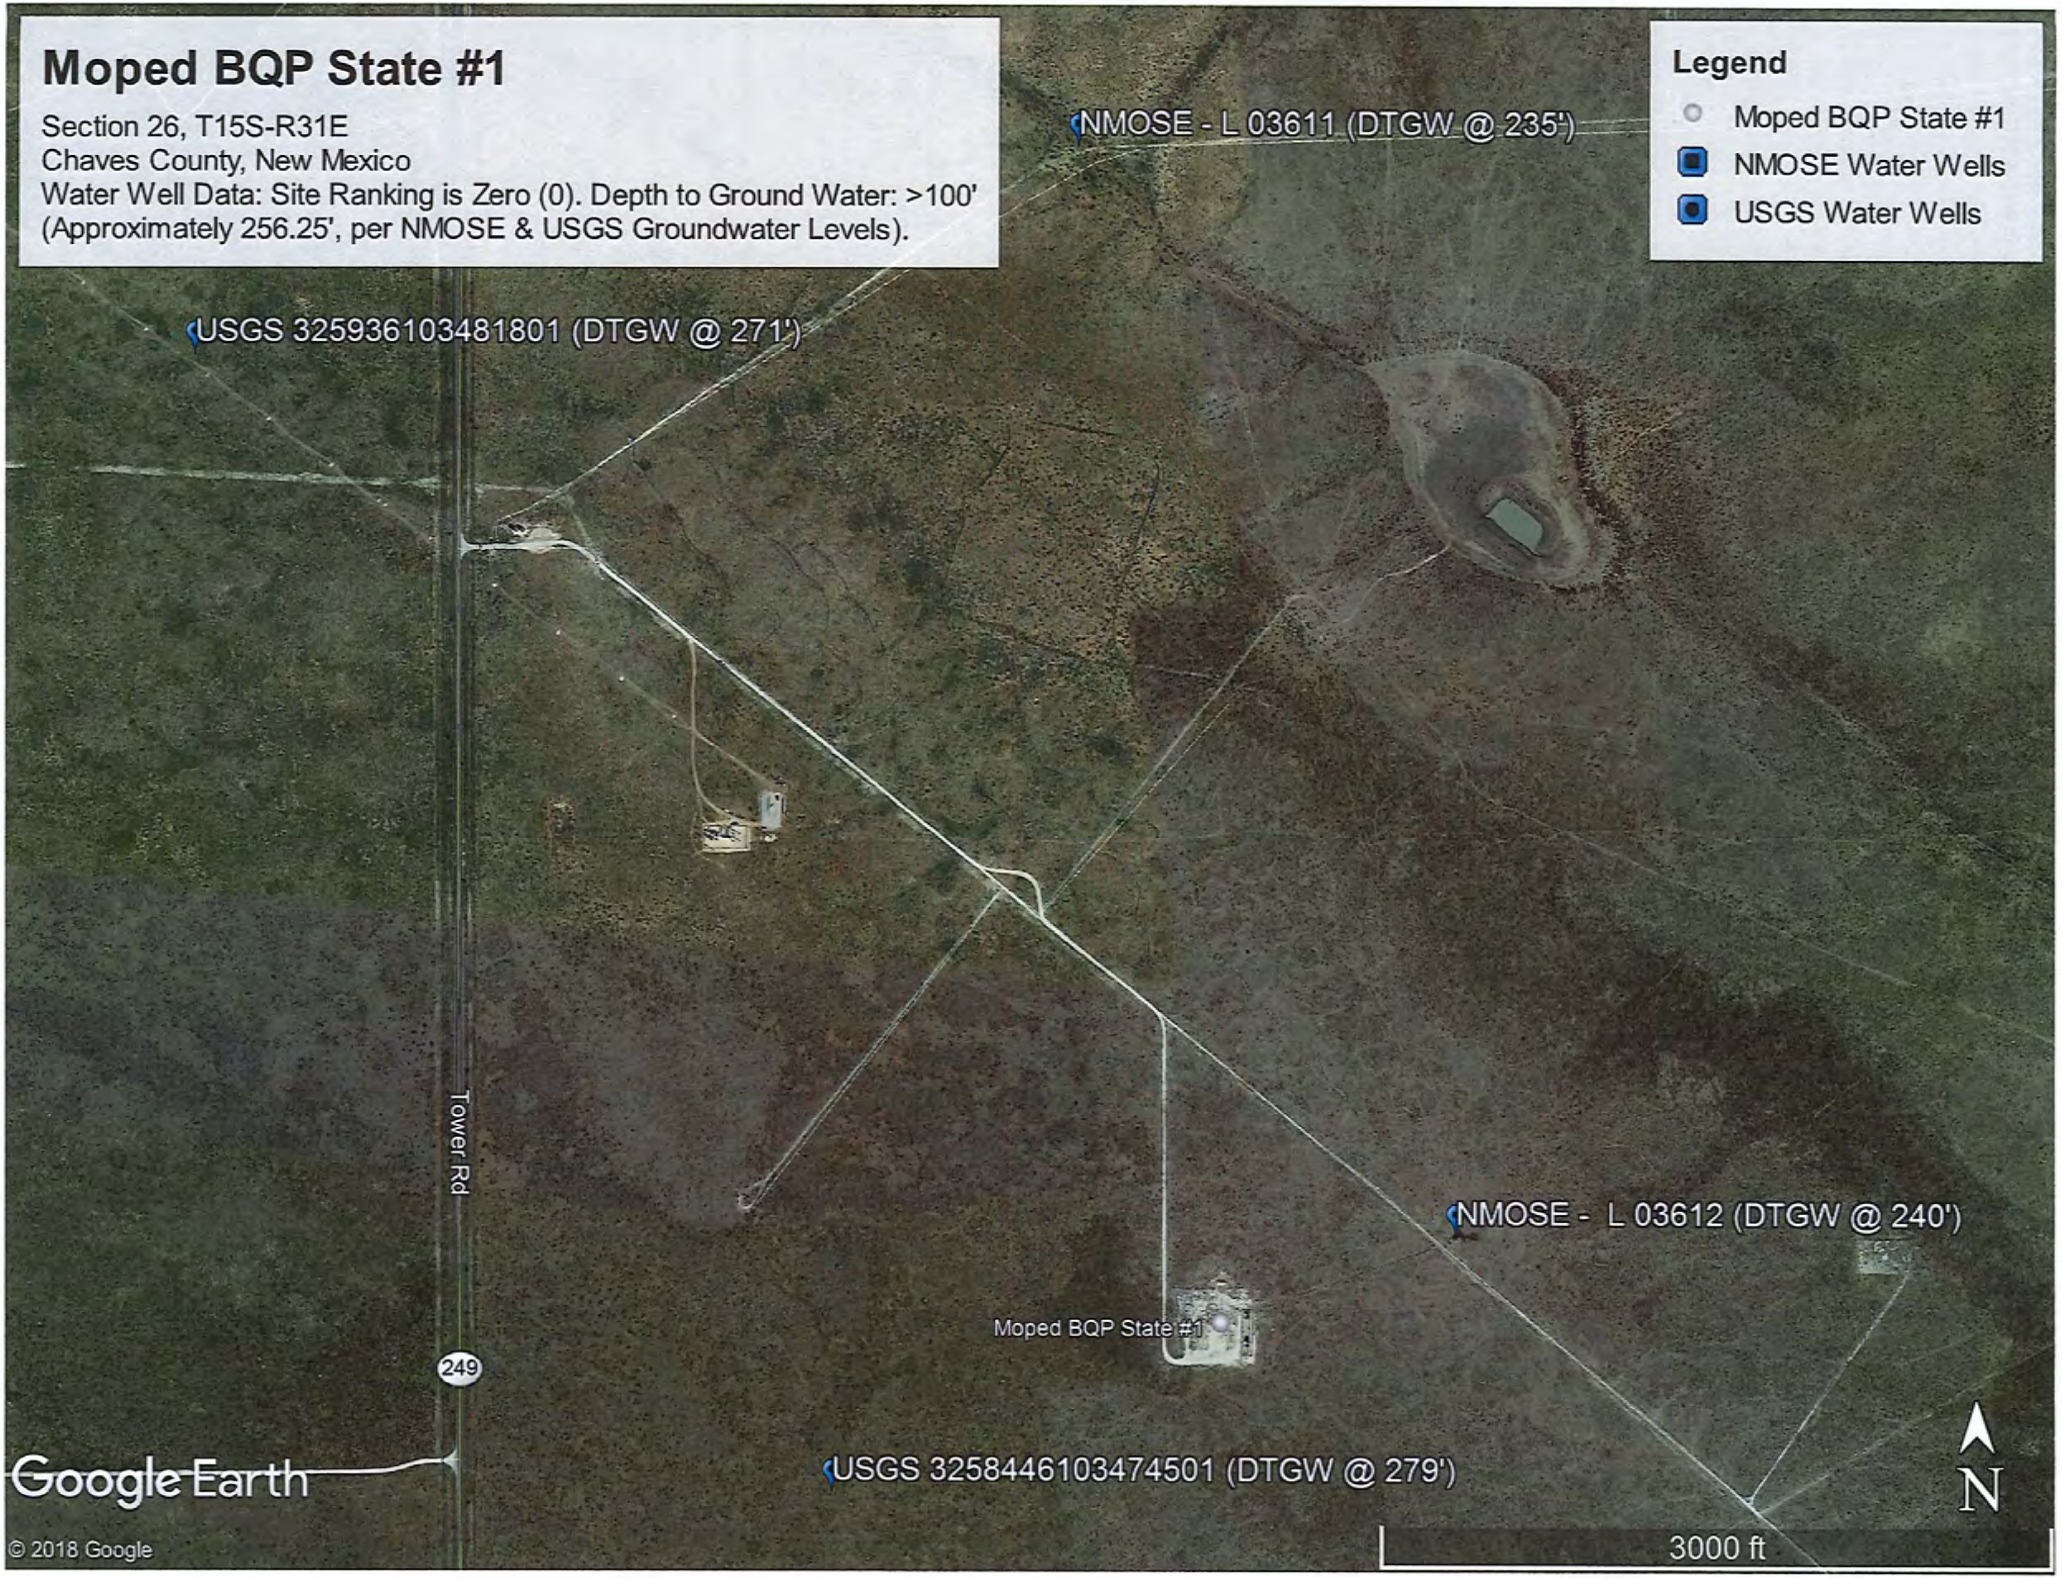
Water Well Date Site Map

Area surface geology is Paleozoic Permian. Based on information regarding this location (Section 26, T15S-R31E), the New Mexico Office of the State Engineer (NMOSE) database depth to groundwater is follows: (NMOSE-L03611, DTGW @ 235' & NMOSE – L03612, DTGW @ 240'), the United States Geological Survey National Water Information System, is as follows: (USGS #325936103481801, DTGW @ 271' & USGS #3258446103474501, DTGW @ 279'). The depth to groundwater is >100', per USGS and NMOSE groundwater level. **Based on this information the Site Ranking is a Zero (0).**

Moped BQP State #1
Section 26, T15S-R31E
Chaves County, New Mexico
Water Well Data: Site Ranking is Zero (0). Depth to Ground Water: >100'
(Approximately 256.25', per NMOSE & USGS Groundwater Levels).
Legend
Moped BQP State #1
NMOSE Water Wells
USGS Water Wells
NMOSE - L 03611 (DTGW @ 235')
USGS 325936103481801 (DTGW @ 271')
Tower Rd
249
NMOSE - L 03612 (DTGW @ 240')
Moped BQP State #1
USGS 3258446103474501 (DTGW @ 279')
Google Earth
© 2018 Google
N
3000 ft
