WELL API NO. 30-025-26681

7. Lease Name or Unit Agreement Name: EAST VACUUM GB-SA UNIT TRACT 3333

EVGSAU 3333-006W
API #30-025-26681
Failed MIT – Resin Job

Project Scope and Procedure

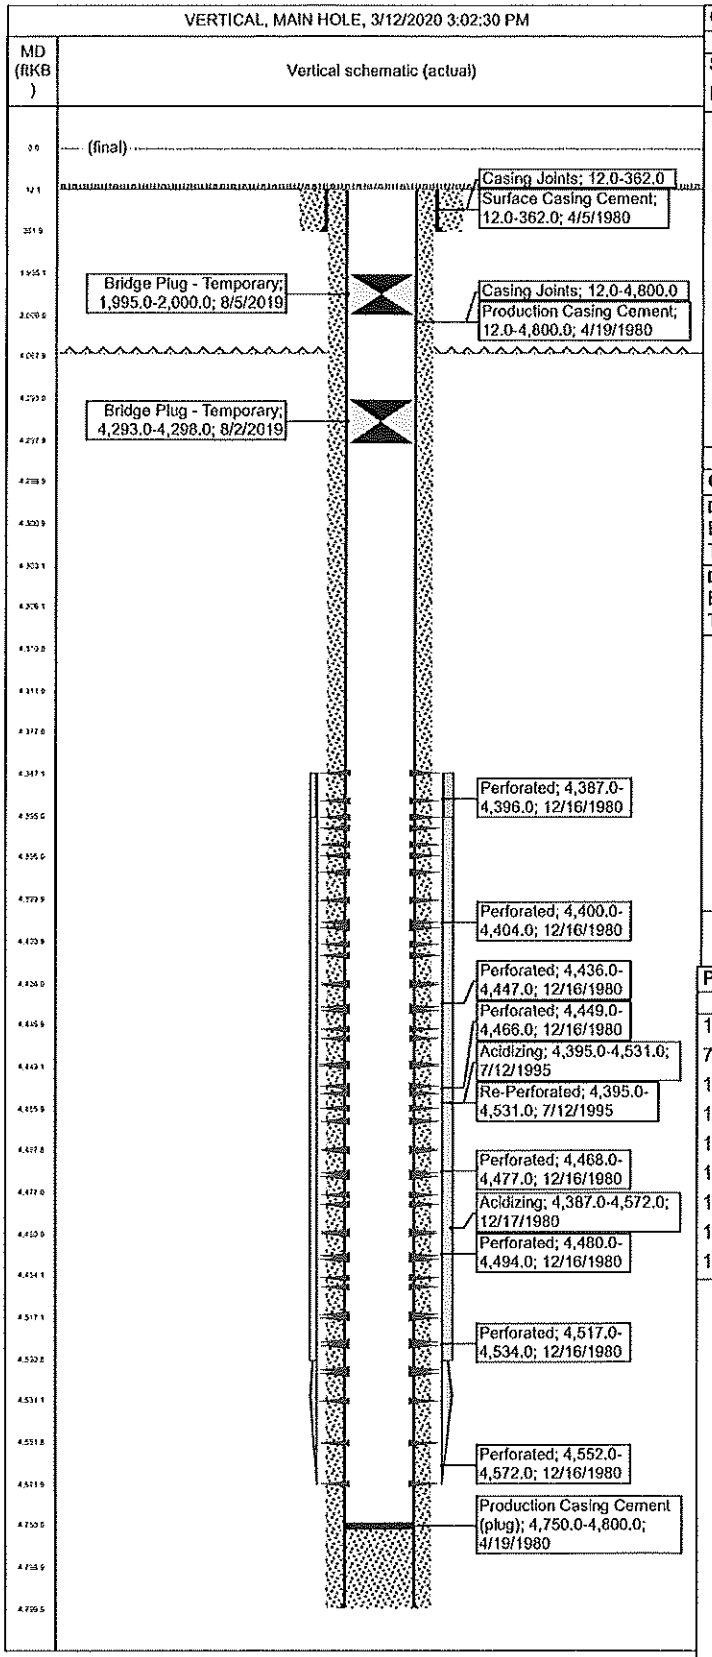
Current Schematic
EAST VACUUM GB-SA UNIT 3333-006W
3002526681

EVGSAU 3333-006W Failed an MIT 2/20 (fluid seen at the braden head) and has a hole in casing at ~25' (at or near casing collar). This prepull covers setting a drillable plug and squeezing the leak with resin; will then drill out the resin and plug, remove RBPs, and run tubing and return to injection. Using resin due to low leak off rate observed; resin has ability to go through low permeability path such as the collar.

7/30/19-8/9/19 Removed packer/tubing and set RBPs at 4298' and 2000'. Isolated leak at ~29', however, were unable to establish rate down production casing. Attempted to establish rate down the rise, however, the production casing collapsed at ~4' below ground, below the flange on 5.5" x 8-5/8" casing. Rigged off and surface projects dug and cut top 8' of production casing.
9/10/19 Ran 40-arm caliper and confirmed leak at ~25'
1/29/20 Pressured up to 500 psi 4 times, and all bled off to 200 psi within 1 min.
