State of New Mexico
Energy, Minerals and Natural Resources Department
Oil Conservation Division Hobbs District Office

BRADENHEAD TEST REPORT

Operator Name	API Number
Cross Timbers Energy, LLC	30-025-26512
Property Name	**Well No.**
Southeast Maljamar GA/SA Unit	105

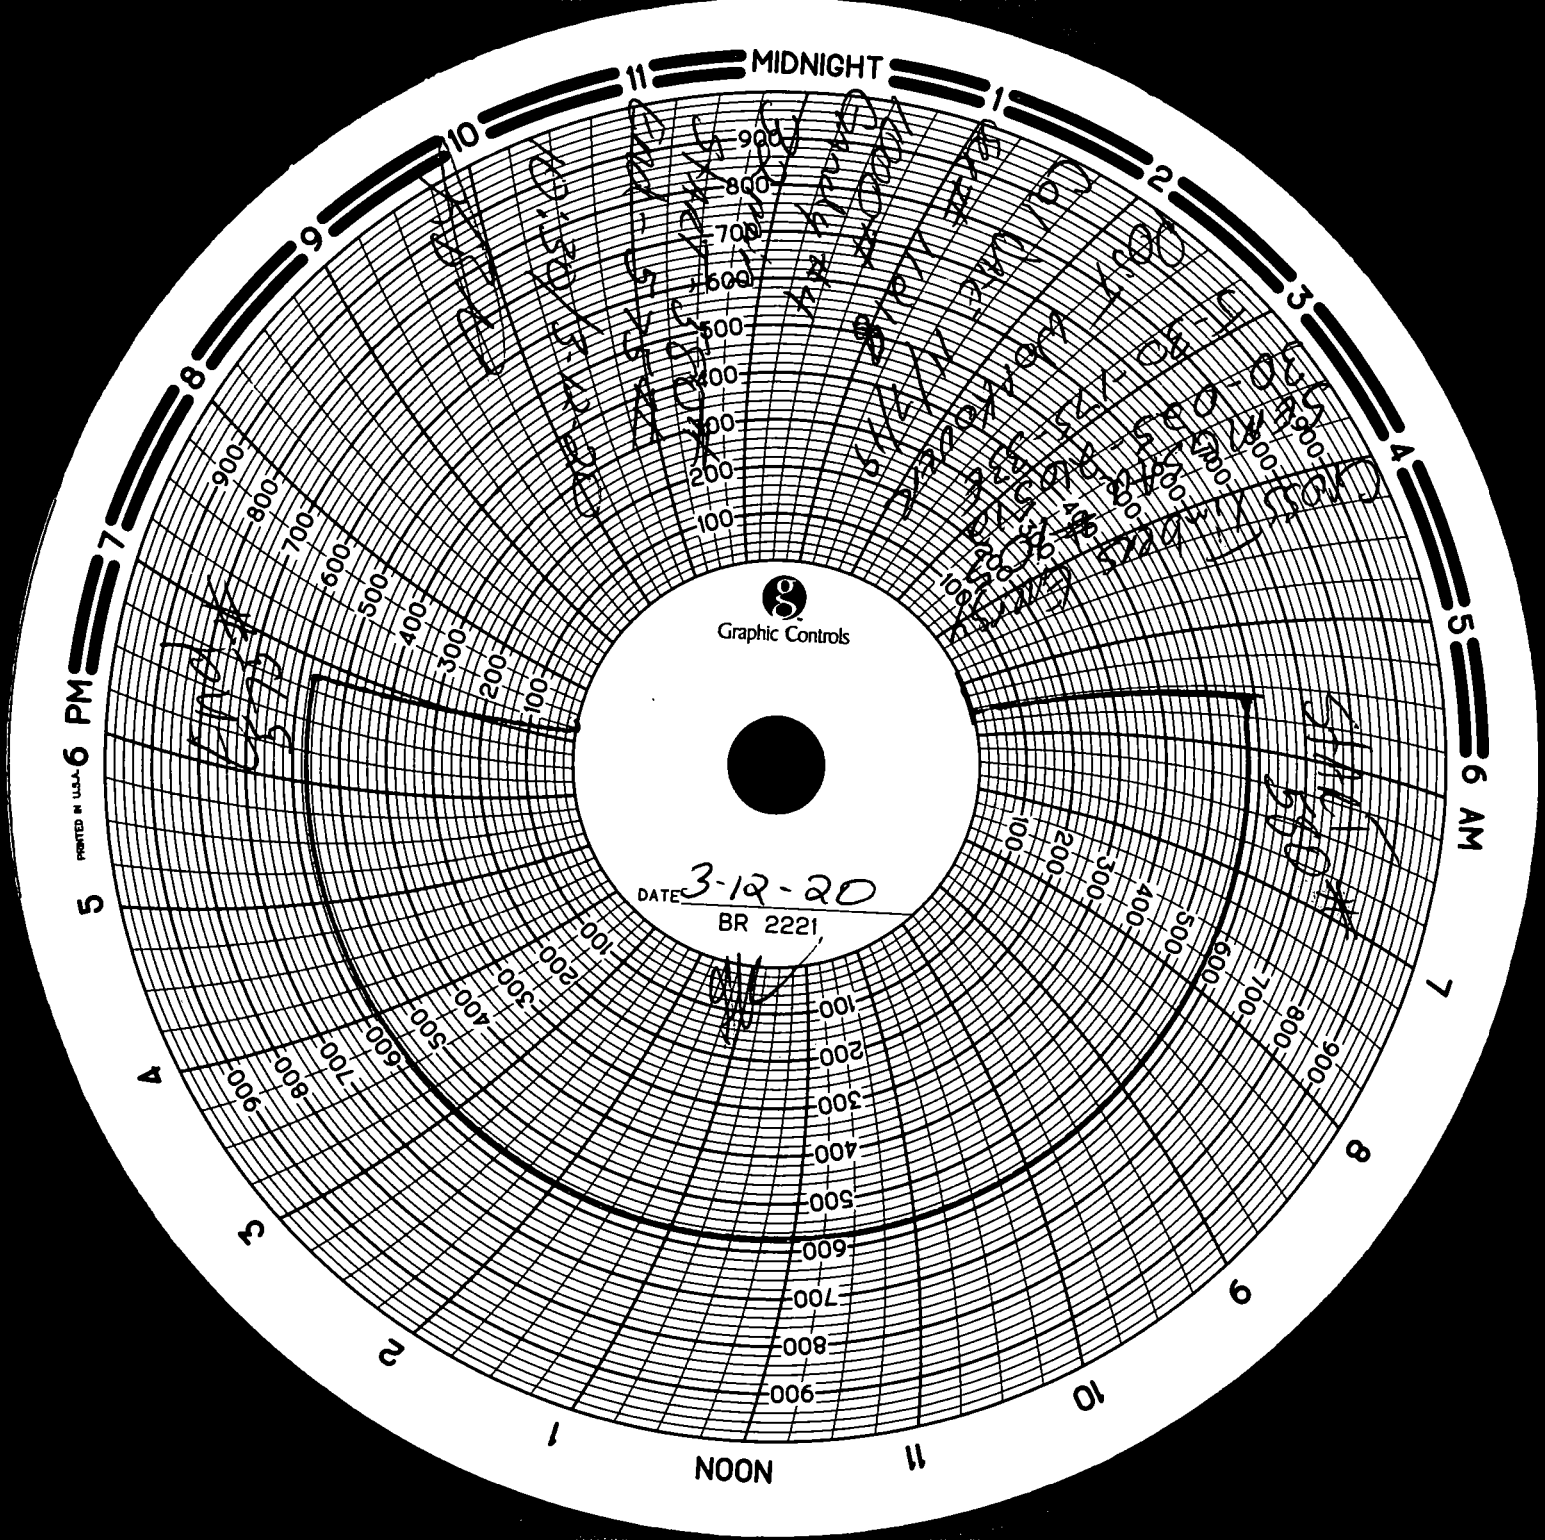
MIDNIGHT
NOON
6 PM
6 AM
Graphic Controls
DATE 3-12-20
BR 2221
PRINTED IN U.S.A.

Post Workover

Start - 580#
End - 575#
Cal Date - 11/7/19
Ser# 11216
Gandy #4 1000# 32 min
