Pit or Below-Grade Tank Registration or Closure

Operator: Chi Operating Energy Telephone: (505) 628-3447 e-mail address: dorseyrogers@aol.com
Address: 1101 North Big Spring Rd. Carlsbad N.M. 88220.
Facility or well name: Scout 18 Fed #3 API #: 30-025-37681 U/L or Qtr/Qtr O Sec 18 T 19S R 34E
County: Lea Co N.M. Latitude N 32° 39' 17.1 Longitude 103° 35' 51.1" NAD: 1927 ☐ 1983 ☐
Surface Owner: Federal ☑ State ☐ Private ☐ Indian ☐

Reserve Pit Remediation

SURFACE PIT CLOSURE PLAN

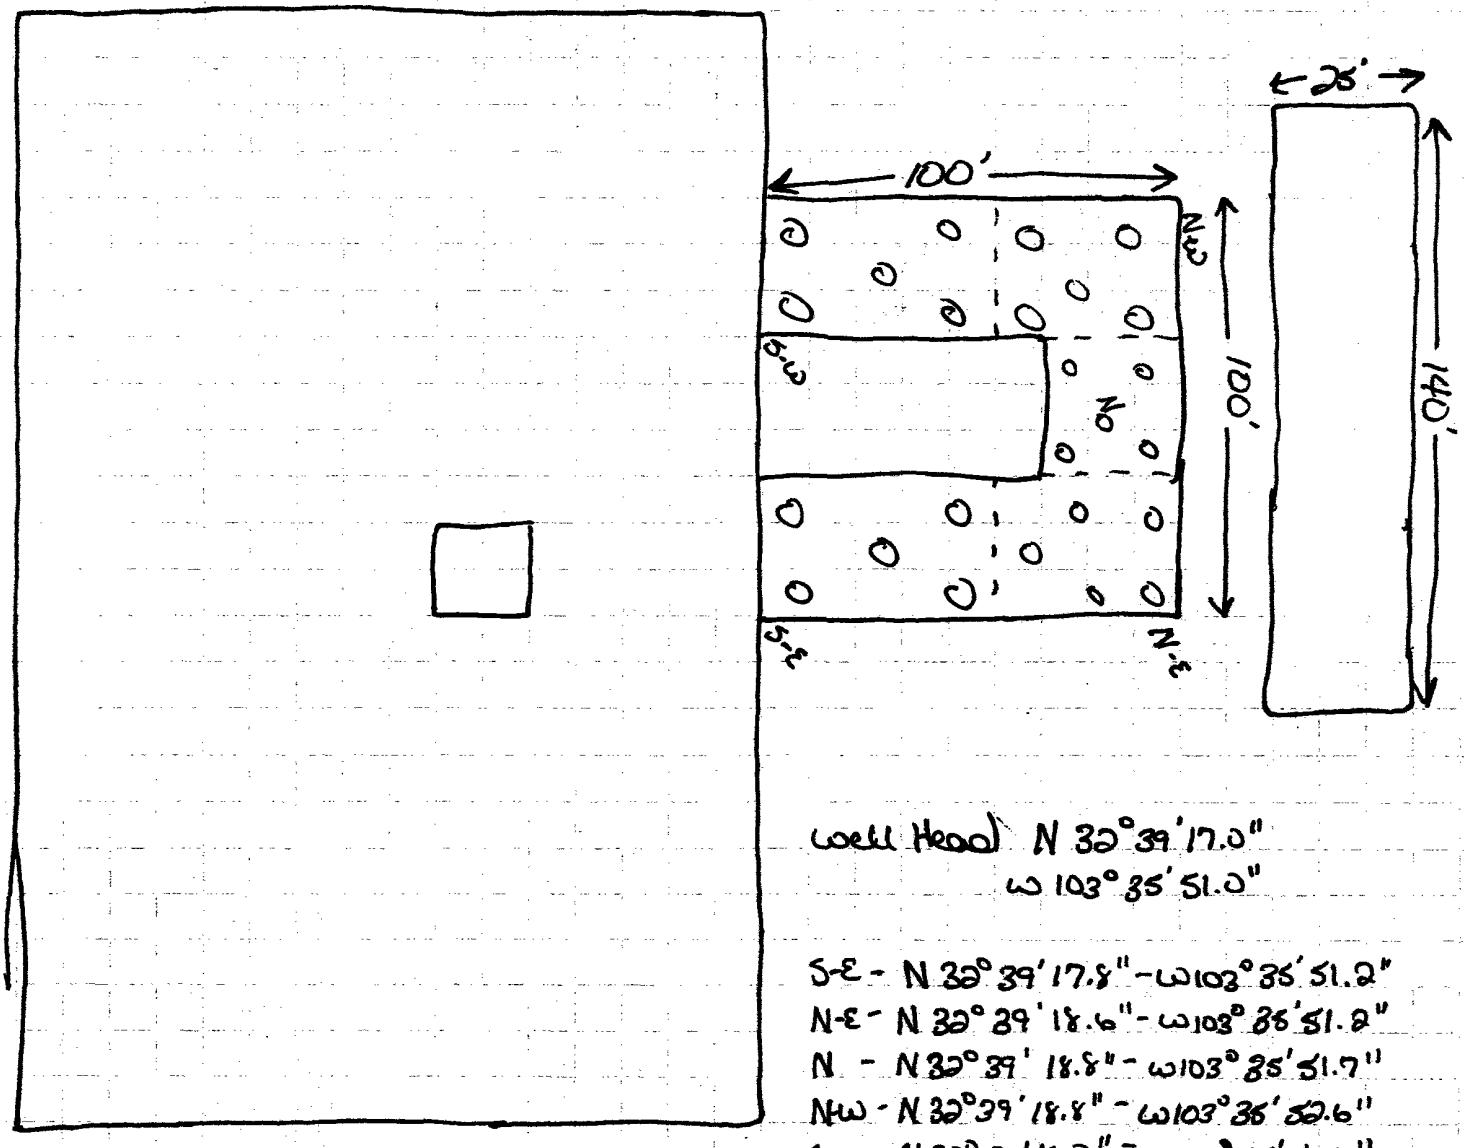
Cimarex Scout 18 fed #5 1600' fsl & 2030 fel.

Well Head N 32° 39' 17.0"
W 103° 35' 51.0"

S-E - N 32° 39' 17.8" - W 103° 35' 51.2"
N-E - N 32° 39' 18.6" - W 103° 35' 51.2"
N - N 32° 39' 18.8" - W 103° 35' 51.7"
NW - N 32° 39' 18.8" - W 103° 35' 52.6"
S-W - N 32° 39' 18.0" - W 103° 35' 52.6"

Tomb: N 32° 39' 19.5"
W 103° 35' 51.7"
