**RE: LINER INSPECTION REPORT  
THISTLE UNIT 109H**

Souder, Miller & Associates (SMA) is pleased to submit this letter report on behalf of Devon Energy Production Company (Devon) summarizing the liner inspection that occurred at the Thistle Unit 22 BS Central Tank Battery (CTB) release that is associated with the Thistle Unit 109H well. The site is located in Unit Letter: B & C in Section 22, T23S, R33E (N32.295239/W-103.560141) Lea County, New Mexico, on BLM land.

Devon Energy Production Company  
Thistle Unit 109H

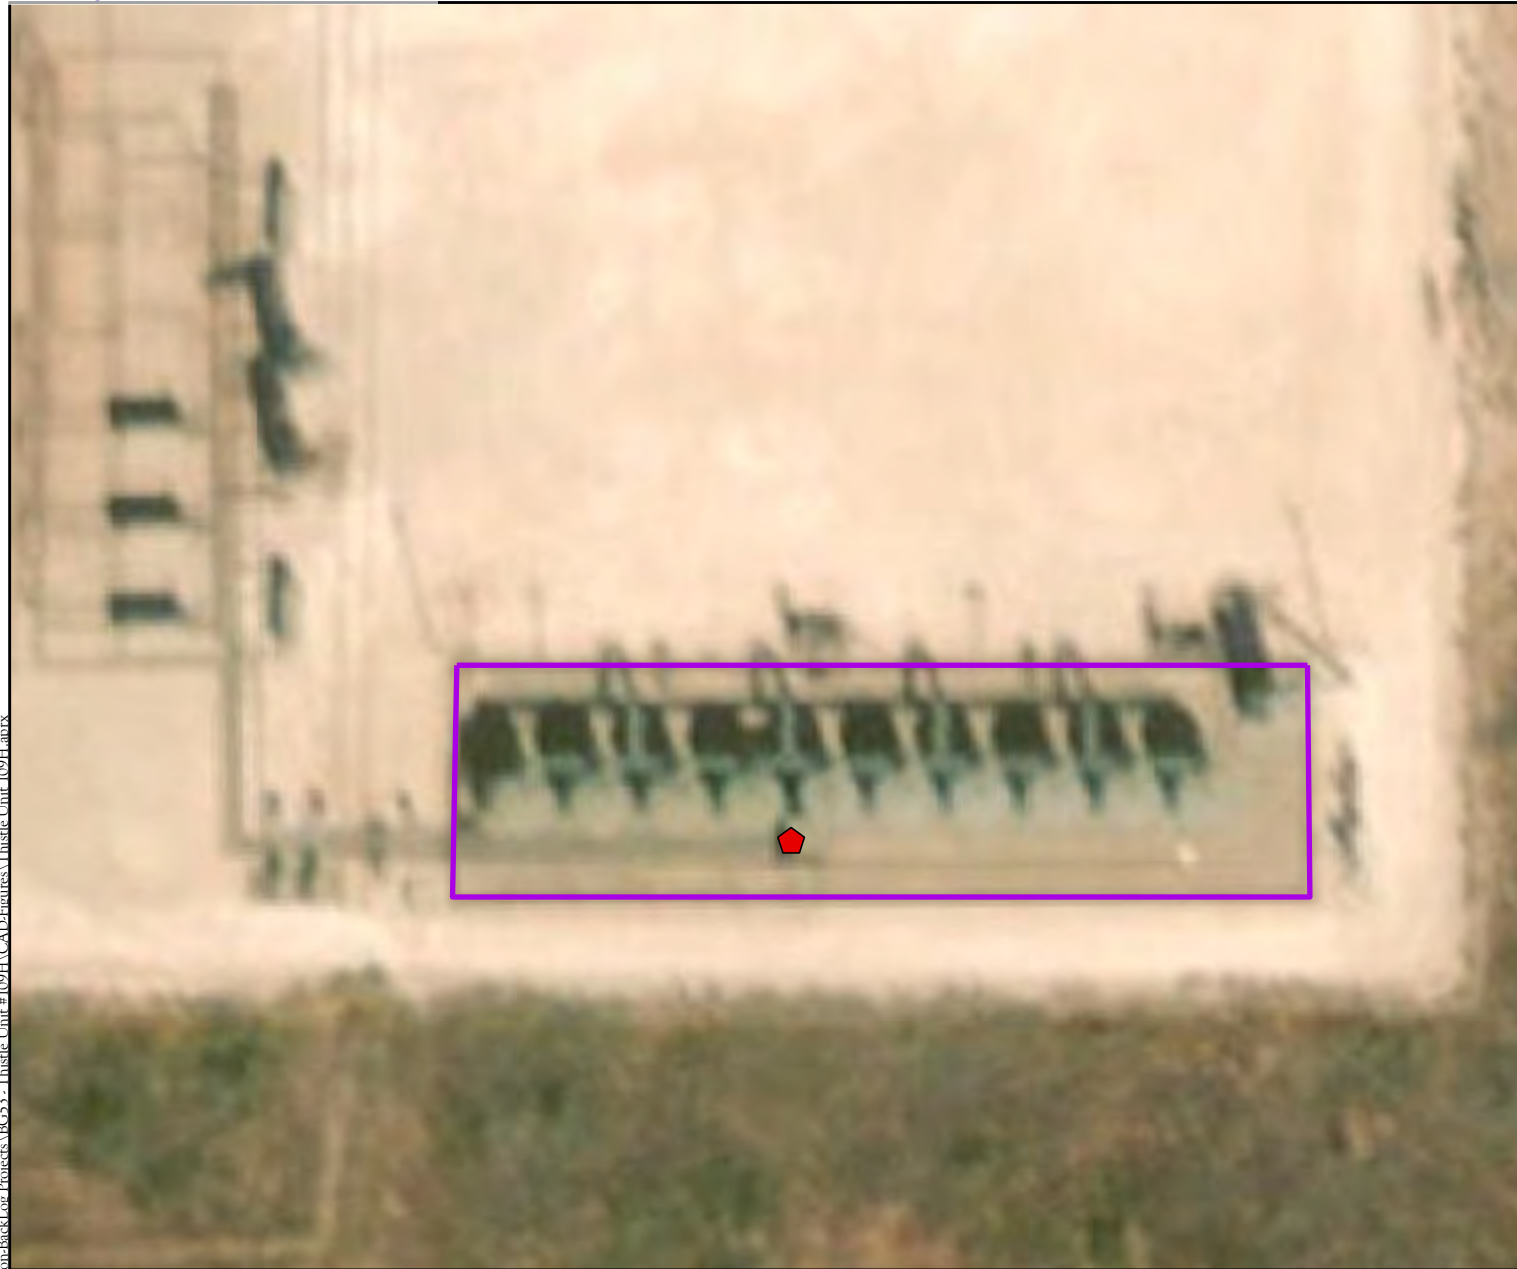
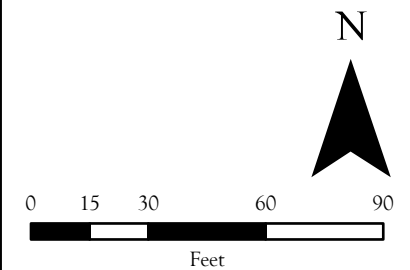
Based upon New Mexico Office of the State Engineer (NMOSE) the average depth to groundwater in the area is estimated to be 341 feet below grade surface (bgs). There are no water sources within ½-mile of the location, according to the NMOSE and USGS water well databases ([https://gis.ose.state.nm.us/gisapps/ose\\_pod\\_locations/](https://gis.ose.state.nm.us/gisapps/ose_pod_locations/); accessed July 26, 2020; Appendix C). The nearest significant watercourse is an unnamed intermittent stream, located approximately 3,550 feet to the northeast. Figures 1 and 2 show the release location and surrounding hydrologic features. Figure 3 shows the location of the facility and the release.

Site and Sample Location Map  
 Thistle Unit 109H - Devon Energy Production Company  
 UL: B & C S: 22 T: 23S R: 33E Lea County, New Mexico
