Site Name Lybrook A12-2306 01H
Date Release Discovered 7/28/2018

RE: CONFIRMATION SAMPLING DOCUMENTATION FOR THE LYBROOK A12 2306 01H UNIT A WELL SITE, RIO ARRIBA COUNTY, NEW MEXICO

**SITE PHOTOGRAPHY
SPILL ASSESSMENT AND CLOSURE REPORT
ENCANA OIL AND GAS INC.
LYBROOK A12 2306 01H UNIT A
PROJECT NUMBER 11195-0228
AUGUST 2018**

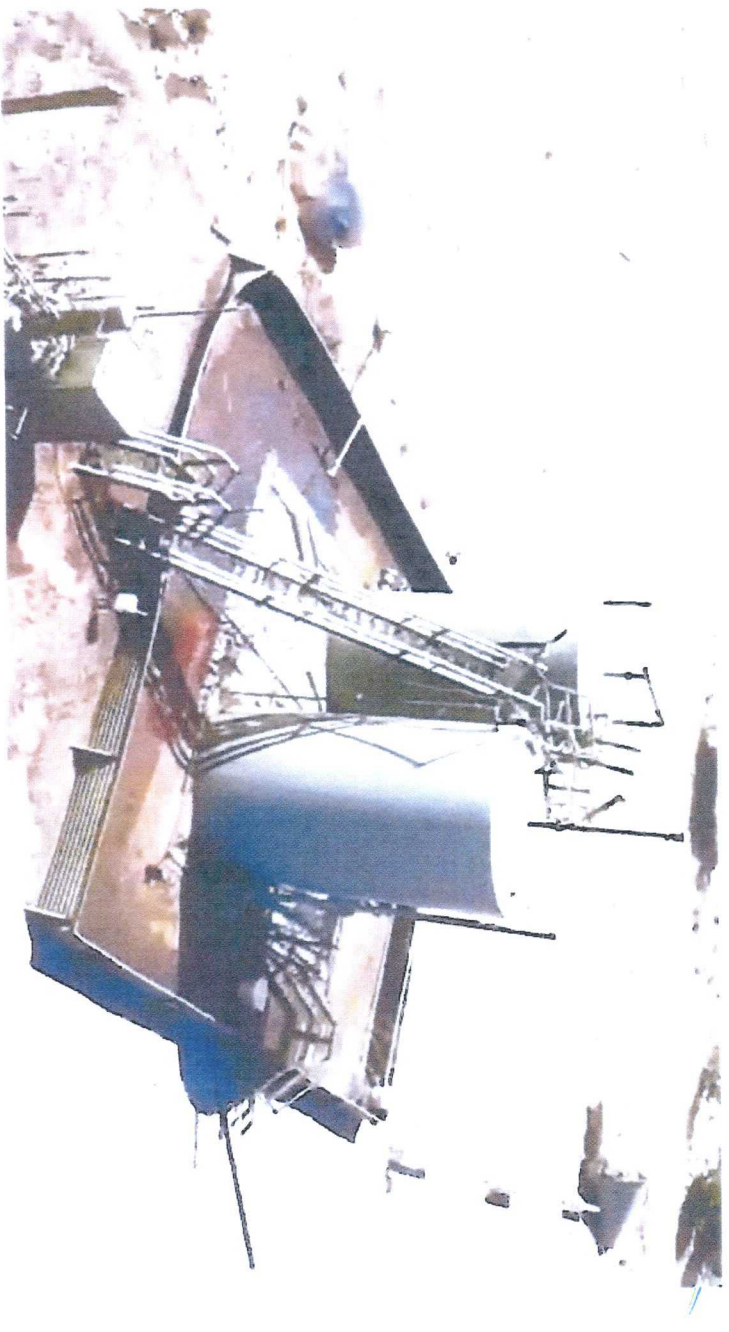
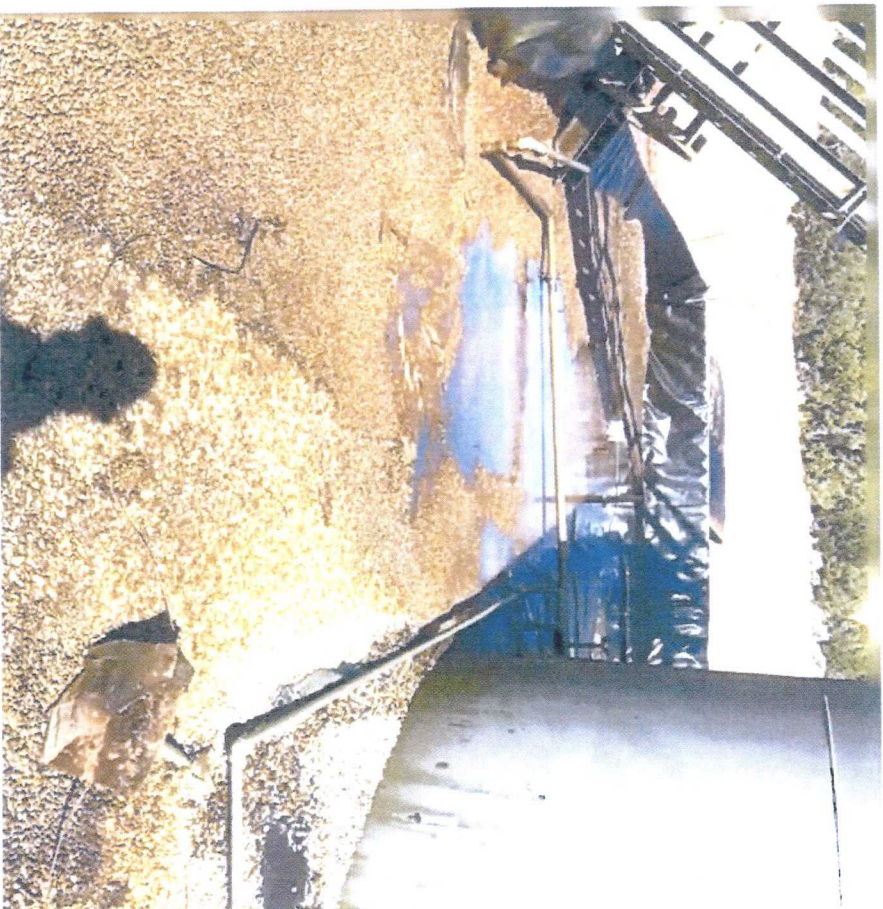
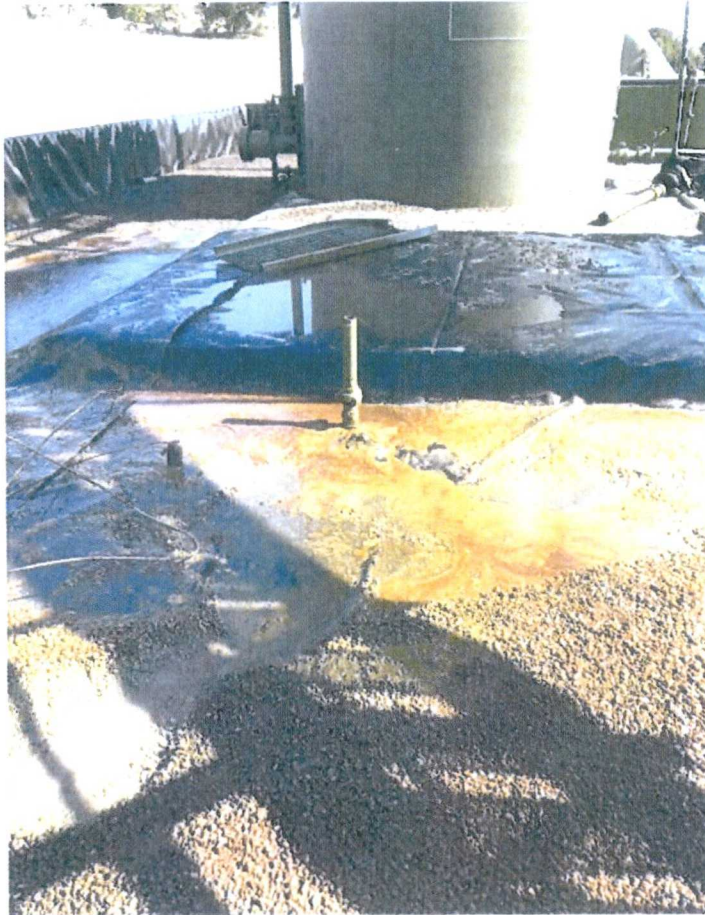
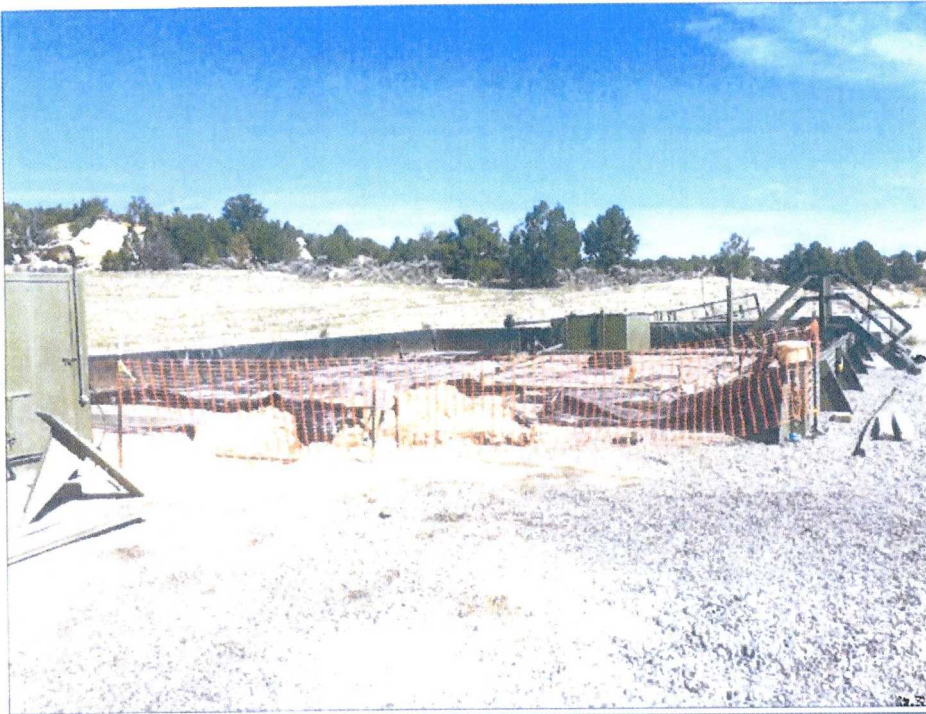
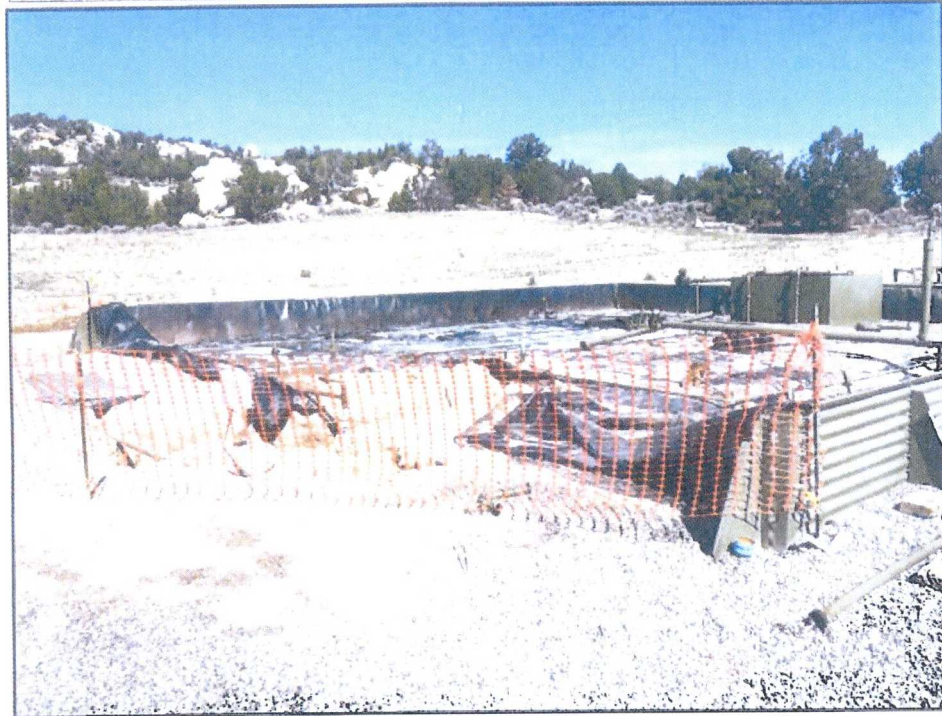
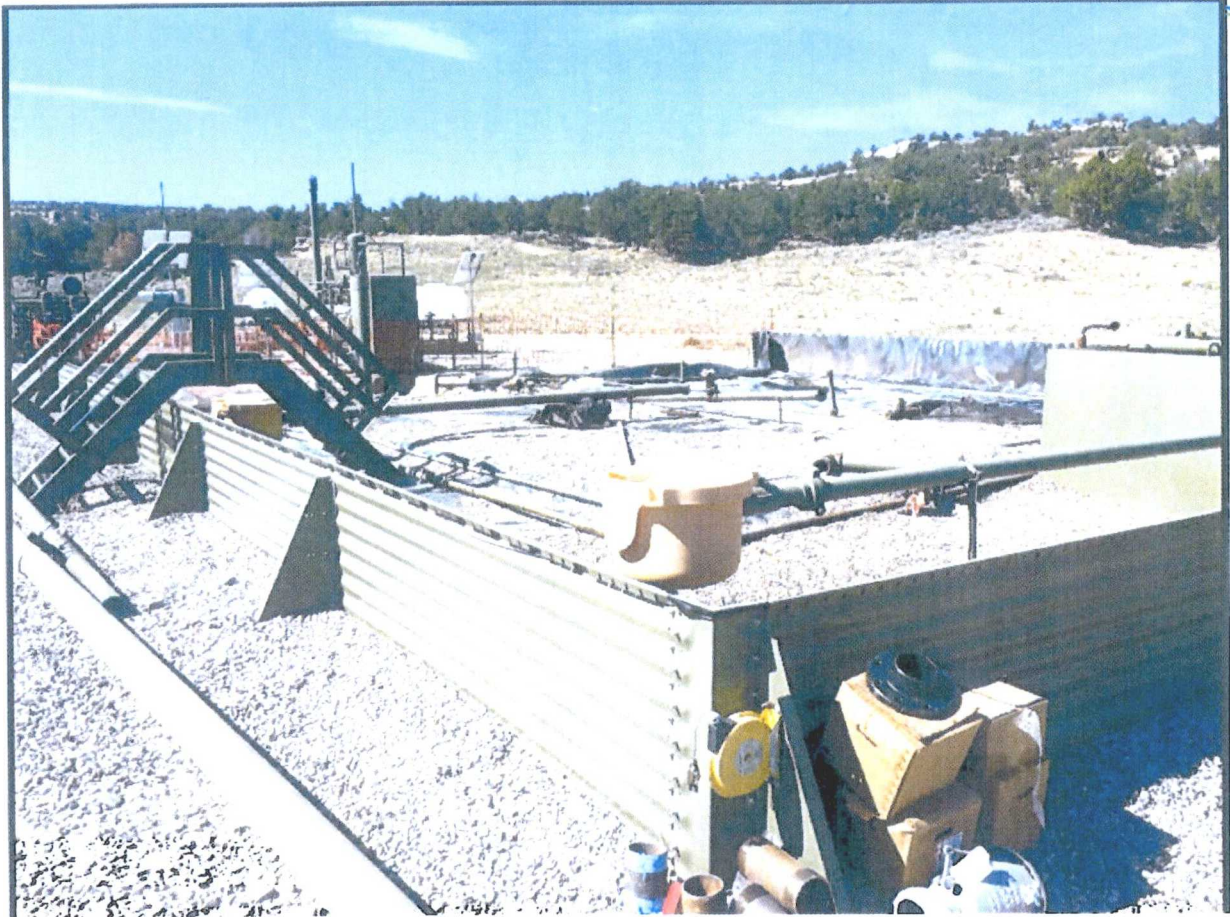
Photographs of Remediated Site prior to Clean Up

When the operator arrived at the Lybrook A12 facility on July 28 it appeared that there had been a lightning strike because the produced water tank was blown out of the containment and roughly 100 feet north of the containment. A vac truck was dispatched to the site the next day to recover liquid in the containment. The area of greatest impact was also bladed to turn the soil and ensure that impacted soil could volatilize clean. Additionally, Encana is working to repair the secondary containment that was blown out of shape due to the lightning.

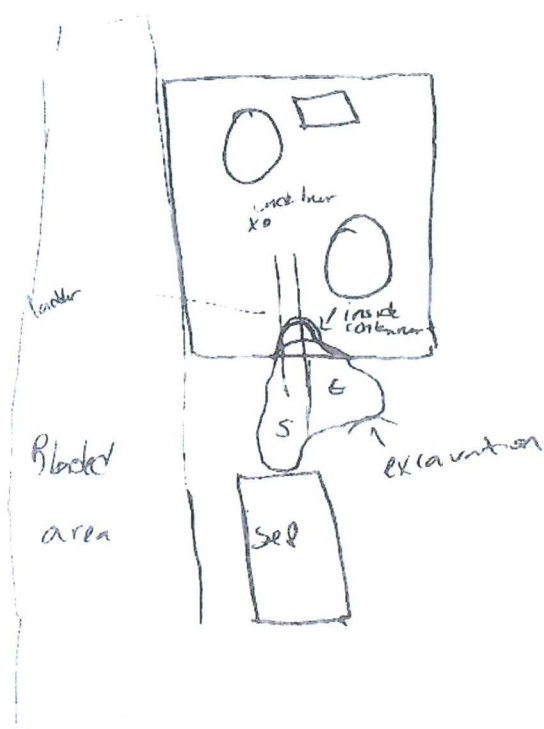
8/16/18 - Closure falls under new rule.

- Spt composite taken from east of ladder
- Spt composite taken from South of ladder
- Spt composite taken from inside containment
- Spt composite taken from blocker area
- 2pt composite from under liner (where hole was found)

S of ladder ~ 5' x 4' w x 1' to 2' deep

Inside containment ~ 6' long x 4' wide x 2" to 3' deep

Plans to be digging out piping to separator & removing/repairing damaged liner probably early next week

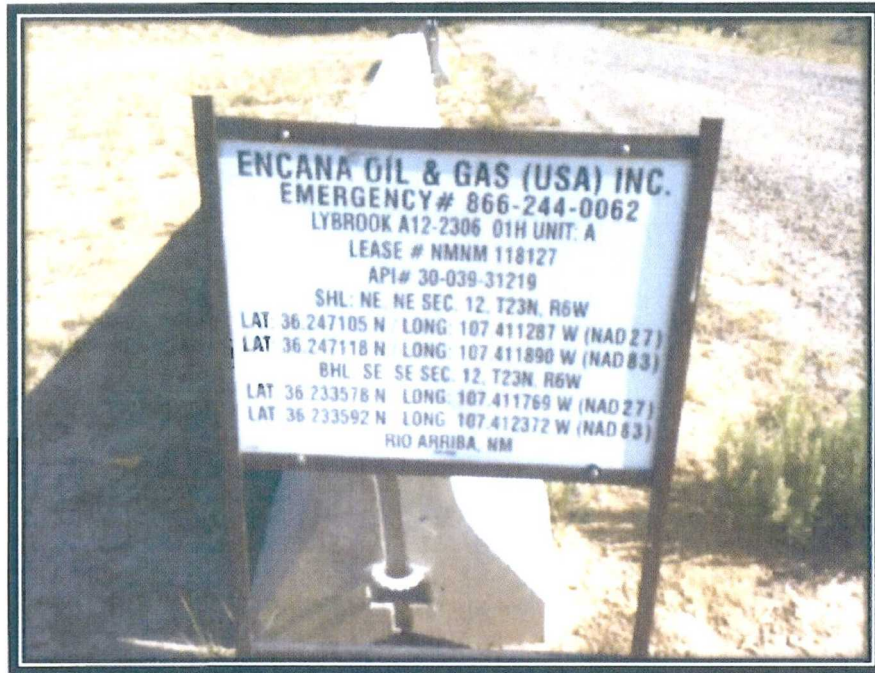
Picture 1: View of Wellsite Sign
