**Jimmy Cooper #6 Closure Report
Duke Energy Field Services
Lea County, New Mexico**

JIMMY COOPER #6 (JC#6)

Re: Removal of Hydrocarbon-Impacted Soils from the JC #6 site
Township 20 South, Range 37 East, Section 8, Unit O

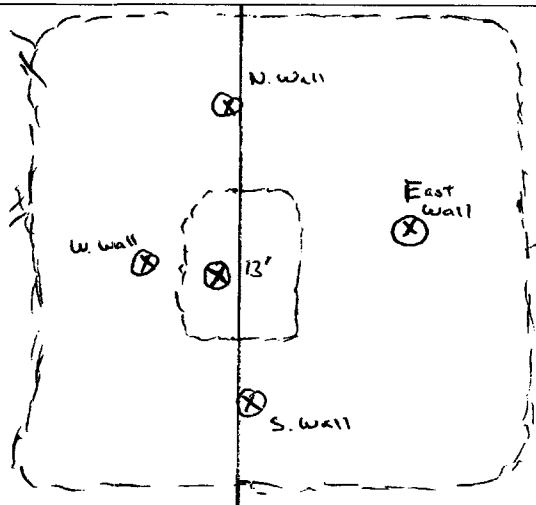
SUMMARY OF OVM, GRO, AND DRO CONCENTRATIONS WITH SAMPLE LOCATION MAP

Sample Location (Depth)	Sample Type	OVM (ppm)	GRO (mg/kg)	DRO (mg/kg)	Benzene (mg/kg)	BTEX (mg/kg)
Pipeline Source Area (surface)	Grab	118	105	133	<0.025	0.054
Floor (10 ft)	Grab	67	< 10	< 10	<0.025	<0.025
Floor (13 ft)	Grab	<1	< 10	< 10	< 10	< 10
West Wall (11 ft)	Grab	<1	< 10	< 10	< 10	< 10
East Wall (8 ft)	Grab	<1	< 10	< 10	< 10	< 10
South Wall (8 ft)	Grab	5	< 10	< 10	< 10	< 10
North Wall (8 ft)	Grab	1	< 10	< 10	< 10	< 10
NMOCD Guidelines		100	100	100	10	50
Samples in red type indicate concentrations above NMOCD guidelines.
