**1RP-5068
DELINEATION PLAN
Jal Cooper Unit #238
Produced Water Spill
Lea County, New Mexico**

LAI Project No. 18-0138-01

August 31, 2018

Prepared for:
Legacy Reserves Operating, LP
303 West Wall Street, Suite 1300
Midland, Texas 79701

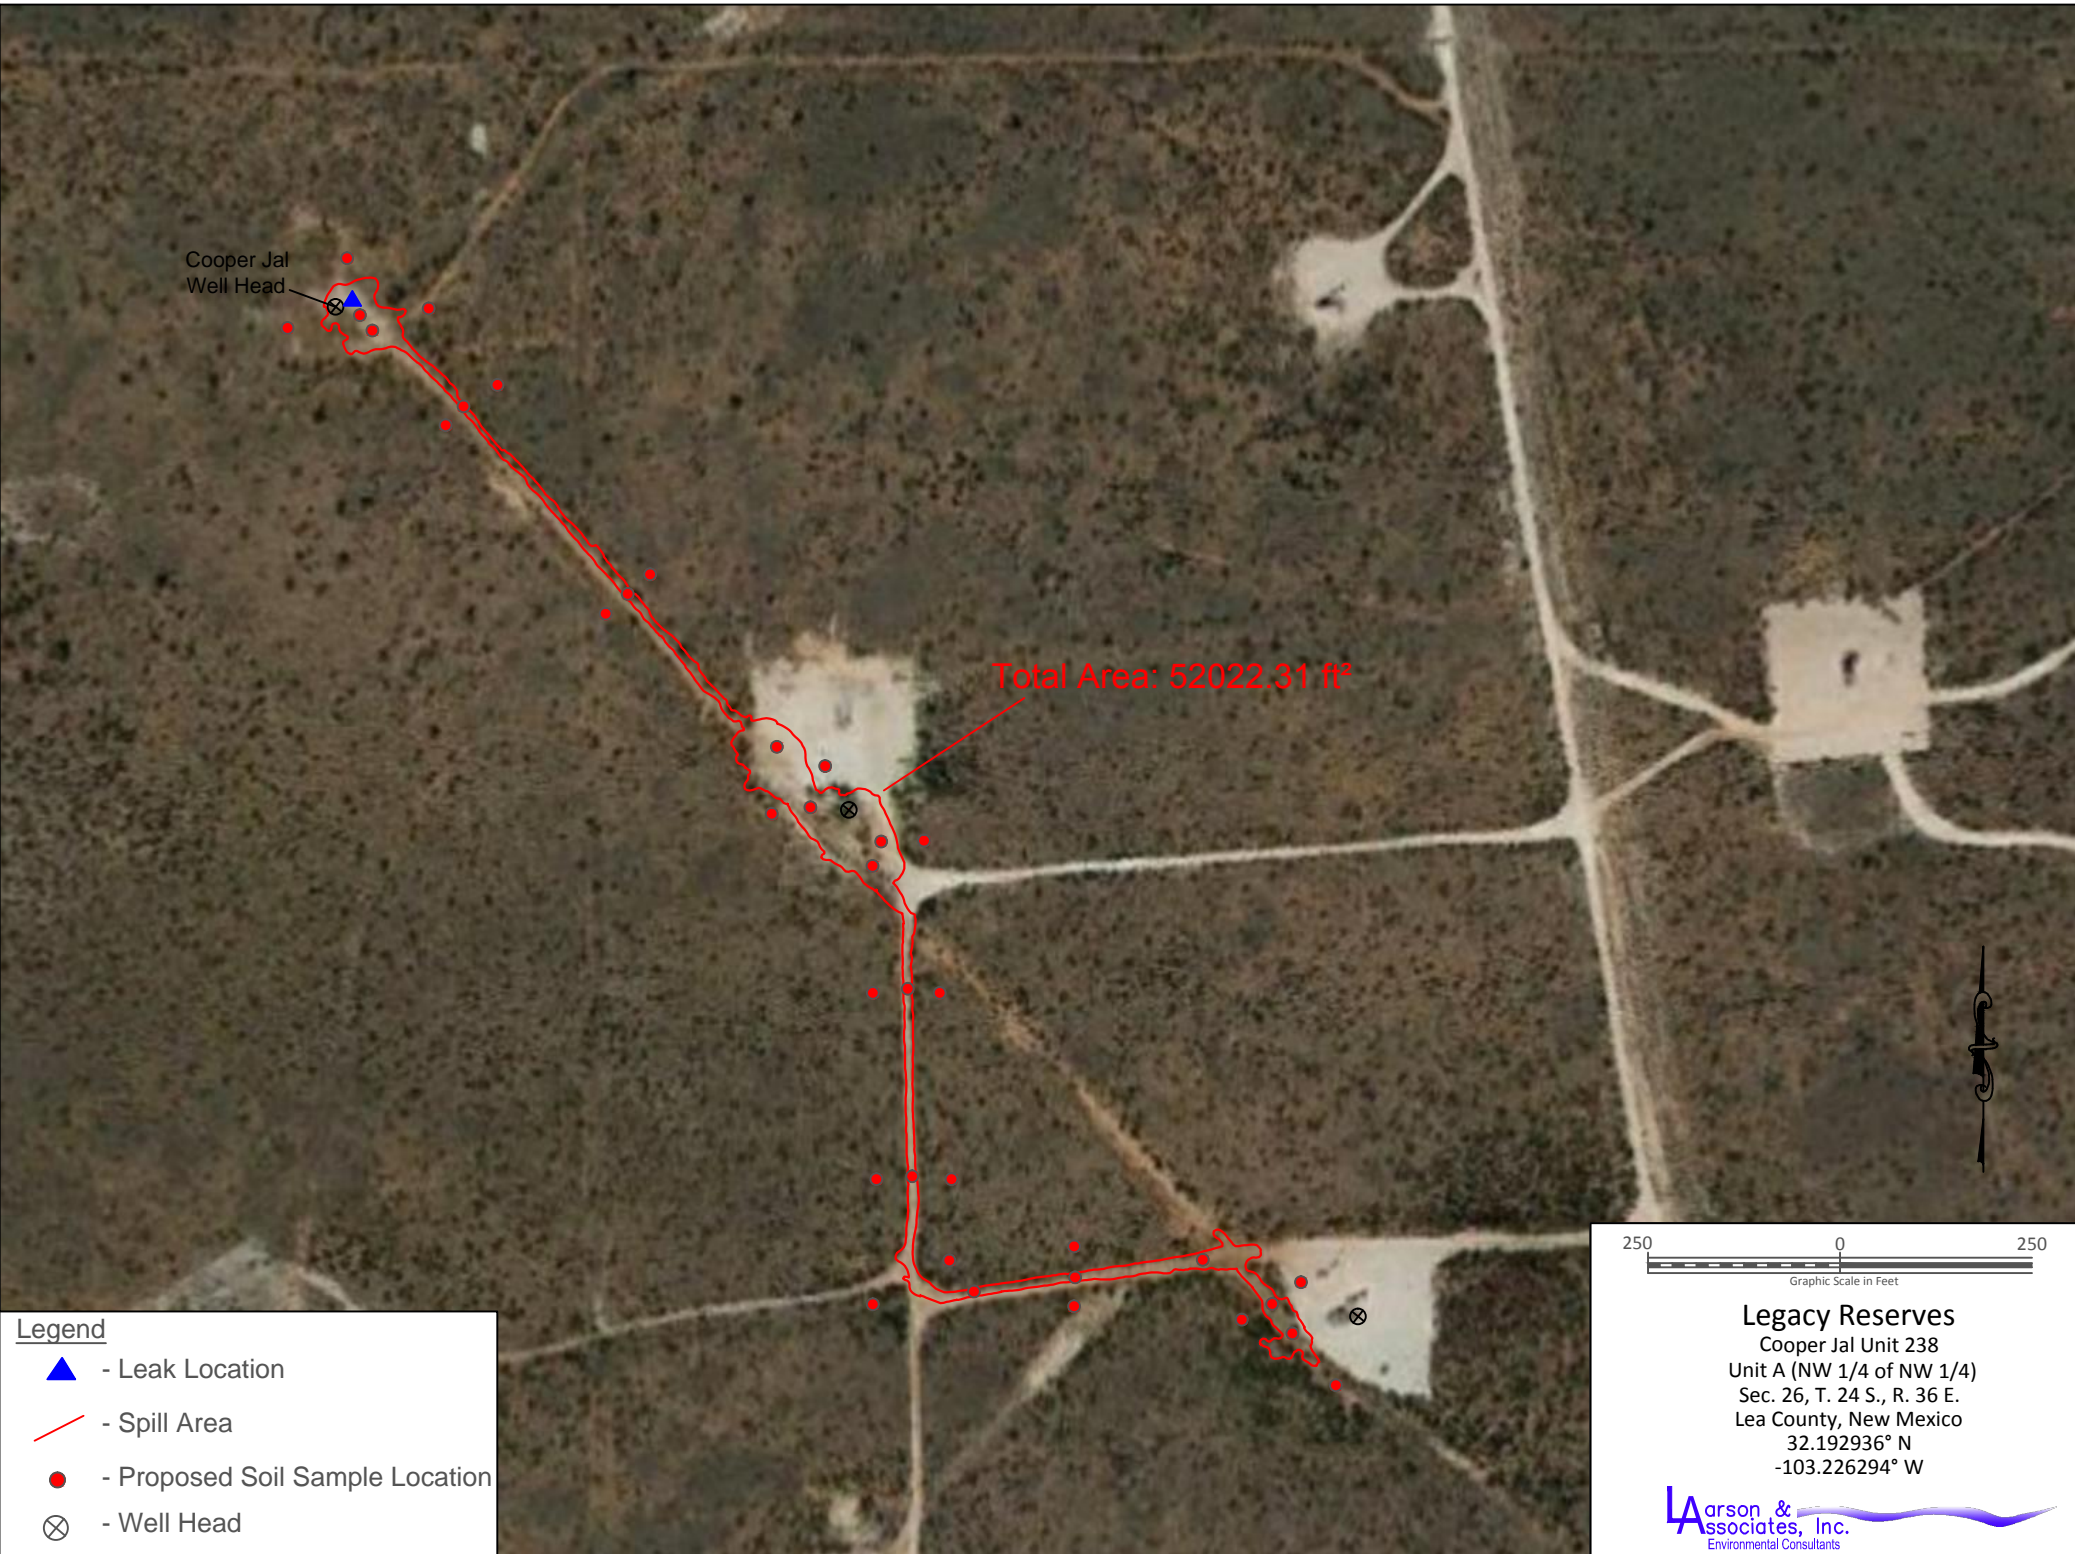
Figure 2- Aerial Map Showing Proposed Soil Sample Locations

LAI proposes to collect soil samples from thirty six (36) locations along the lease road and in each cardinal direction (north, south, east and west) of the spill area.. The samples will be collected at 1 foot intervals to approximately 4 feet bgs (0-1, 1-2, etc) and 2 foot intervals to approximately 12 feet bgs (4-6, 6-8, etc) using direct push technology (DPT) depending on subsurface conditions. The soil samples will be delivered under preservation and chain of custody to Xenco Laboratories (Xenco) in Midland, Texas. The upper samples (0 to 1 foot) will be analyzed for BTEX (the sum of benzene, toluene, ethylbenzene and xylenes) and TPH (total petroleum hydrocarbons), including gasoline range organics (GRO), diesel range organics (DRO) and oil range organics (ORO) by EPA SW-846 Methods 8021B and 8015M, respectively. Additional samples will be analyzed for BTEX and TPH for vertical delineation should the initial samples report concentrations above the RRAL. All samples will be analyzed for chloride by Method 300 respectively. Pending laboratory results, further delineation will be determined to reach clean up level standards. Figure 2 presents the proposed sample locations. Appendix B presents photographs.
