RE: Rule 34 Variance Request –Produced Water Impoundment Construction on Unstable Area

Cave and Karst Resource Inventory Report WaterBridge Burton Flats I Pond Eddy County, New Mexico

July 20, 2022

PW-085B-20220515

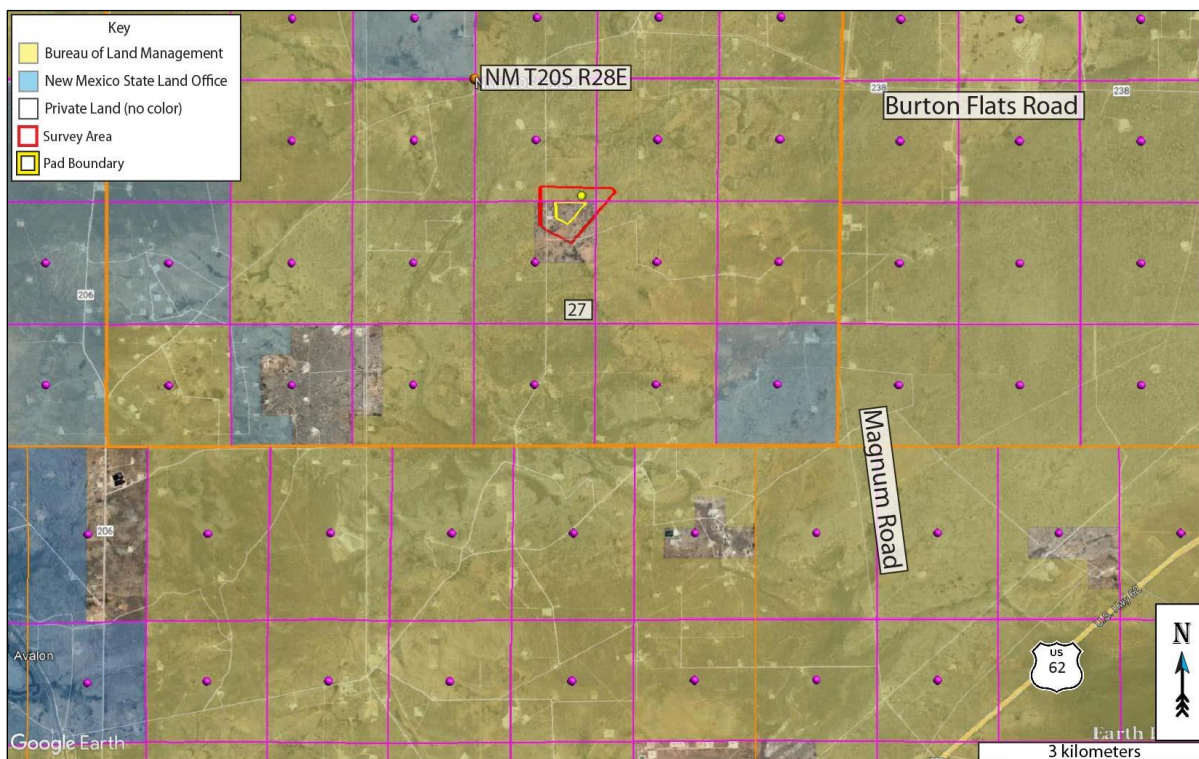
The WBBF_PND project site is located in Eddy County, New Mexico, 16.0 kilometers (9.9 miles) northeast of Carlsbad, New Mexico, south of Burton Flats Road and west of Magnum Road. (**Figure 1** and **Figure 2**). The site is located within section 27 of NM T20S R28E^[3]. The region is semi-arid with an average annual precipitation of approximately 13 inches, of which about two-thirds falls as rain during summer thunderstorms from June to October. Summers are hot and sunny while winters are generally mild, with an average maximum temperature of 96°F in July and an average minimum temperature of 28°F in January^[4]. This area is within the Chihuahuan Desert Thornscrub as defined by the Southwestern Regional ReGAP Vegetation map^[5] and the vegetation consists mostly of areas of grass, sparse creosote, and sparse yucca, with very good visibility in most locations. See section **2.2 Local Geology** for the geology of the area. The project site is located entirely within an HKOZ^[1] (**Figure 1**) and entirely within privately managed (fee surface) land^[6] (**Figure 2**).

Figure 2: Land ownership overview^[3,6]. Background image credit: Google Earth. Image date: December 21, 2019. Datum: WGS-84.
