**From:** [Shelly Cowden](#)  
**To:** "Venegas, Victoria, EMNRD"  
**Subject:** RE: 1RF-463 - JAVELINA FACILITY [FVV2108855989]  
**Date:** Monday, March 30, 2026 12:14:00 PM

I wanted to follow up regarding the inspection structure for the Javelina Recycling Facility and clarify how our current practices align with the approved permit requirements.

**New Mexico Recycling Facility Monthly Inspection**

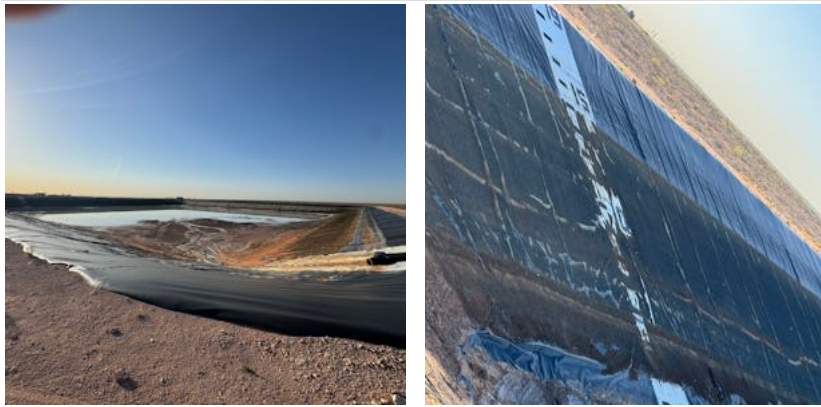
**SOUTH POND**

Is there fluid in the leak detection system?	Yes
Has the fluid been pumped out or is it scheduled?	N/A
Are pond level markers visible?	Yes
Is pond level sensor working?	N/A
Is there any visible damage to the pond liner?	No
Any migratory birds or wildlife discovered in the pond?	No
Is bird deterrent working?	Yes
Is there any evidence of cracking or subsidence around the pond berm?	No
Is there any erosion on the outside of the berm?	No
Is life vest and related pond safety equipment in working condition?	No
Is pond aeration system functional?	Yes

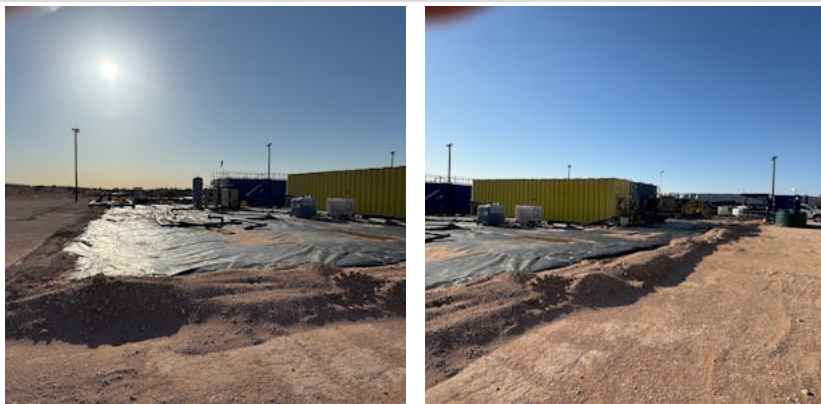
TREATMENT FACILITY

Is fencing and cattle guard in good condition?	Yes
Is there any evidence of spills or soil staining that have not been cleaned up?	Yes
Any migratory birds or wildlife discovered in the facility?	No
Are there any holes found in the containment liner?	No
