Remediation and Reclamation Summary Report

Chalupa #4 SWD – North Remediation Area 1RP-4633 Lea County, NM

October 29, 2019

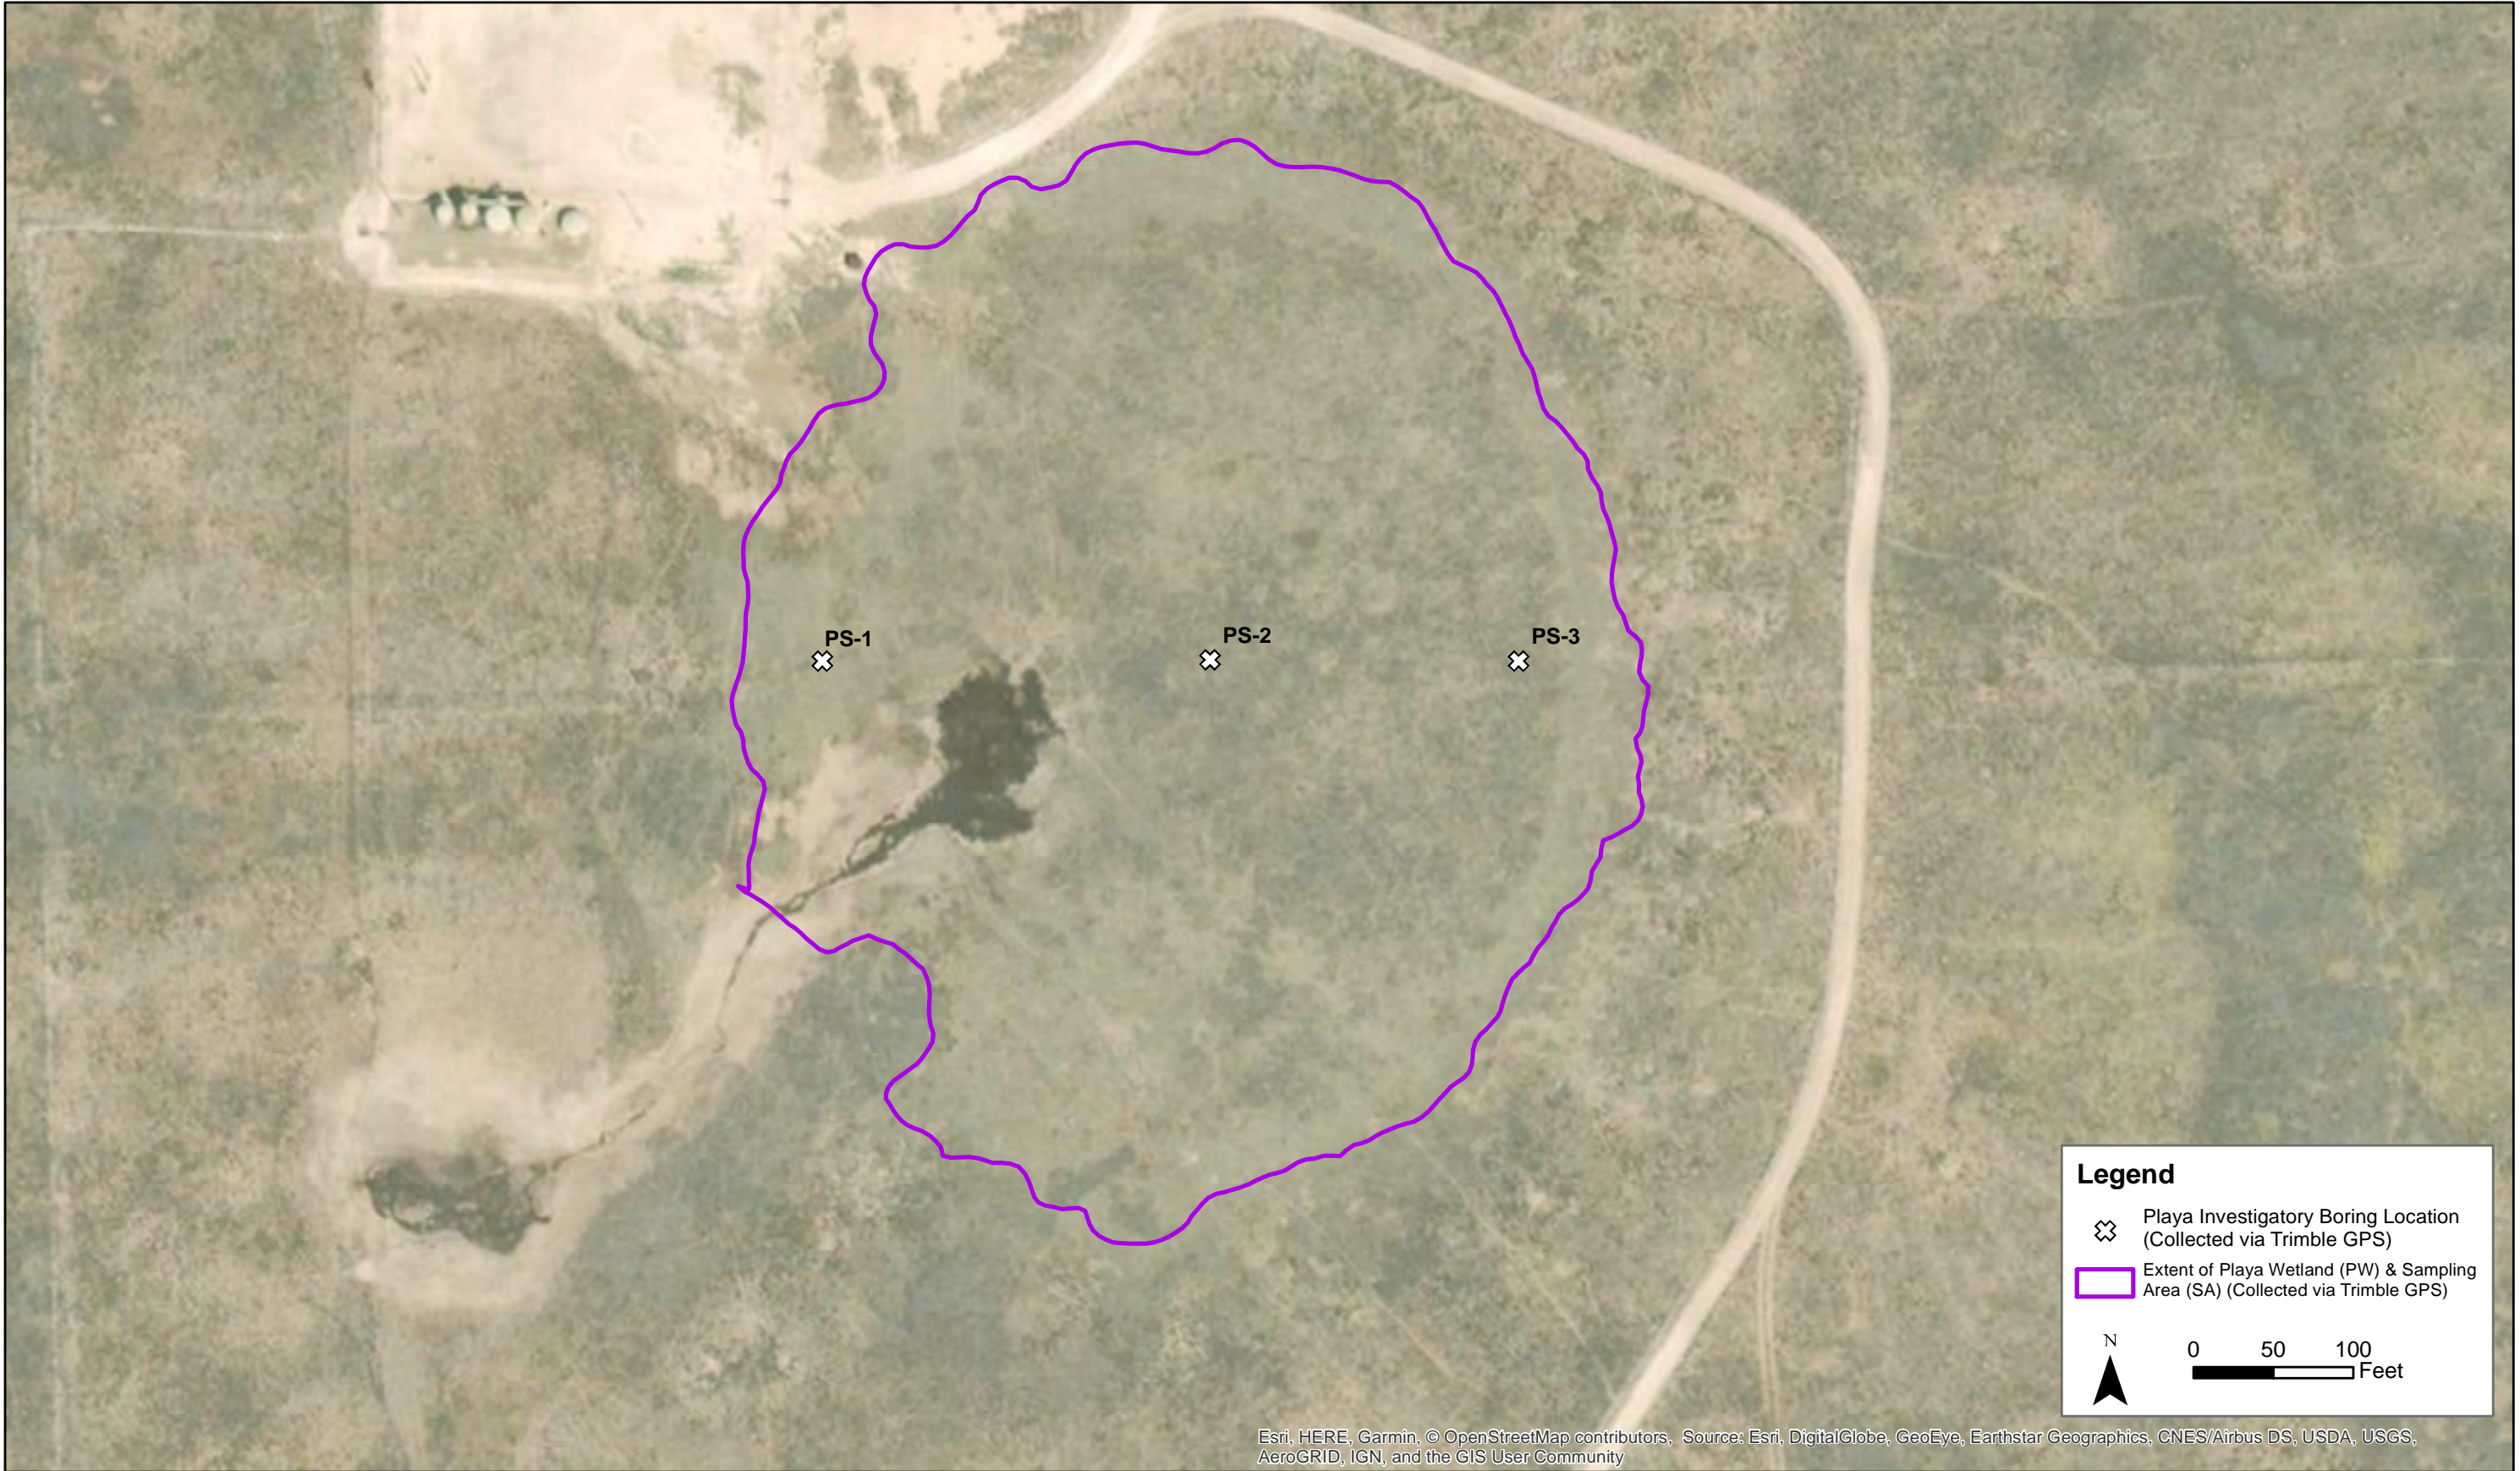
Areas of dead vegetation from SWD line rupture in the west towards the playa to the east. West side of playa has areas of dead vegetation from saltwater infiltration.

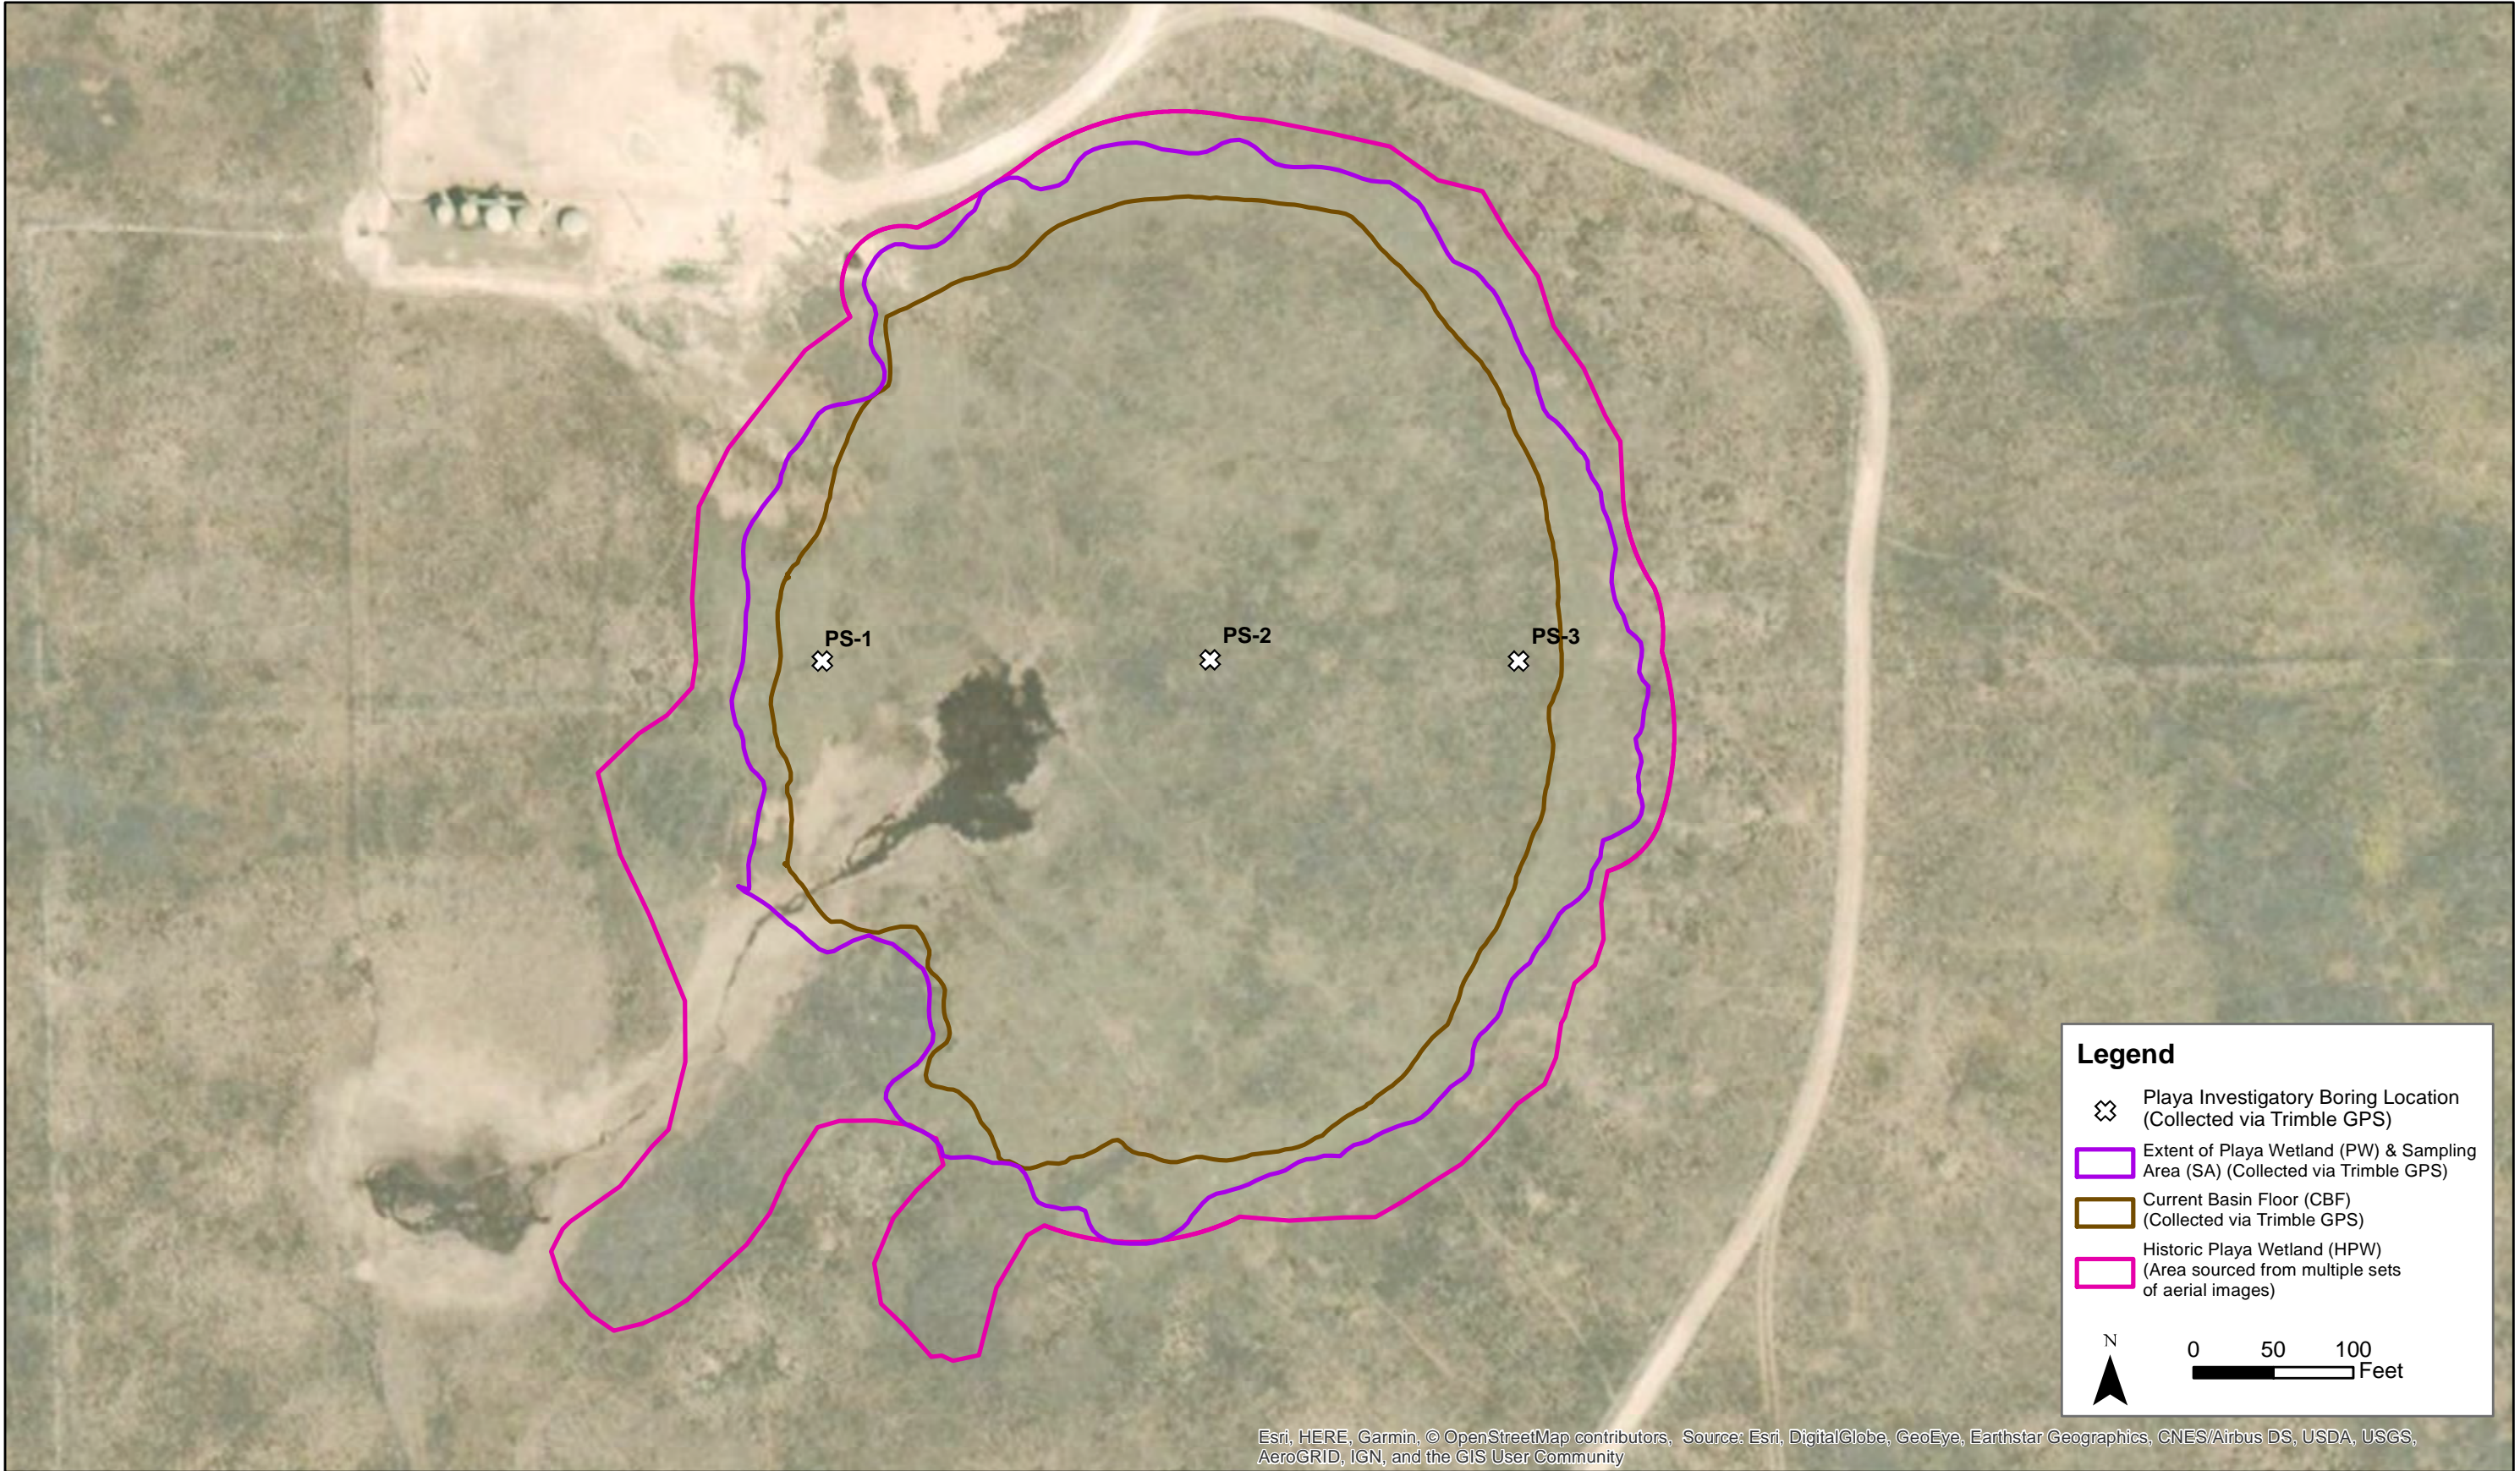
Natural water runoff in the north-northwest of the playa has been altered due to containment berms for SWD tank batteries and trenching from buried pipelines. Stream-like erosion occurred in the west of the playa in the natural landscape due to the saltwater line rupture.
