Pima Environmental Services, LLC
1601 N. Turner Ste 500
Hobbs, NM 88240
575-964-7740

November 1st, 2021

Re: Site Assessment, Remediation, and Closure Report
Forty Niner Ridge Unit #14
API No. 30-015-38563
GPS: Latitude 32.31320 Longitude -103.86963
Unit Letter "I", Sec. 10, T23S, R30E
Eddy County, NM
NMOCD Ref. No. NAPP2116666757

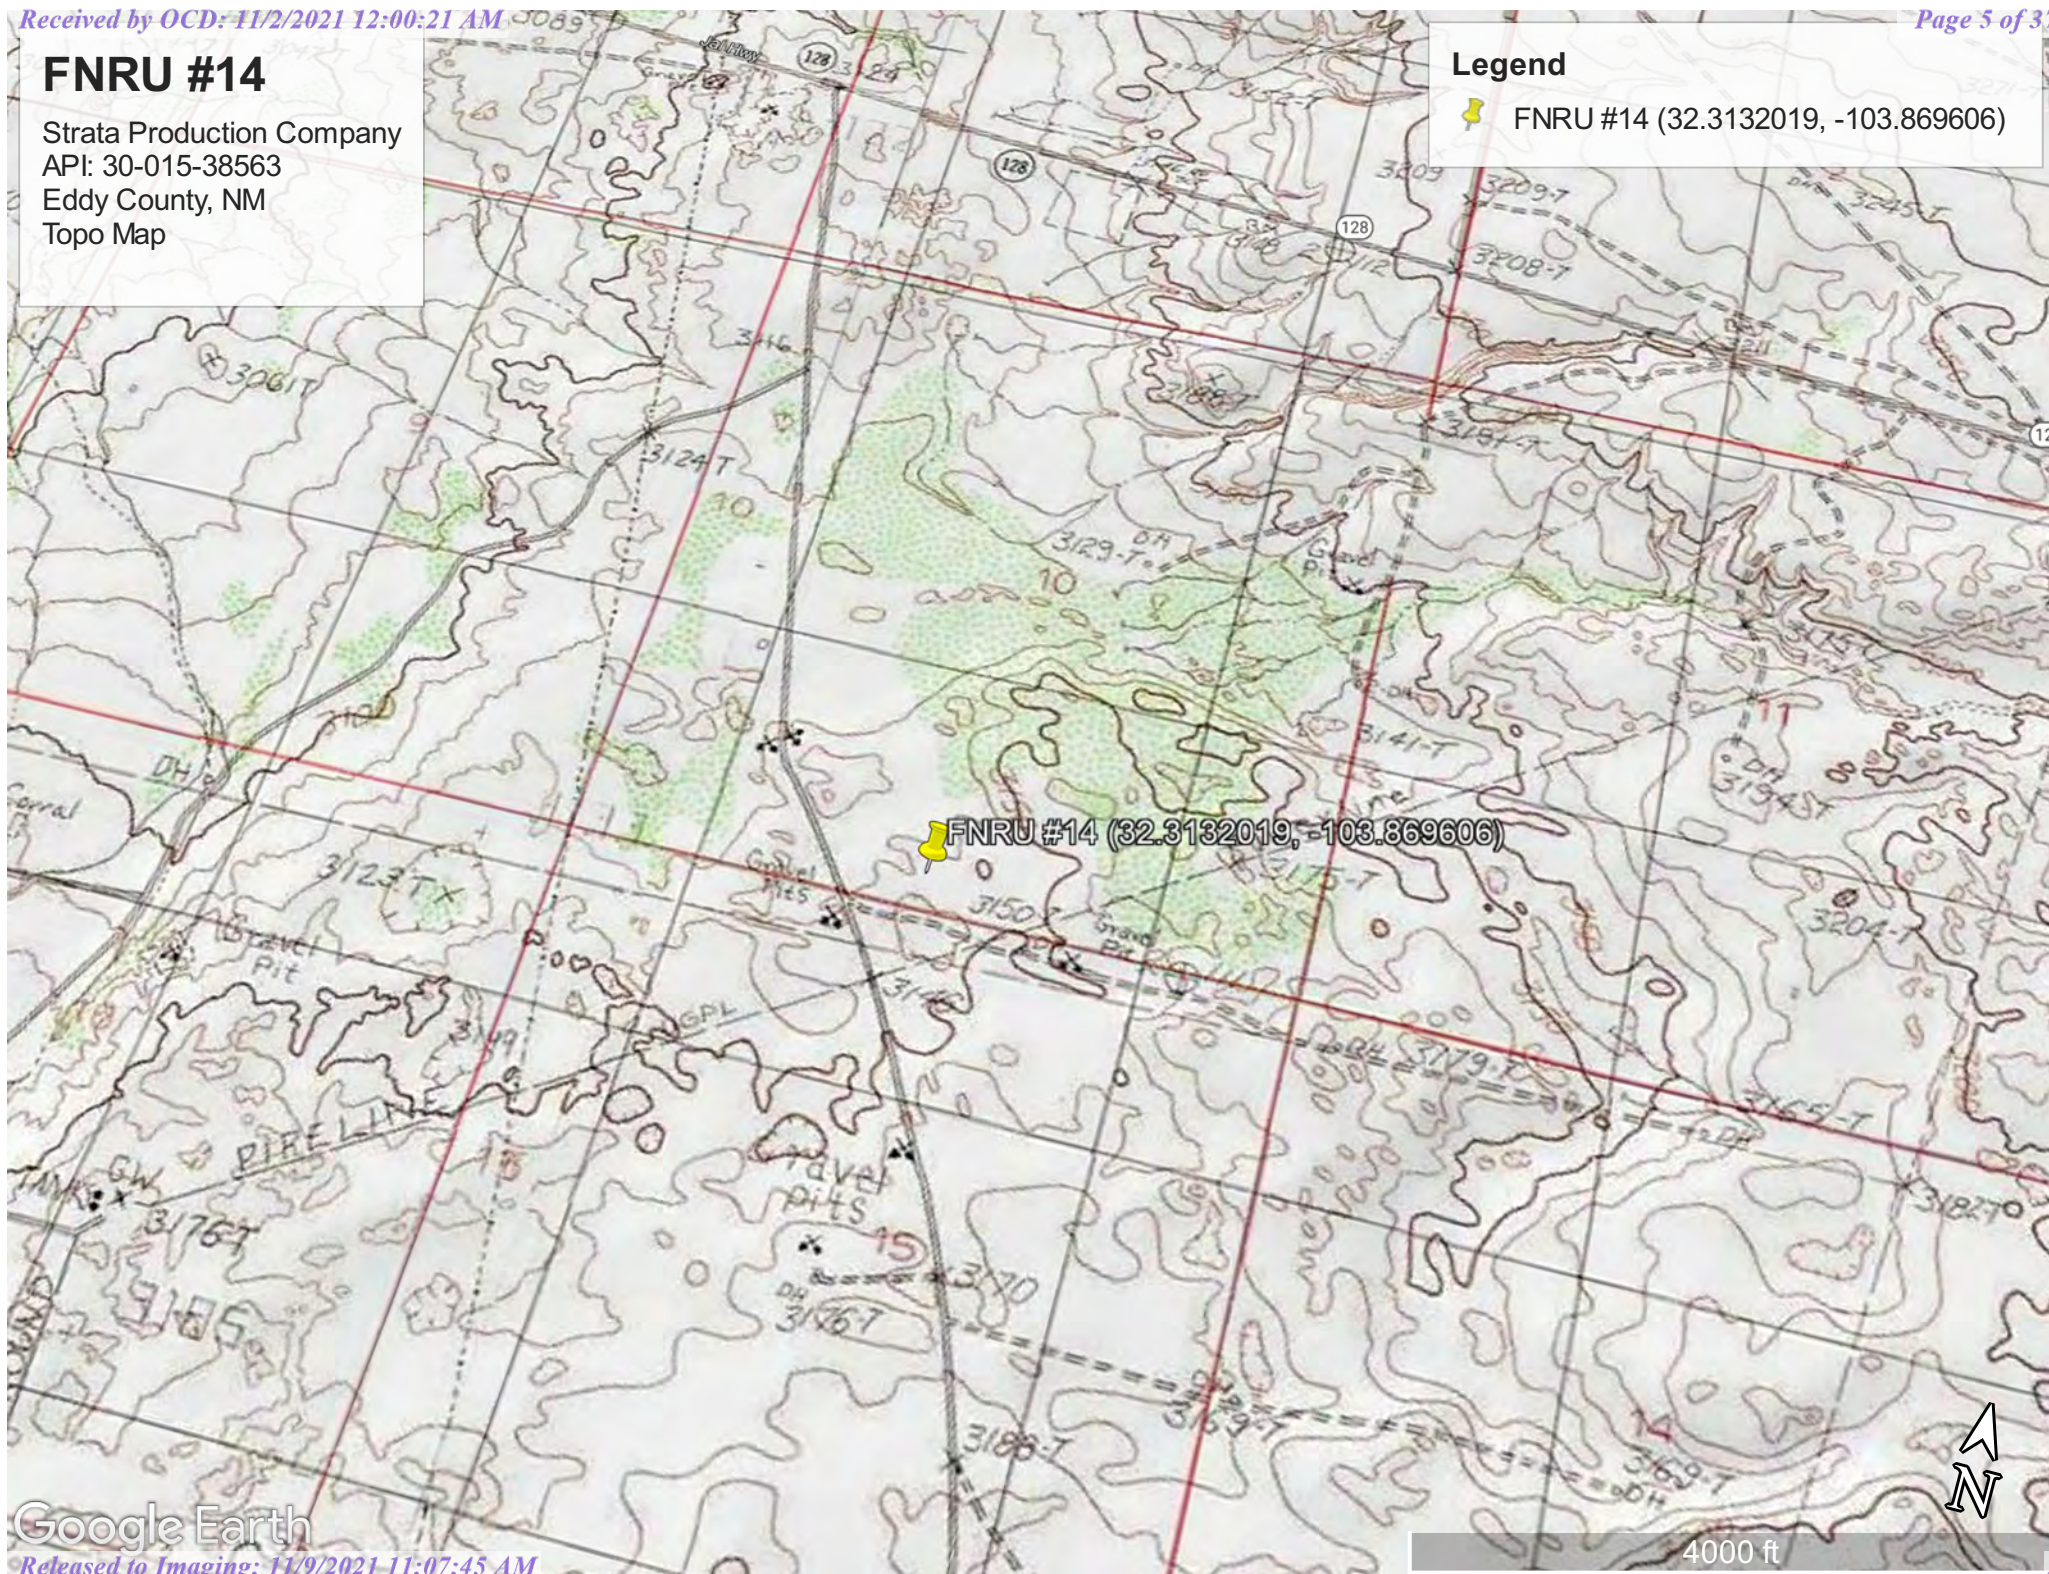
Per the New Mexico Bureau of Geology and Mineral Resources, the geology is in the Quaternary Formation – Eolian deposits (Holocene to middle Pleistocene). Interlayered eolian sands and piedmont-slope deposits along the eastern flank of the Pecos River valley, primarily between Roswell and Carlsbad. Typically capped by thin eolian deposits. The soil in this area is made up of Gypsum land-Reeves complex, 0 to 3 percent slopes according to the United States Department of Agriculture Natural Resources Conservation Service soil survey (Appendix B). The drainage courses in this area are excessively drained. There is a medium potential for karst geology to be present around the FNRU #14 (Figure 3).
