# 2018 ANNUAL VEGETATION MONITORING REPORT

CVU 106/136

Lea County, New Mexico

1RP-2642-0 and 1RP-3244

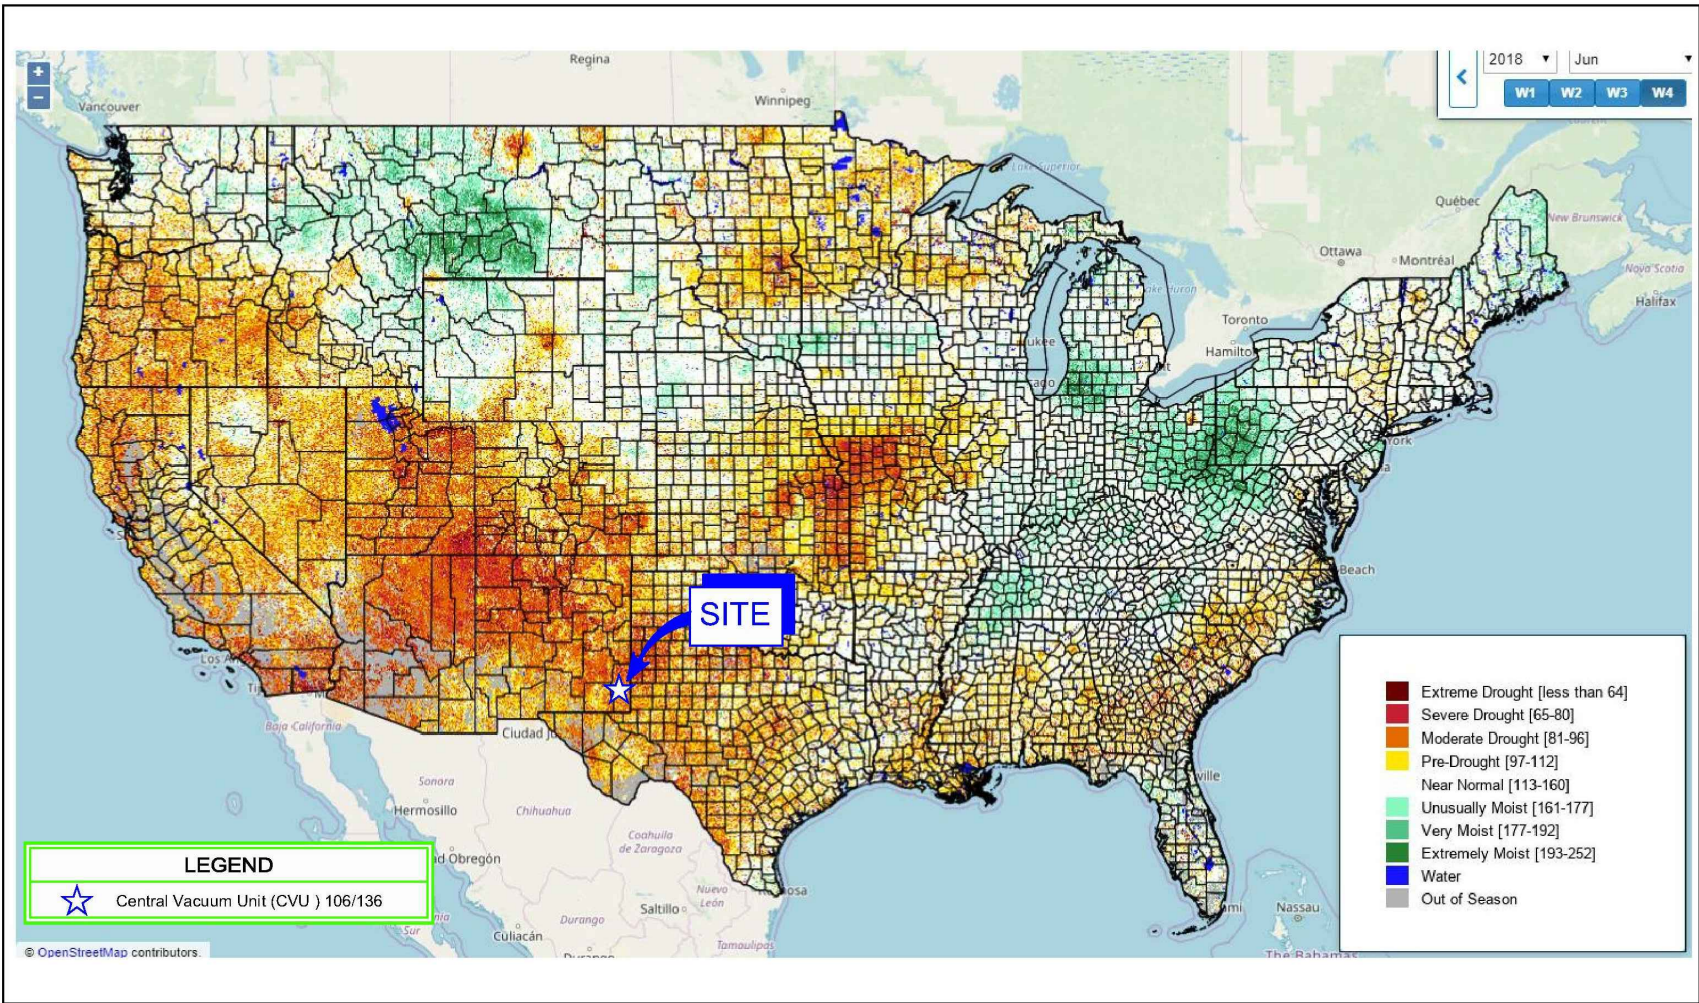
FIGURE  
**2**

The first half vegetation-monitoring event occurred on June 26, 2018 (eight months following the initial reseeding activities). Grasses and flowering shrubs had just begun surfacing through the topsoil. Those that had appeared were green and thriving on the Site (Appendix A: Photos 1 and 2). The vegetation is patchy, but otherwise appears to be in the same condition as within the surrounding area. Regional water conditions are moderate to severe drought based on the USGS Vegetation Drought Response Index for June 2018 (Figure 2).

**USGS VEGETATION DROUGHT  
RESPONSE INDEX - JUNE 2018**

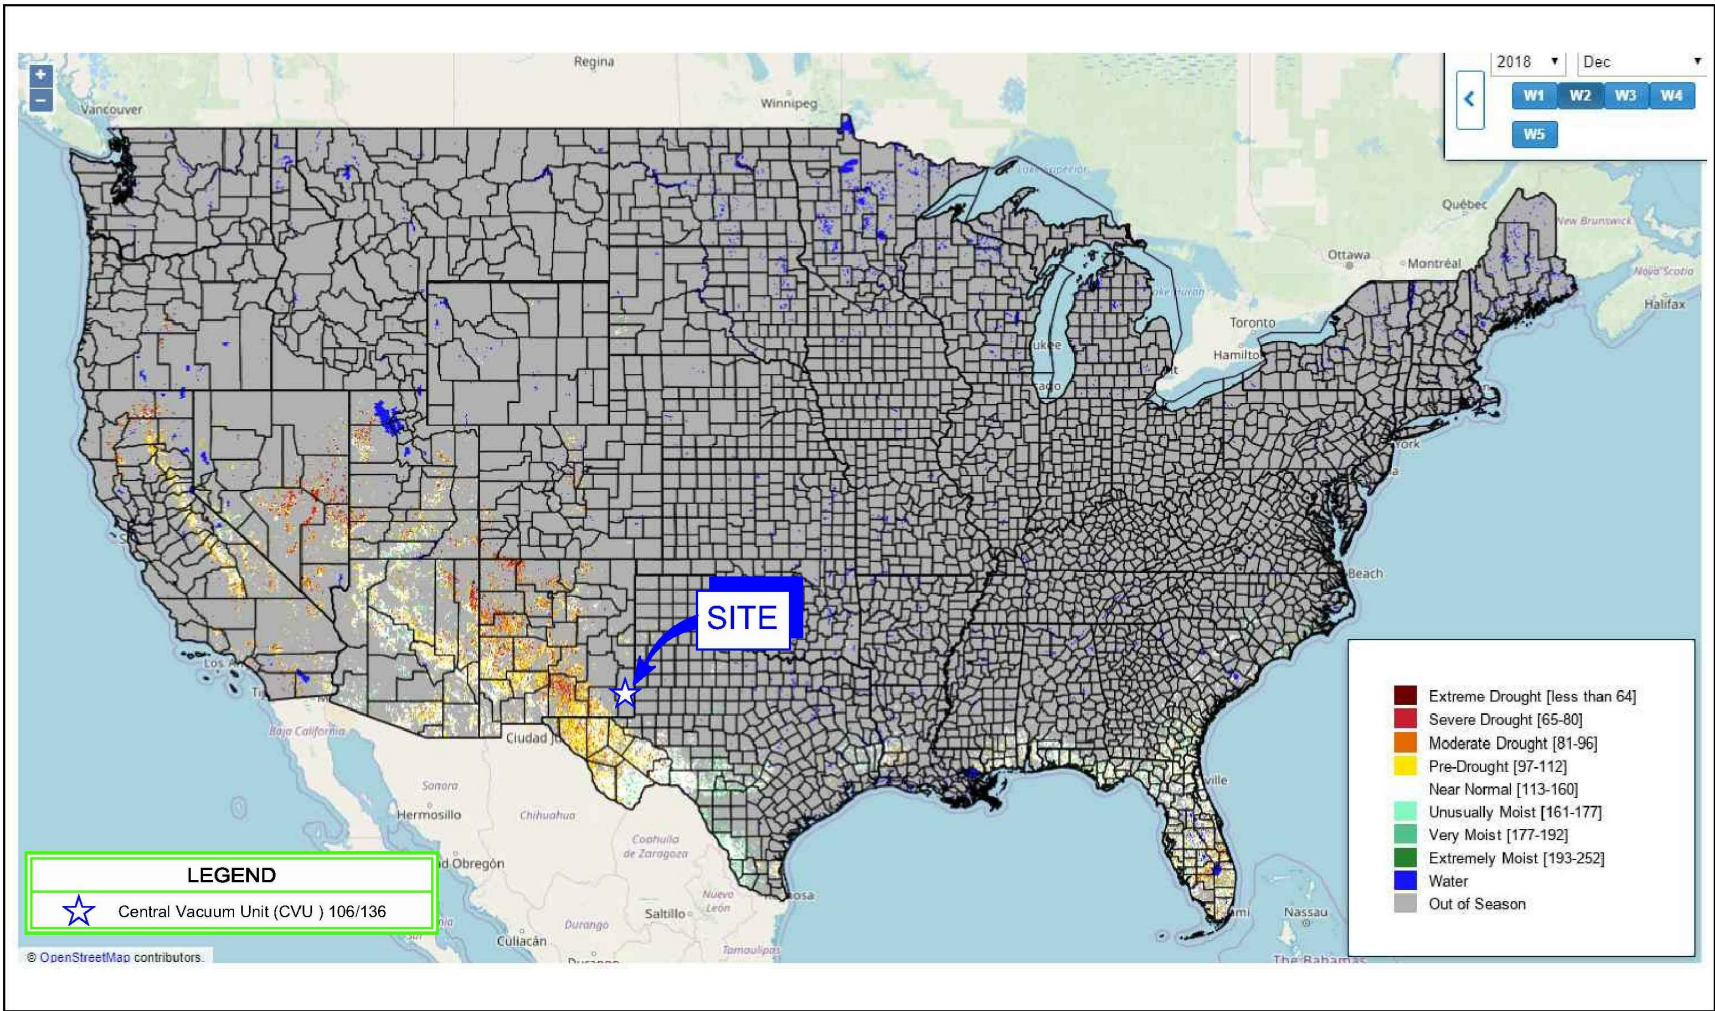
The second half vegetation-monitoring event occurred on December 18, 2018 (fourteen months following the initial reseeding activities). The majority of the vegetation has dried out and gone dormant due to worsening drought conditions in the region and seasonal conditions (Appendix A: Photos 3 and 4). Only a few patches of grass remain green and present on the Site. The vegetation within the remediated area continues to fill in compared to past monitoring events but remains slightly patchy. Regional water conditions are pre-drought to severe drought for available locations based on the USGS Vegetation Drought Response Index for December 2018 (Figure 3).
