RE: Liner Inspection and Closure Report
Falabella 31 Fee #001H Battery
API No. N/A
GPS: Latitude 32.69749 Longitude -104.42780
UL- M, Section 31, Township 18S, Range 26E
NMOCD Reference No. NAPP2324038155

Liner Inspection Form

Site: Falabella 31 Fee #1 Battery

**SPUR ENERGY PARTNERS
FALABELLA 31 FEE #1 BATTERY
SITE PHOTOGRAPHS**

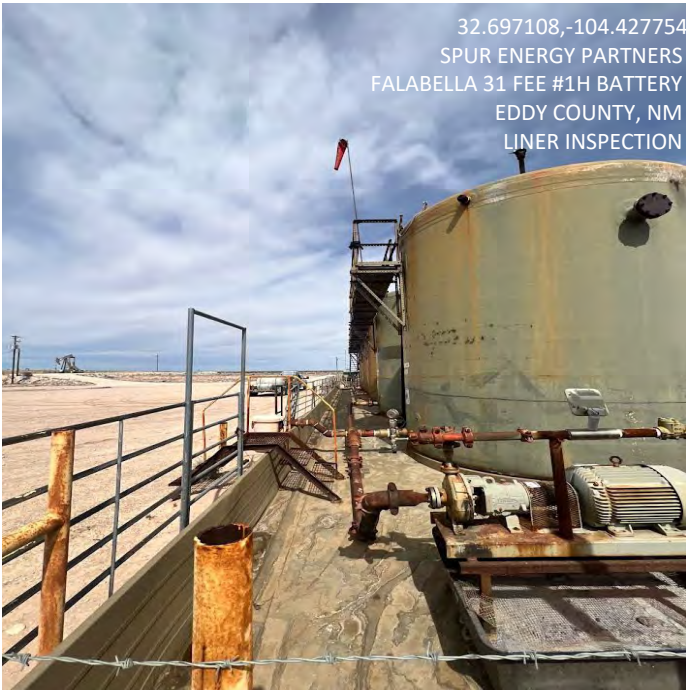
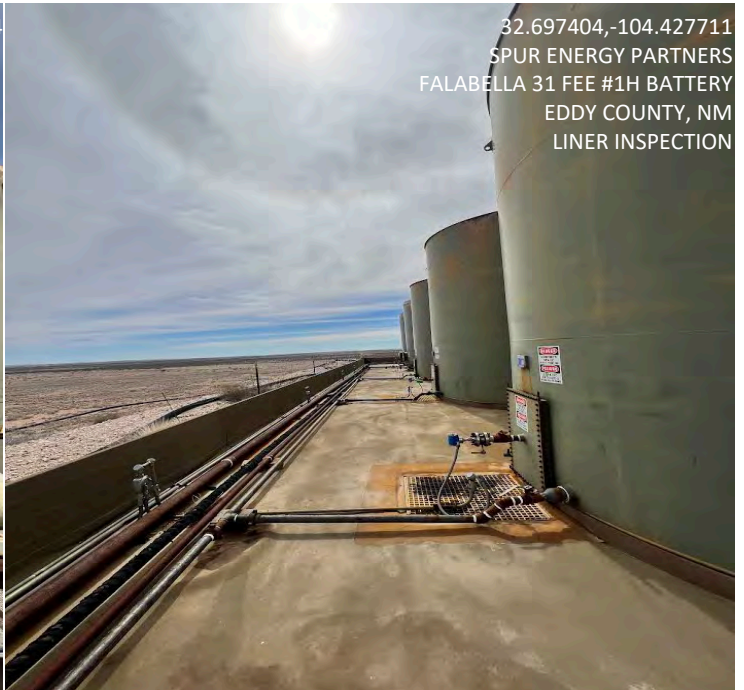
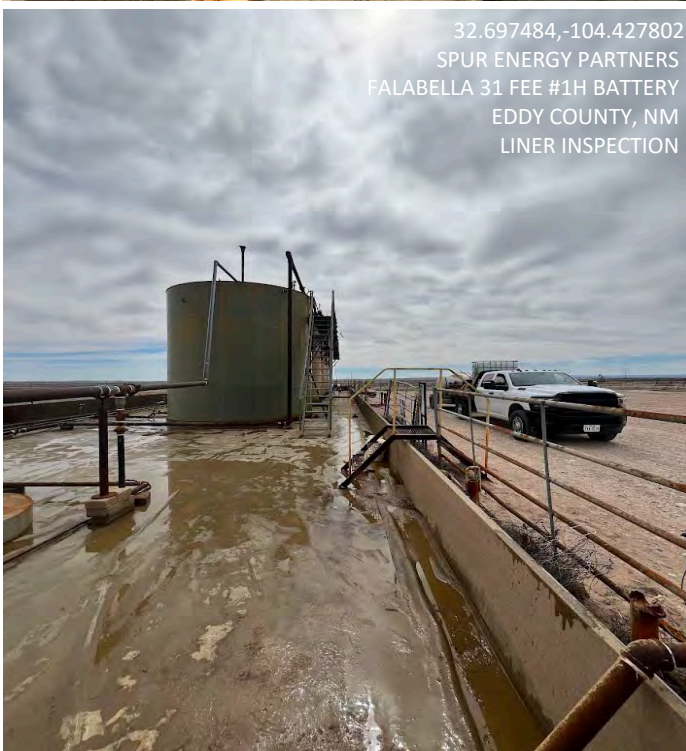
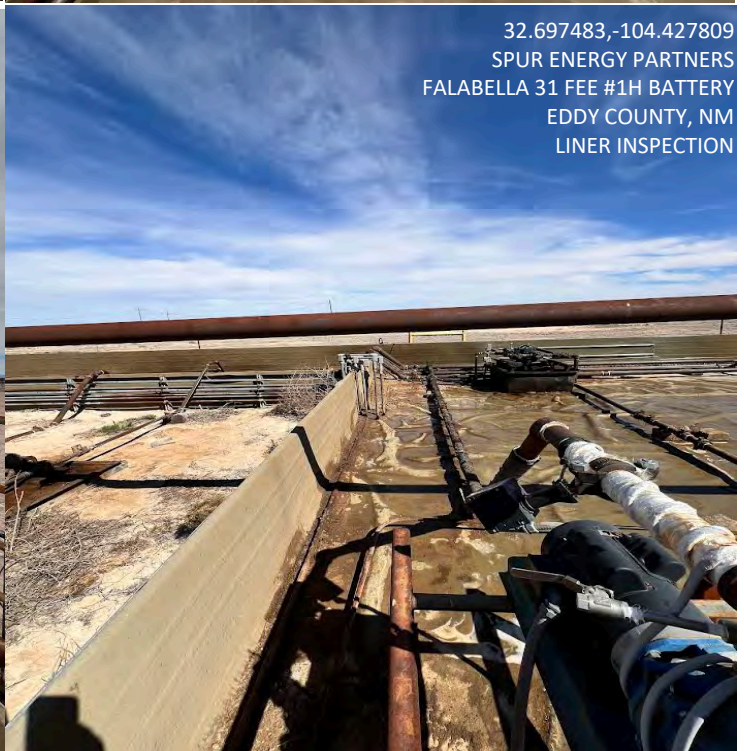
LINER INSPECTION-

On February 28, 2024, Pima Environmental conducted a liner inspection at this location. We concluded that this liner and containment maintained its integrity and was able to retain the fluids. The liner inspection form and photographic documentation can be found in Appendix C.

Visualization	Yes	No	Comments
Is there a tear in the liner?		X	
Are there holes in the liner?		X	
Is the liner retaining any fluids?	X		The inspection images of the liner reveal residual fluid resulting from the remediation event involving power washing.
Does the liner have integrity to contain a leak?	X
