SUBJECT: Liner Inspection and Closure Report for Tater Tot 2 CTB 2 – May 8, 2026 and May 12, 2026 Site Visits

Incident IDs: nAPP2606428628 and nAPP2612734857  
Facility API (Name): fAPP2416935463 (TATER TOT 2 CTB 2)  
Facility Location: Unit M of Section 2, Township 24 South, Range 29 East, New Mexico  
Facility GPS Coordinates: 32.2422093, -103.9601062  
Eddy County, New Mexico

# LINER INSPECTION FIELD NOTES & PHOTOLOG REPORT

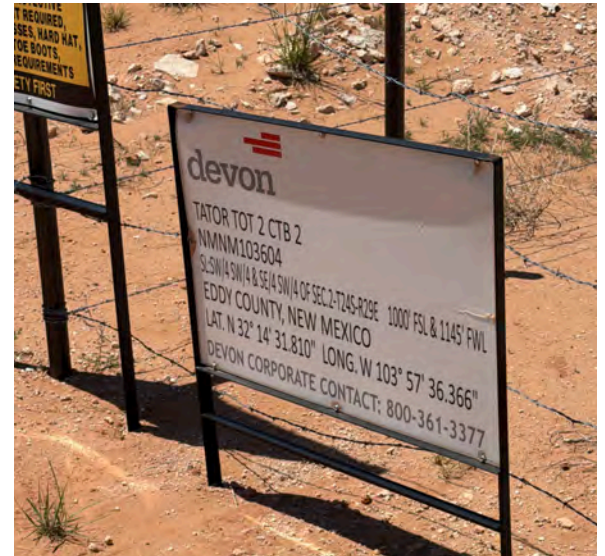
5/8/26

- \* Travel to site, complete JHA, ramp test monitor.
- \* Begin inspection, check liner for any areas showing signs of rips, tears, cuts or weathering where a potential breach could occur.
- \* Take photos of liner in all cardinal directions
- \* Inspect liner under equipment, congested areas and any place where the potential for stress cracks or degradation
- \* ~~Signs~~ No signs that liner integrity has been breached.

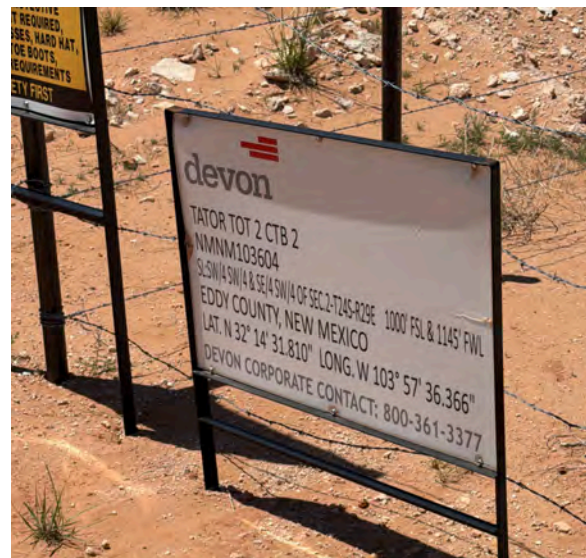
5/12/26

- Arrive on site, check in with supervisor.
- Begin Inspection
- Walk containment area and observe for any areas that may have led to a potential breach
- Check liner for any cuts, rips, tears, weathered spots or pinch points.
- Take photos in all cardinal directions
- Check and observe liner under piping, equipment and congested areas where concern of liner integrity is potentially compromised.
- No signs of stress cracking or seam failures.
- Liner integrity is confirmed.
- Liner passes inspection and ready to request approval for closure.
