Re: Closure Report  
Bora Bora 13 CTB 2  
Incident Number nAPP2607927390  
Incident Number nAPP2609628554  
Incident Number nAPP2611730726  
Eddy County, New Mexico

**Bora Bora 13 CTB 2 Incident Number(s): nAPP2607927390; nAPP2609628554; nAPP2611730726**

**Closure Report**

Liner Integrity Inspection | May 14, 2026 | Photos 1-20 (chronological)

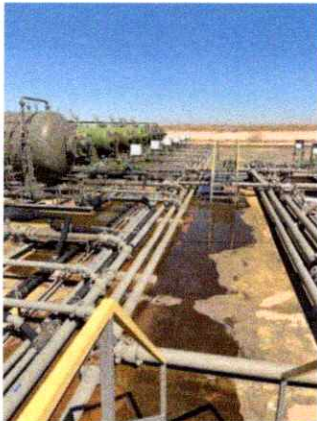
**Photo 5 of 5 - Pipeline and Valve Area**

**View:** Looking along pipeline run on skid deck

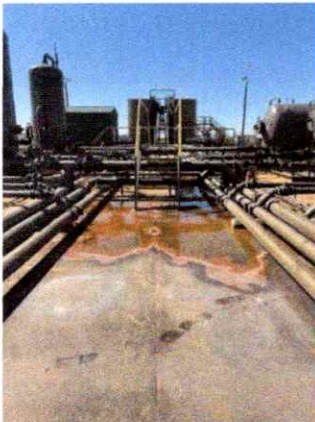
**Photo 3 of 5 - Spill on Skid Deck Surface**

**View:** Ground-level looking across skid deck

**Fluid:** Pooling visible along full corridor length

Produced water accumulation observed between vessel skid structures. Spill appears confined between vessel rows.

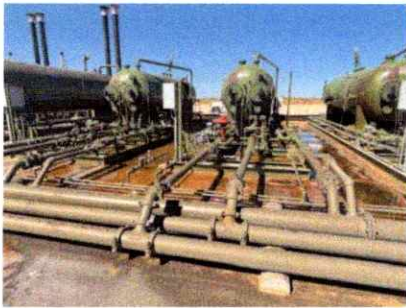
**Photo 5 of 5 - Overview of Skid Deck and Vessel Area**

**View:** Elevated overview of main skid deck

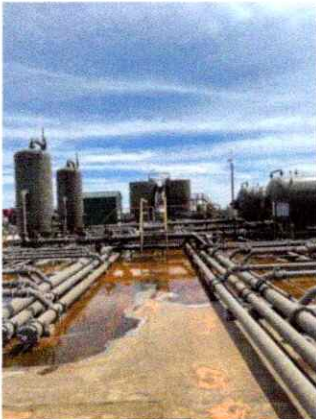
**Photo 3 of 5 - Spill Across Pipeline Skid**

**View:** Ground-level looking along pipeline skid

**Fluid:** Pooling covers full visible deck surface

Produced water with sheen visible across the skid deck.  
Multiple green horizontal pressure vessels with confined space labeling visible.  
Horizontal heater treaters in background.

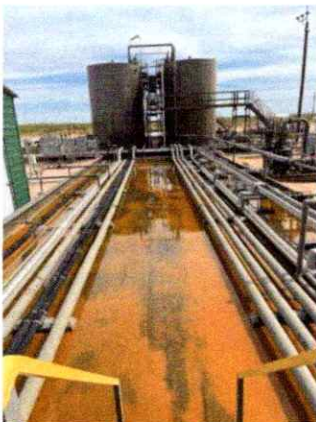
**Photo 5 of 5 - Pipeline Run and Fluid Extent**

**View:** Looking along full pipeline run

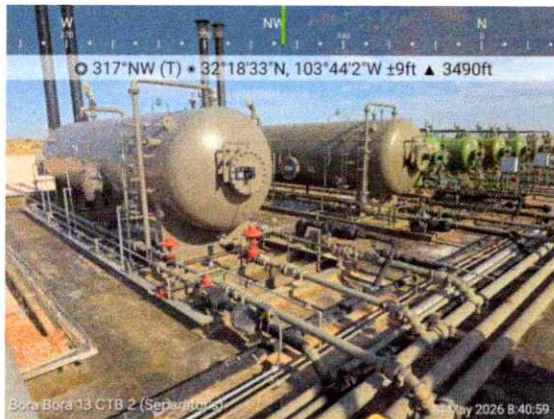
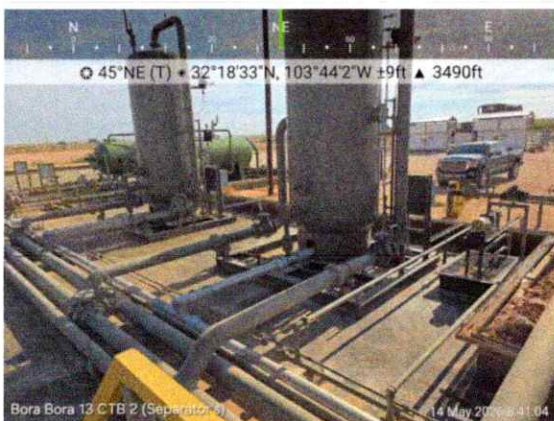
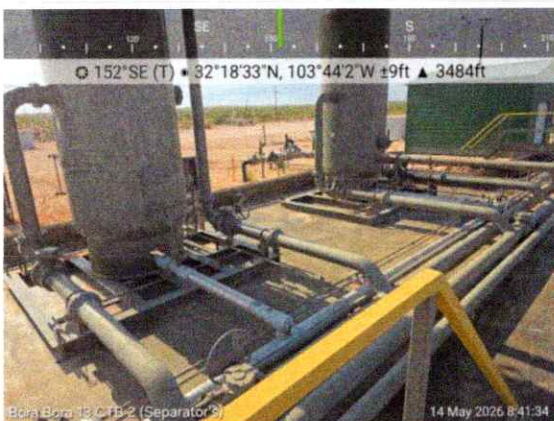
Description: Southwest view showing horizontal inlet separator and process vessel (confined space placard visible). Pipe rack and manifold in foreground. Liner surface inspected along west equipment and no breaches, tears, punctures, uplift, or other indications of compromised liner integrity were found.

Description: North-facing view of northeast corner of green separator skid. Single separator vessel and inlet/outlet piping manifold. The secondary containment liner along the equipment perimeter was inspected and determined to be intact, with no evidence of breaches, tears, punctures, uplift, seam separation, or other conditions indicative of compromised liner integrity.

Description: Northwest overview of the green separator battery depicting all vessels, piping, and instrument enclosures. Inspection of the liner surface identified no tears, seam failures, or compromised penetration integrity.
