Release Notification and Corrective Action

Name of Company: BOPCO, L.P.	Contact: Tony Savoie
Address: 522 W. Mermod, Suite 704 Carlsbad, N.M. 88220	Telephone No. 575-887-7329
Facility Name: JRU-21-Legg Federal SWD Battery	Facility Type: SWD

FIELD SPILL REPORT

LOCATION OF SPILL SITE: Legg Federal SWD Battery (API-30-015-04734)

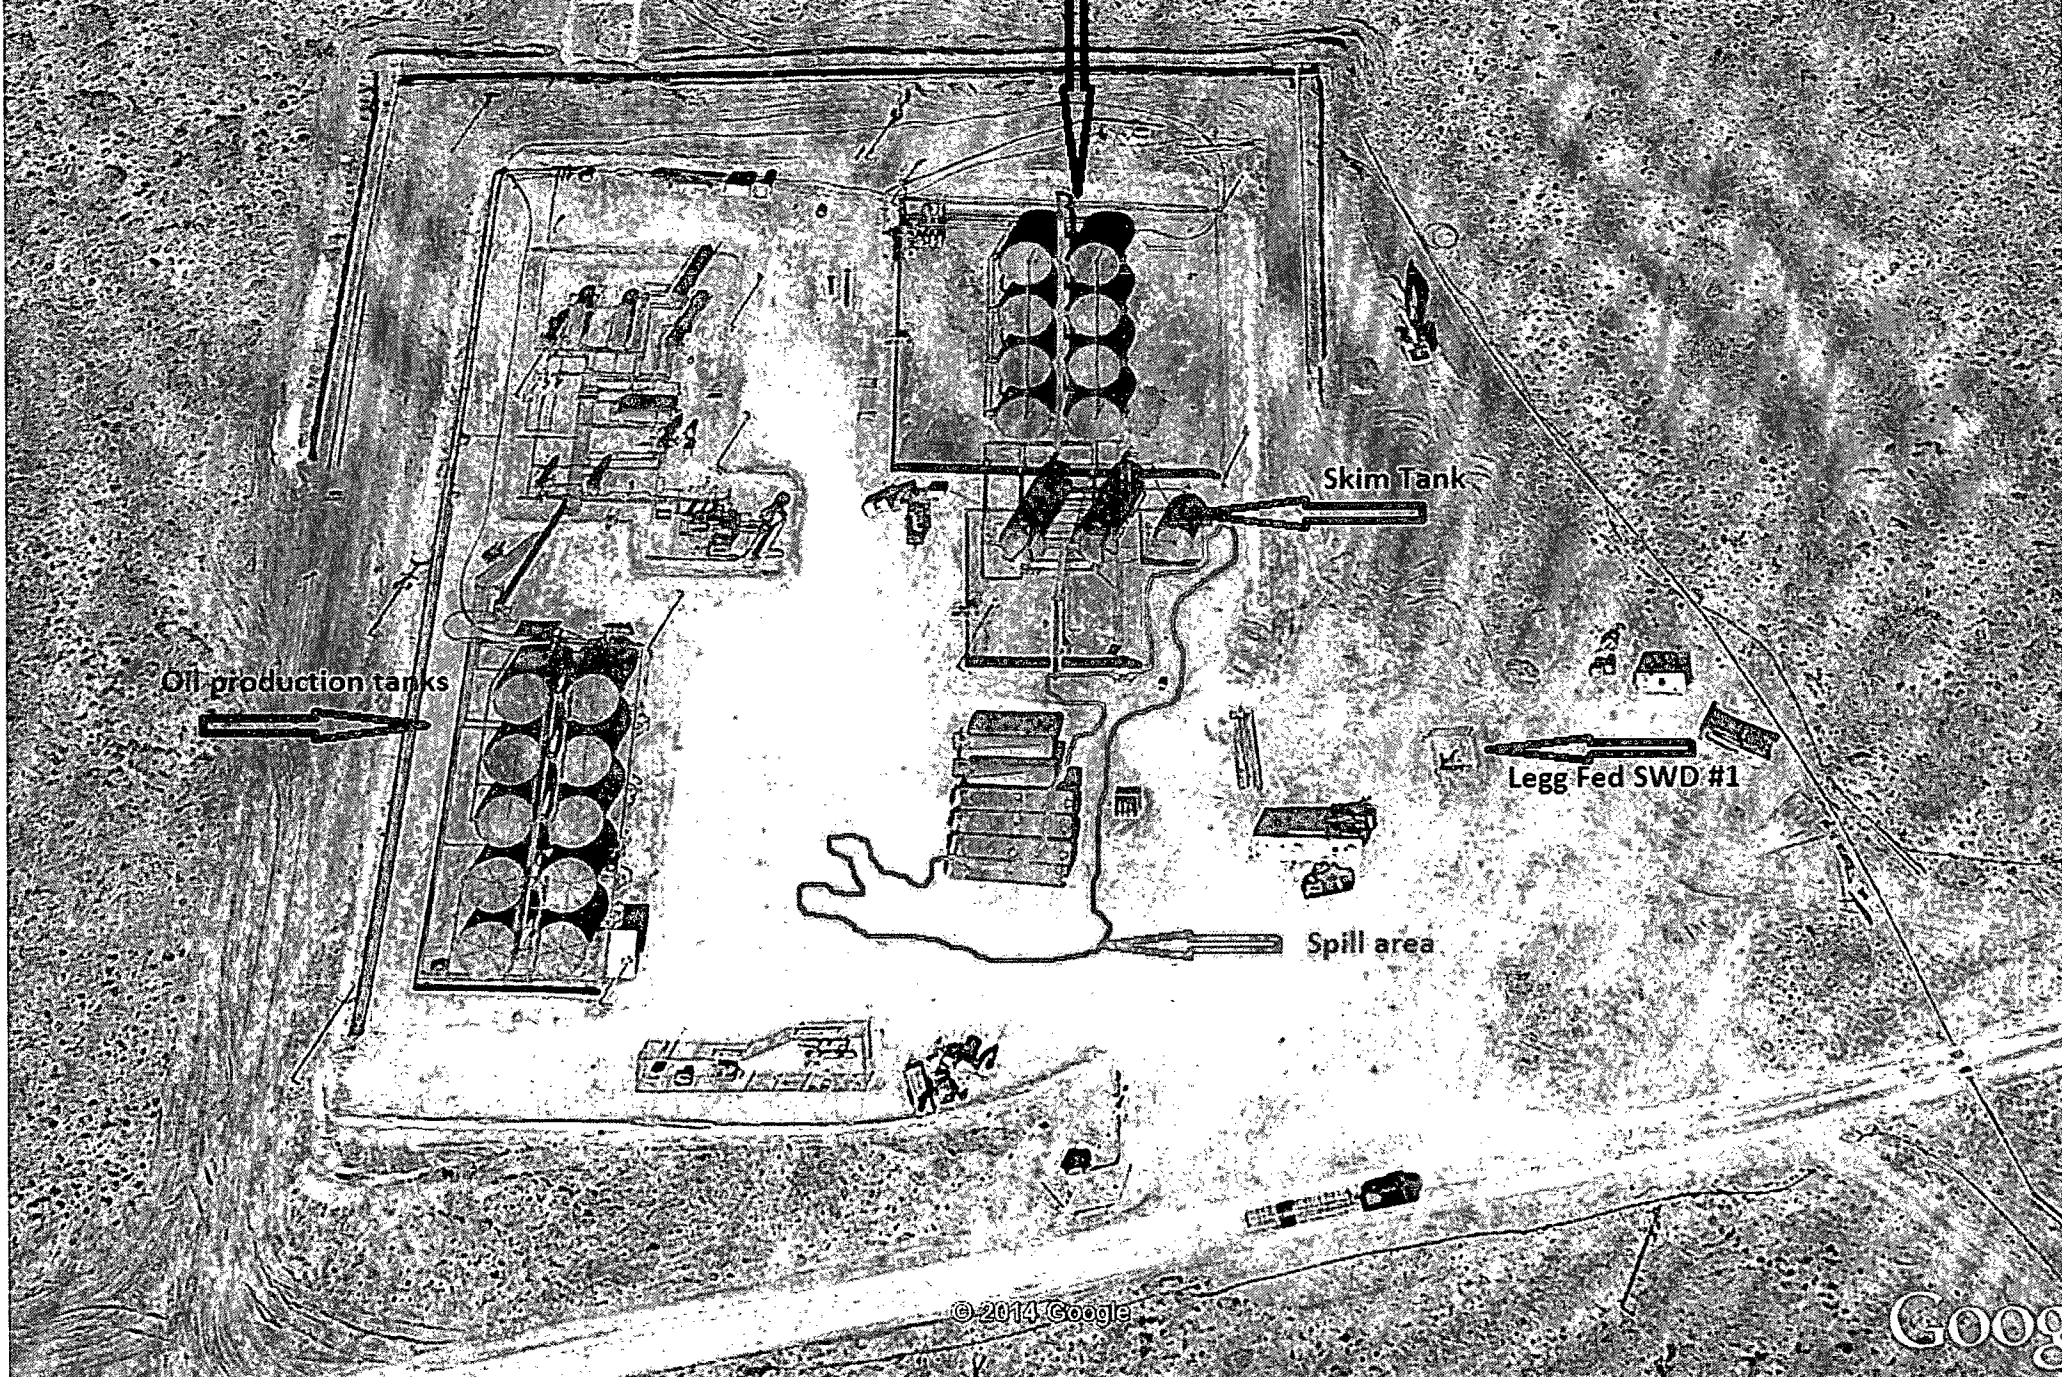
A motor valve failed causing the skim tank to overflow. The containment around the skim tank overflowed to the ground and to the containment around the gun-barrel tanks. Discovered at 4:00 a.m. 12/21/14. Reported to agencies at 3:10 p.m. 12/21/14

Describe Cause of Problem and Remedial Action Taken.* A motor valve failed sending all of the fluid to the skim tank causing it to over-flow. The vessel was by-passed until the motor valve could be replaced.
