# SITE INFORMATION

## Report Type: Work Plan

June 27, 2012

**Re: Assessment and Work Plan for the COG Operating LLC.,  
Diamondback State Tank Battery, Section 28, Township 17 South,  
Range 29 East, Eddy County, New Mexico.**

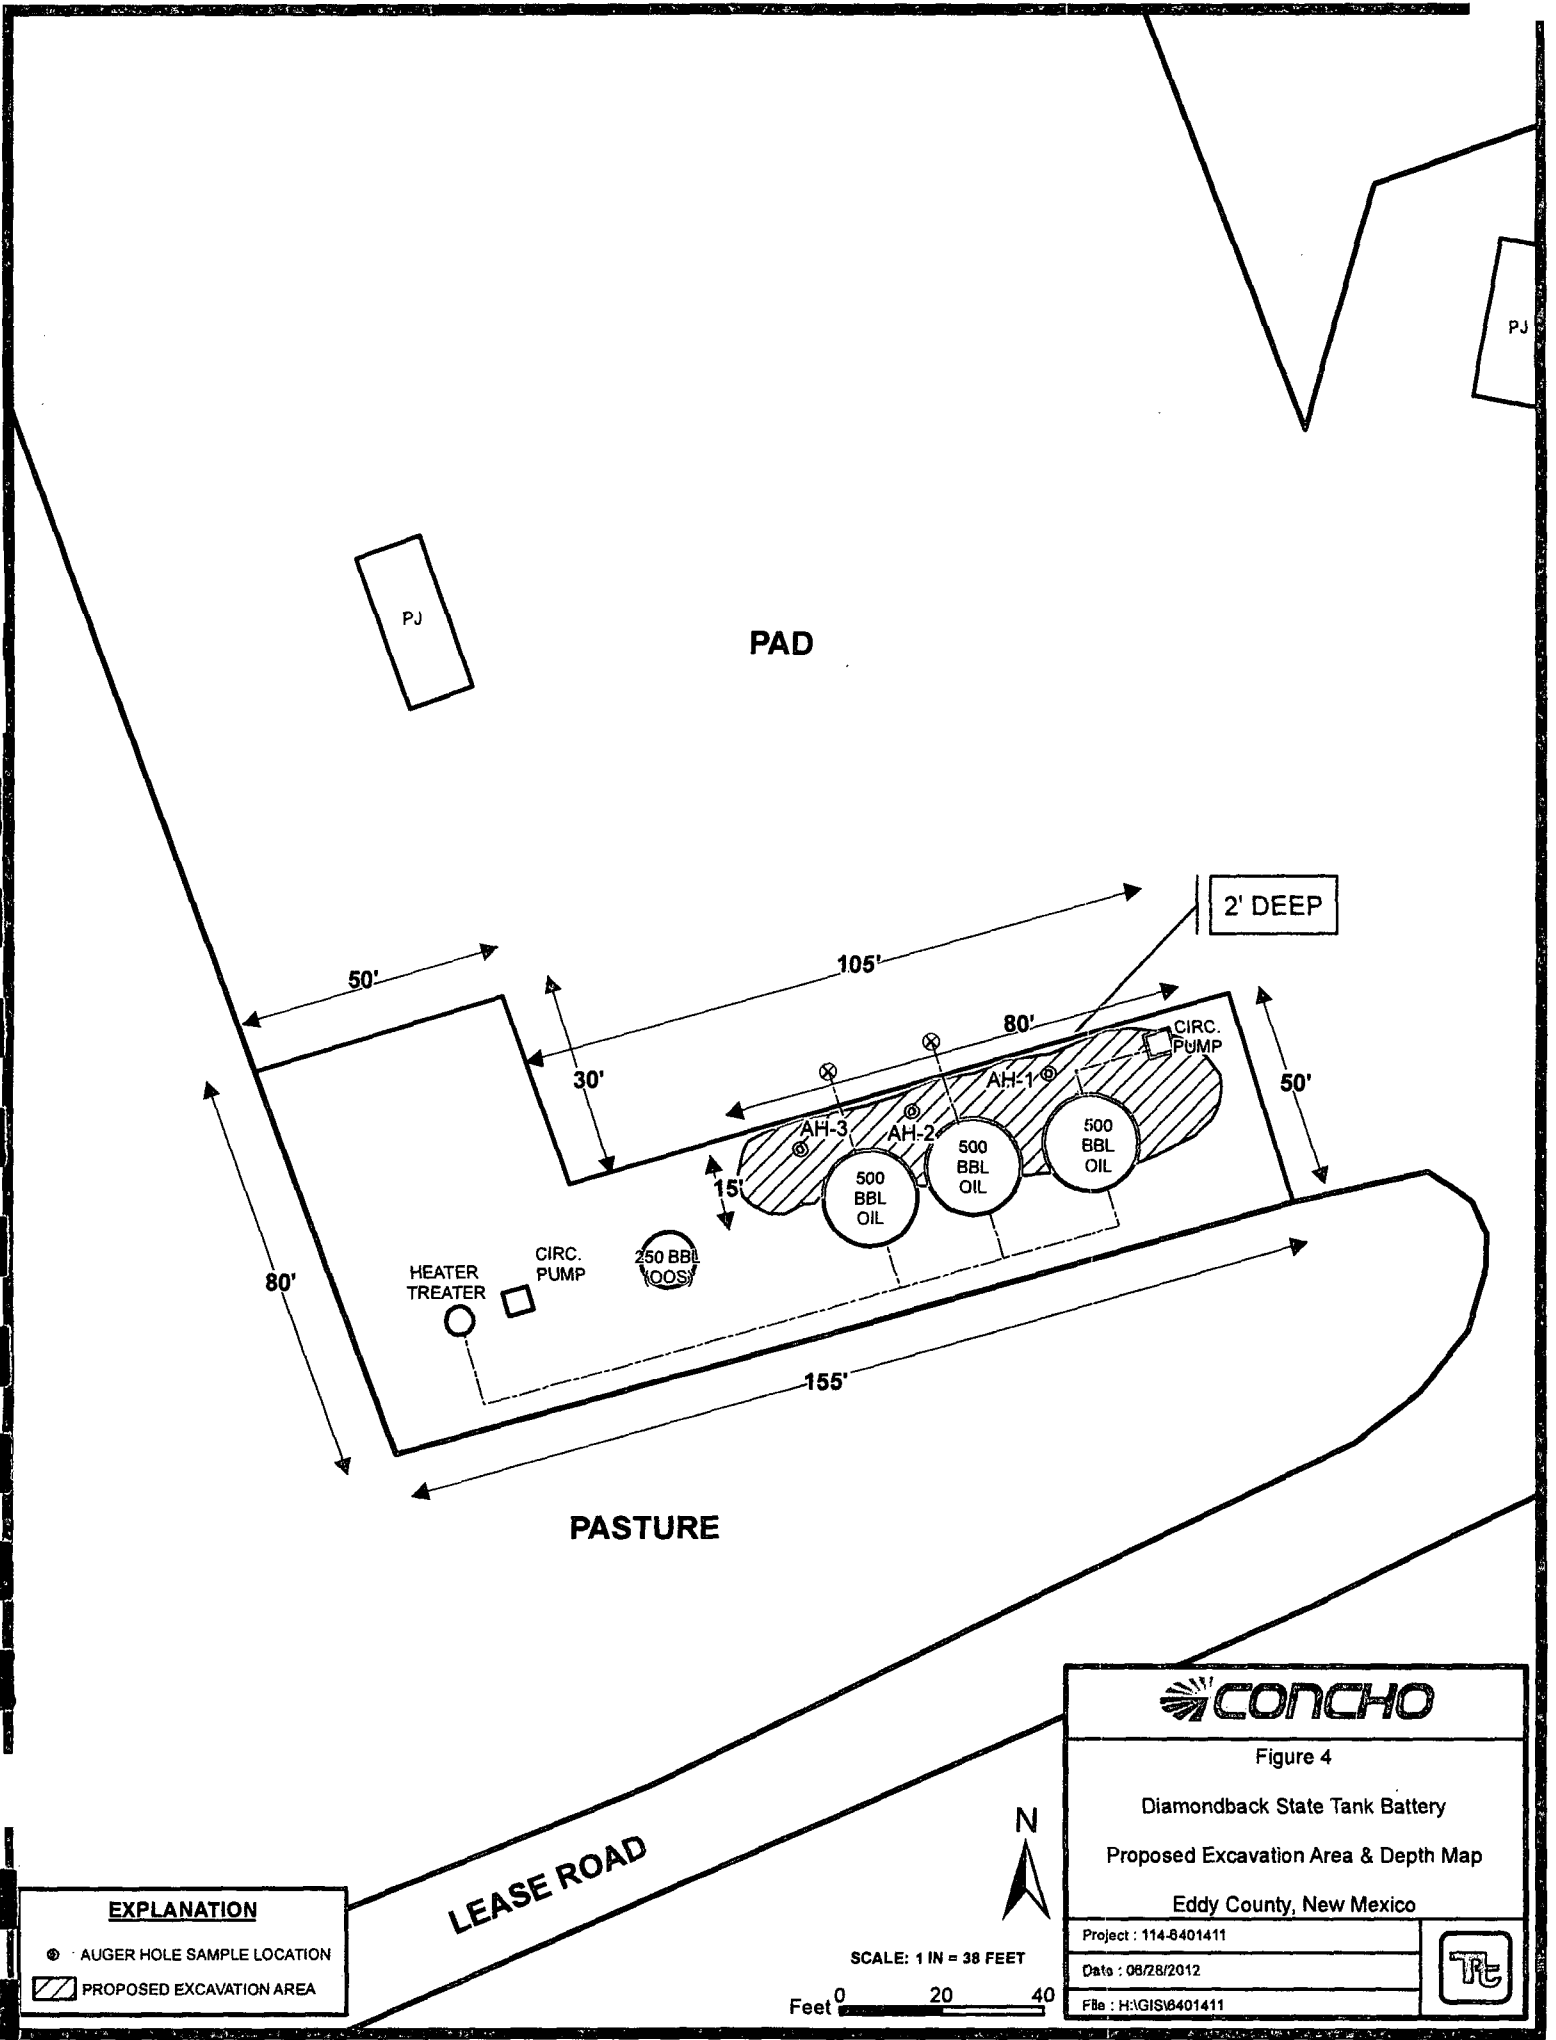
Figure 3

According to the State of New Mexico Oil Conservation Division (NMOCD) Form C-141 Initial Report, the leak was discovered on April 25, 2012. The spill released approximately thirty-nine (39) barrels of oil from an over-pressured load line. COG was able to recover approximately 35 barrels of oil with a vacuum truck. To alleviate the problem, COG repaired the line and installed a pressure vent. The impacted area measured approximately 15'x 80'. The entire spill area was contained within the facility firewalls. The spill area is shown on Figures 3. The initial Form C-141 is enclosed in Appendix A.

On May 30, 2012, Tetra Tech personnel inspected and sampled the spill area. A total of three (3) auger holes (AH-1 through AH-3) were installed using a stainless steel hand auger to assess the impacted area. Selected samples were analyzed for TPH analysis by EPA method 8015 modified, BTEX by EPA Method 8021B and chloride by EPA method 300.0. Copies of laboratory analysis and chain-of-custody documentation are included in Appendix C. The sampling results are summarized in Table 1. The auger hole locations are shown on Figure 3.
