Release Notification and Corrective Action

Name of Company	Apache Corporation	Contact	Natalie Gladden
Address	PO Box 1849 Eunice NM 88231	Telephone No.	575-390-4186
Facility Name	Southeast Lusk 34 #6 Battery	Facility Type	Production Facility
Surface Owner	BLM	Mineral Owner	State
		API No.	30-025-37681

APACHE SE LUSK 34 FEDERAL #006 TANK BATTERY

Southeast Lusk 34 Federal #6

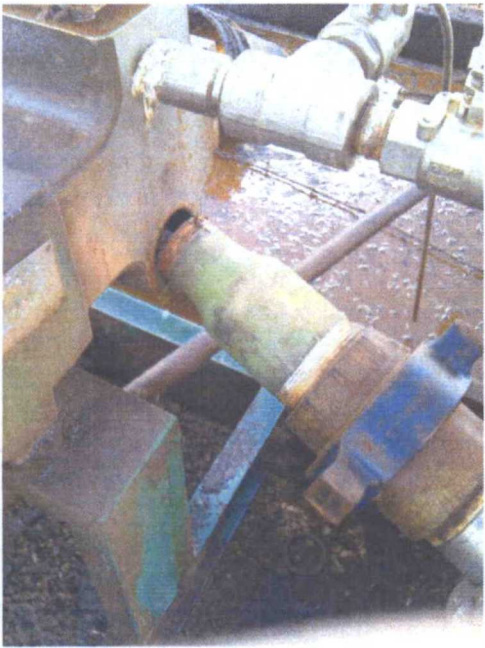
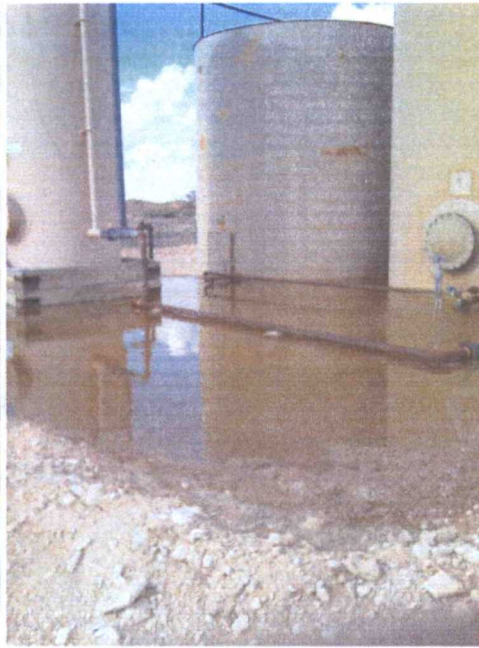
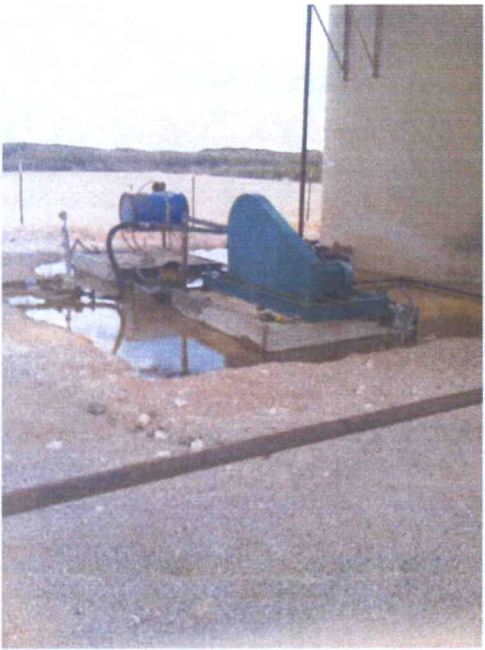
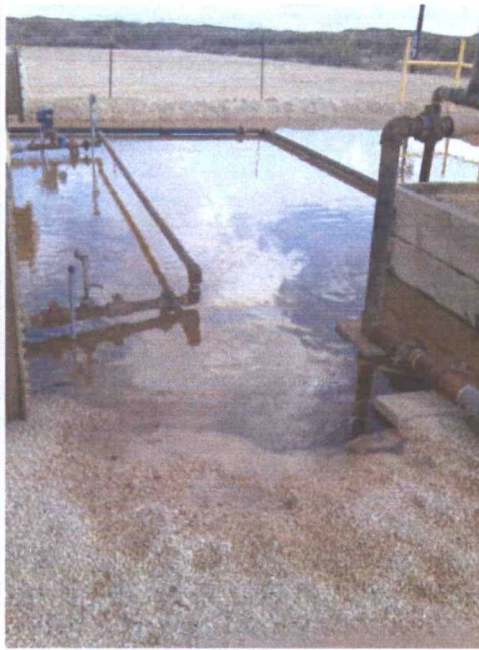
The swedge going into the circulating pump busted loose due to corrosion. All fluid remained inside the containment berms. Standing fluid was recovered.

Full summary: The swedge going into the circulating pump busted loose due to corrosion. 20bbls of produced water was released and 17bbls of produced water was recovered. The swedge has been replaced. All of the fluid remained inside the containment walls of this facility. The NMOCD will be notified this morning and a work plan will be submitted.

Root cause of incident: Corrosion
