GW - 156

Re: Response to Inspection Report, GW-156
Key Energy Services facility, 5651 US Highway 64
San Juan County, New Mexico

**Re: Inspection Report, GW-156
Key Energy Service facility, 5651 U.S. highway 64
San Juan County, New Mexico**

OCD Inspection Key Energy 5651 U.S. Hwy., GW - 156

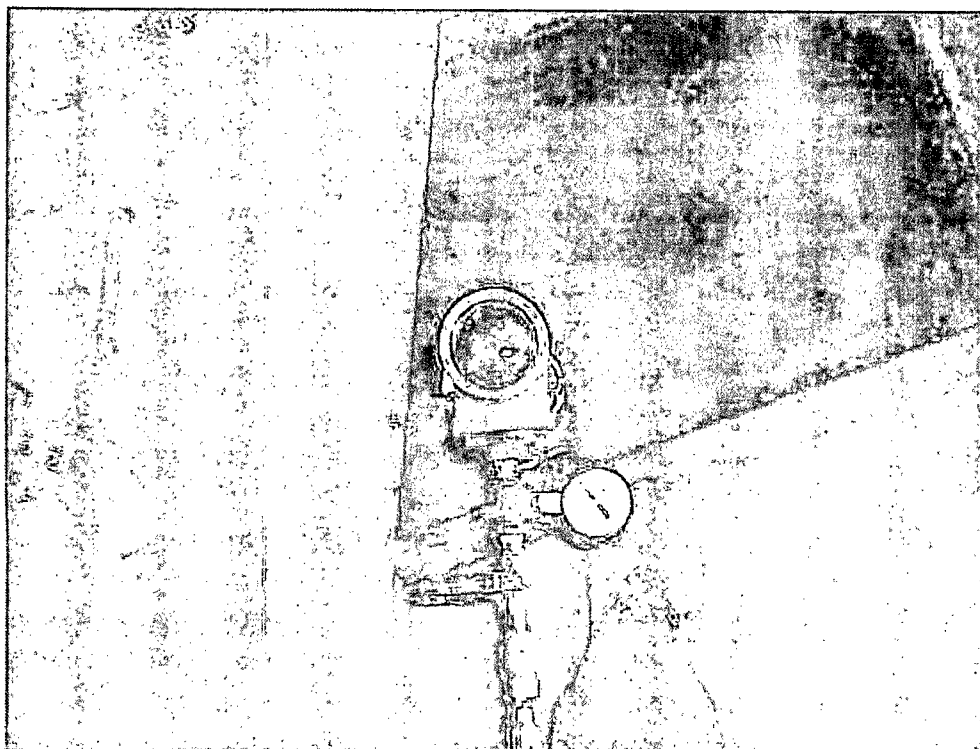
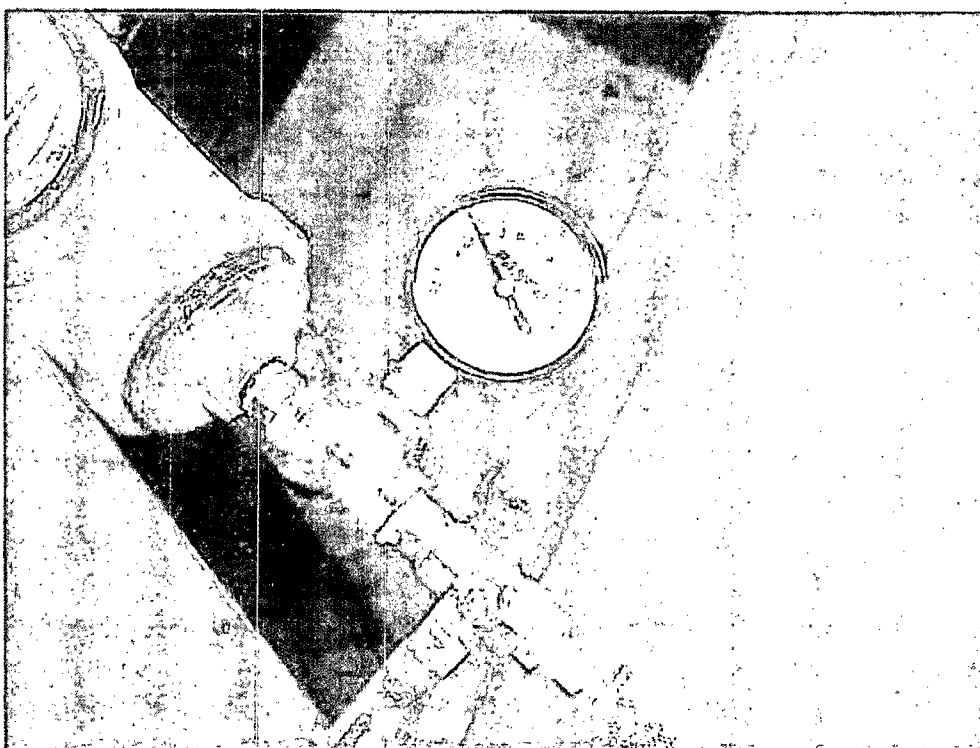
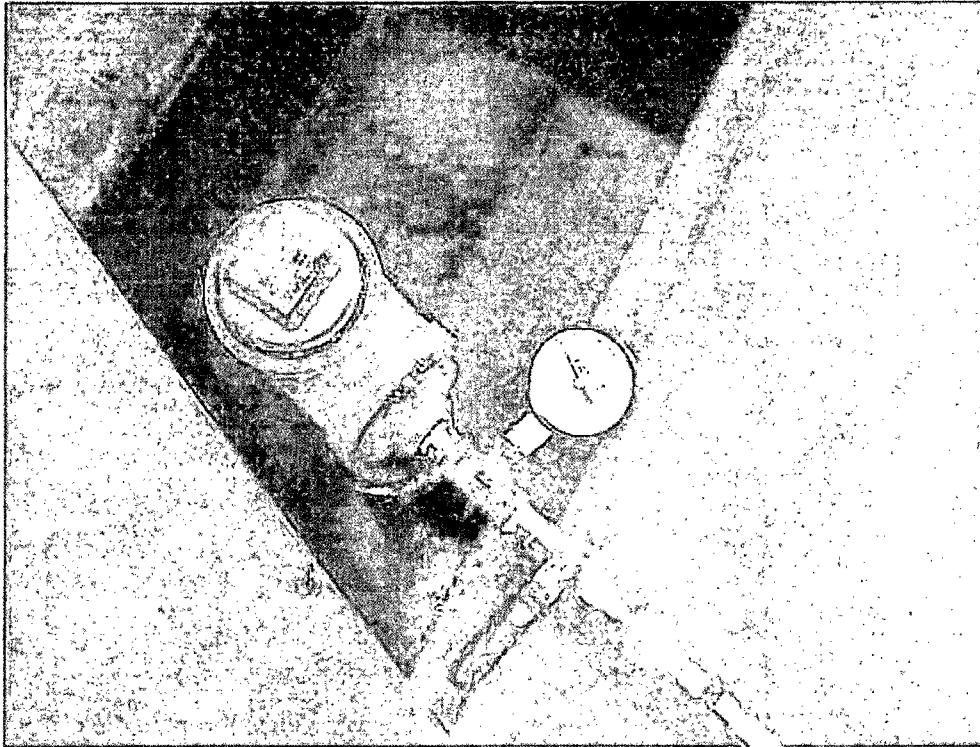
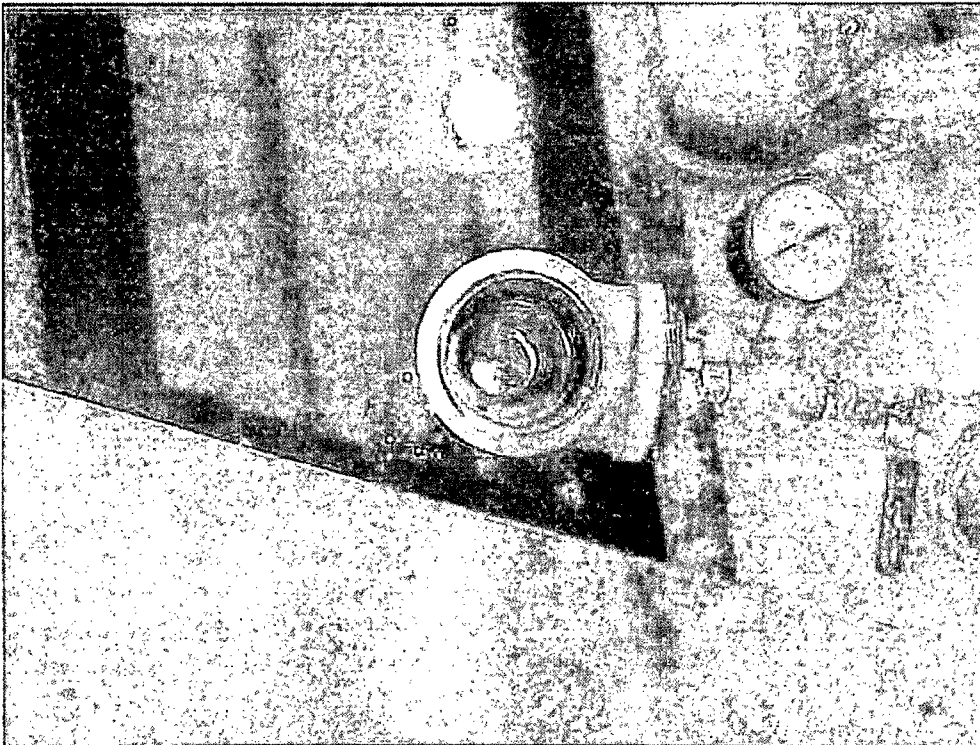
Tested for 24 HRS, next time I will test for 30 min.

Tested all lines at once
by use of plugs.
