EMSU-B #908 INJECTION LINE C141 CLOSURE REPORT

API 30-025-043136

NMOCD RP #1944

May 8, 2009

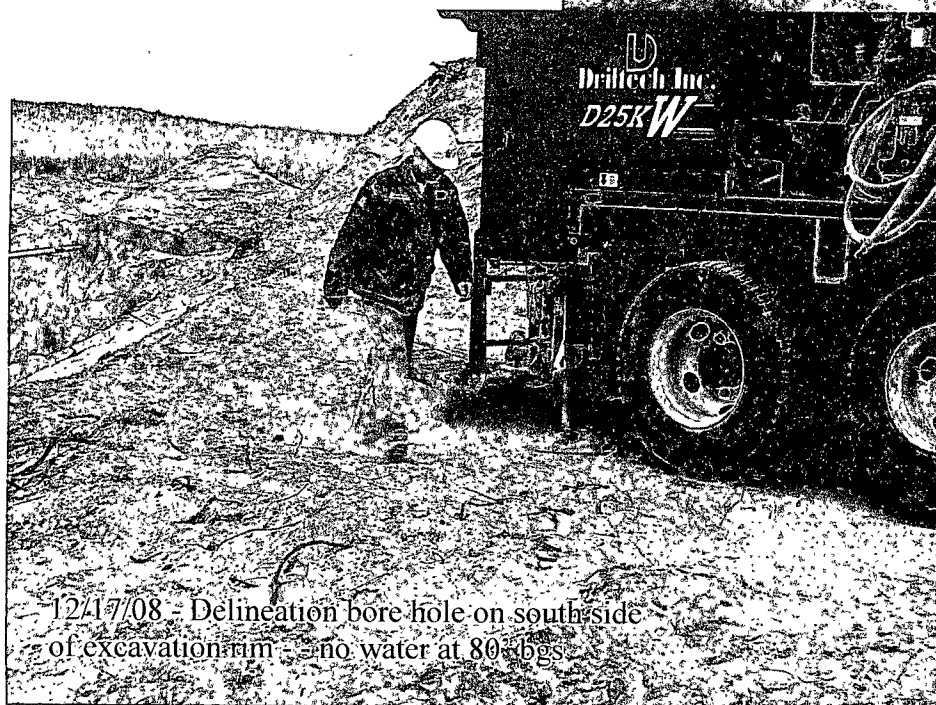
The Chevron-Texaco water contour map (*Plate 4 of Attachments*) indicates that water in this area is 25' – 75' bgs. The delineation well drilled at the south edge of the excavation penetrated below the Red Bed layer present at 25-ft bgs. No ground water is present at this release site.

12/17/08 - Delineation bore hole on south side of excavation rim - no water at 80' bgs
