Release Notification and Corrective Action

IRP-03469

***Attachment for Final C-141 Closure Report for Grand Banks 1RP-03469
AUR#14 Well Site:***

Grand Banks-AUR #14 Oil Well Pad
OCD 1RP-03469
UL I-Sec 2-Ts16s-R32E
Aerial Plot Plan of Original Spill Footprint
Annotated by Price LLC-Oct 10, 2015

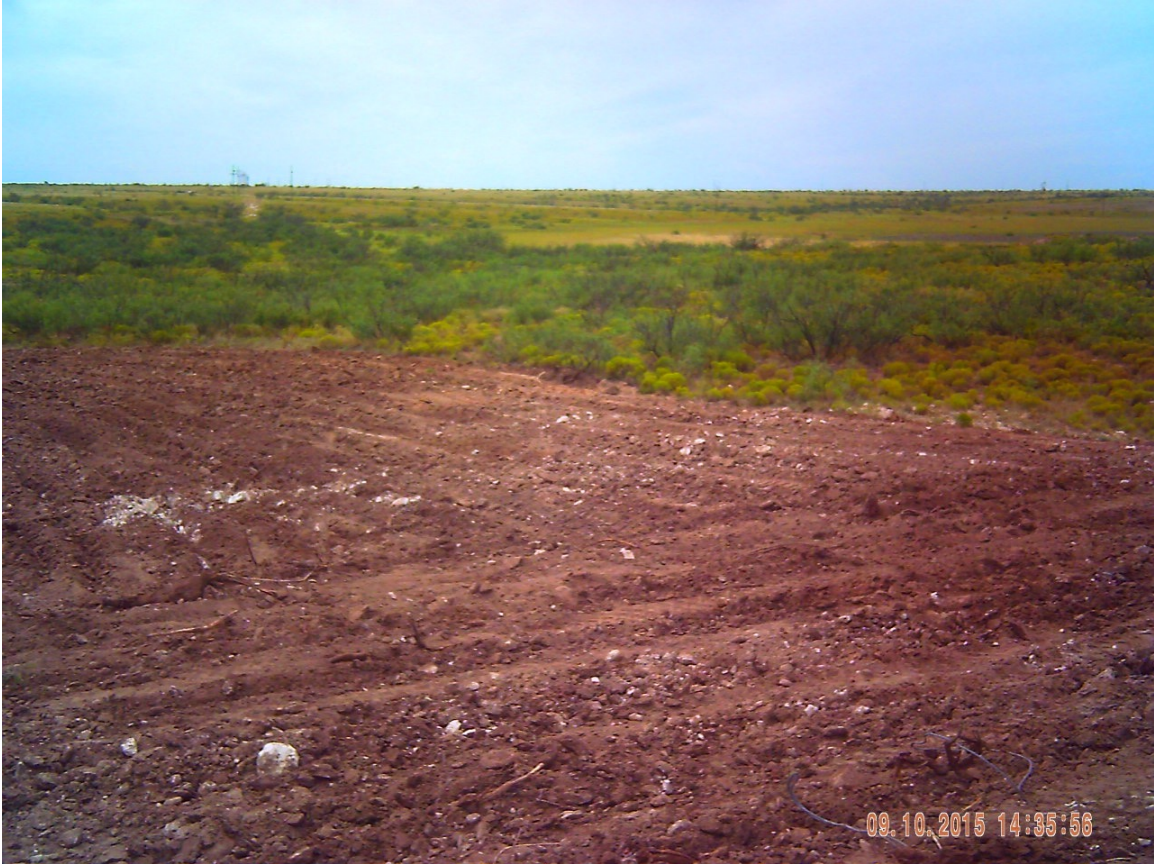
Pool #1 Area-plowed, disked and fertilizer application-Looking East with well pad in background.

The final step including plowing, disking and applying a winter (Hold Over) conditional fertilizer, (8-8-8).
